Hunan University Campus “Teaching and Research Building Two” Preservation and Reuse Design

To cite this article: Francesco Augelli *et al* 2019 *IOP Conf. Ser.: Mater. Sci. Eng.* **471** 082020

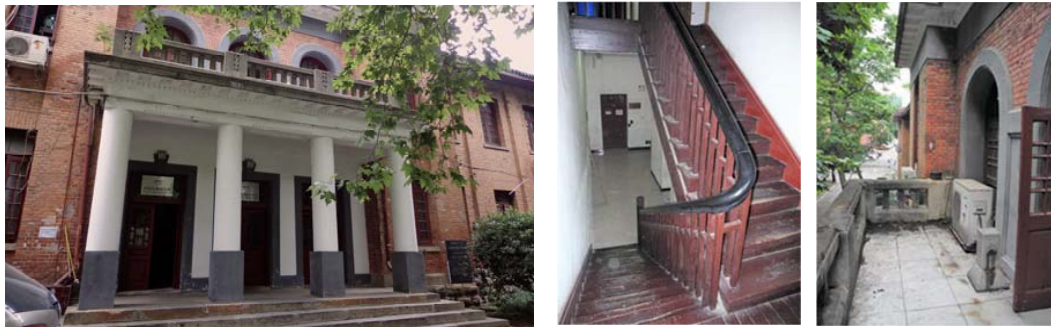
Figure 1, 2, 3 (from left to right): *The Main Entrance of the building located on the Southern Façade; A detail of the eastern wooden staircase; A detail of the loggia on top of the Main Entrance Porch.*

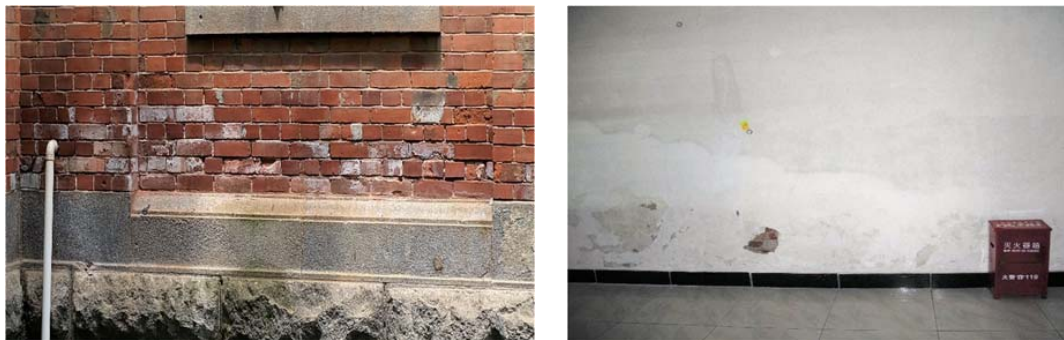
Figure 11, 12 (from Left to Right): Efflorescences and Salt Crusts phenomena are extensively present on the totality of the lower part of the façades; Raising Dump related Decay episodes are also present on many indoor walls

provoked by inappropriate repairs that left painting and plastering remaining. Black stains under the eave and above the windows have been caused by bombings during wartime. Sometimes colour or aspect incongruous films are present in different part of the building due to old coatings and sealants or other protective materials. Some graffiti have been sprayed on walls or carved in wooden elements. Inappropriate repairing episodes and incongruous element placement are present, incompatibility of cement-based mortar with the original design materials composition has not been considered. Moss and vegetation presence have not been removed. Detachments on plasters of walls and ceilings is often visible. In the first case the causes could be due, both or separately, to infiltration from the top and/or of bending of timber structures of the floor, in the second case due to the high humidity from the foundations and in some cases by cement mortar based interventions.

Generally the presence of humidity seemed one of the most prominent problems in the building especially the decay episodes related to raising dump phenomena from the soil. This aspect needed to be investigated further, so some destructive tests were made to understand better the morphology of the original building, especially the foundation, slabs and ventilation shaft systems, and the characteristics of the additional interventions made during the late eighties, most importantly the substitution of the slabs with concrete and the landfill operation that closed all ventilation possibilities (figure 14).

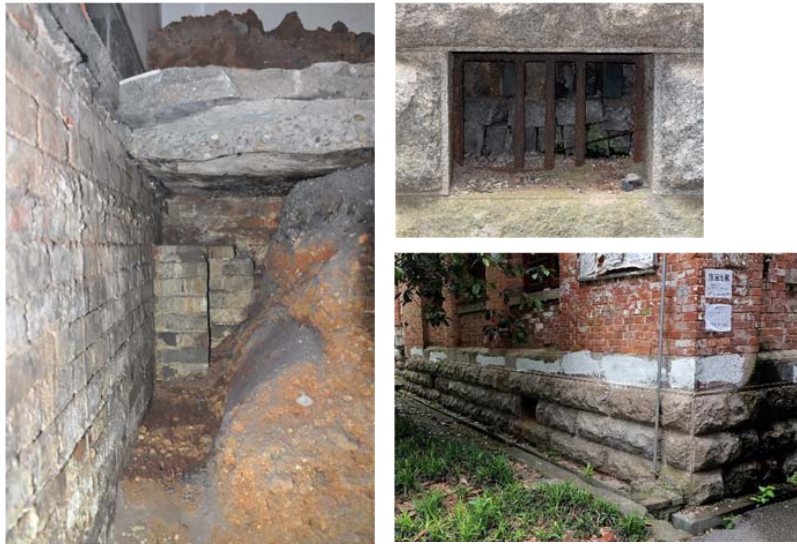
Figure 13, 14, 15: (from Left to Right, Top to Bottom): One of the diagnostic tests realized unveiling the land filling realized to build the ground level floor slab; A detail of one of the closed technical shaft windows; The technical shaft seen from the South-Eastern corner of the Building

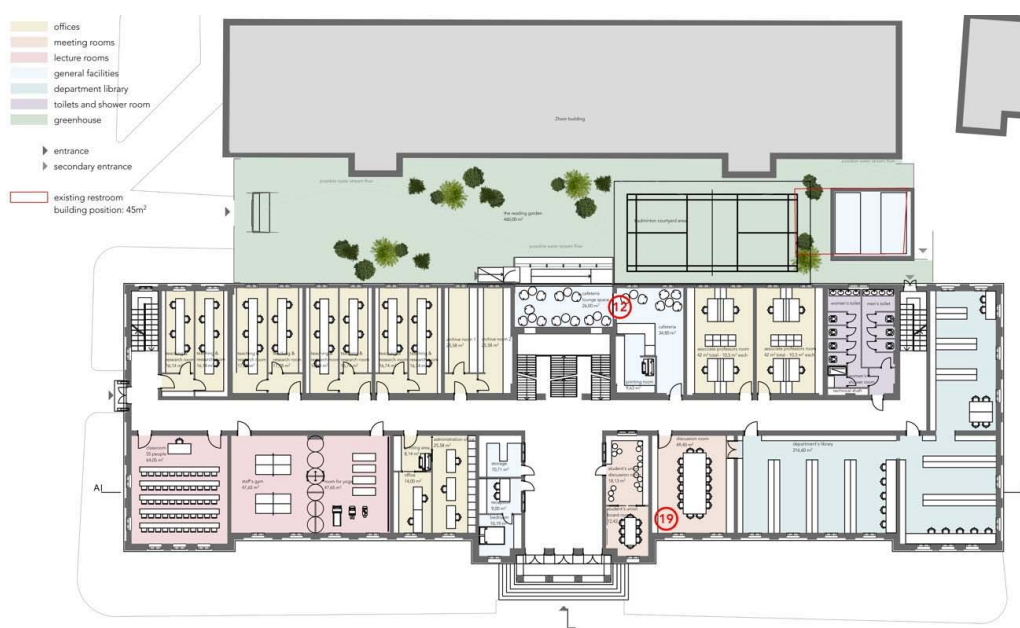
Figure 16: Adaptive Reuse Project Functional Layout – First Floor (Ground)

The preservation and reuse of the building has been commissioned by the Chinese Literature Department of Hunan University whose main aim is to set inside the building the offices of the headquarters of the department and the administration, plus a substantial number of teaching and research personnel offices. Aside to these facilities few services were defined as important to insert: a library, a room dedicated to the Students Union, some discussion rooms, few restrooms with a shower room, a cafeteria, a reception that may host the keeper overnight, a flexible yoga and table tennis oriented relaxing room, some technical utility rooms. The majority of these functions had a fixed square meter standard fixed by the law: particularly the offices had a maximum space available per person to follow. This had major repercussions on the final spaces layout and purposed interior solutions especially considering the “minimum intervention” aims that led to reducing the demolitions to the lowest possible amount in the original 1925 part of the building and respecting the existing windows and doors. The space restrictions were set to 18 sqm each person for the two department leaders offices and ordinary professors, 12 sqm to associate professors, 10 sqm to administrative staff and 6 sqm to researchers. All furniture disposition requests and interior experience needs were arranged combining the two Department Leaders visions through a set of strategical meetings where the designers gave support into defining a satisfactory common ground, respectful of all local laws and standards. The department library is intended to host the many books possessed and offer volumes accessibility to mainly researchers but possibly students too. The possibility to expand the rooms in the future occupying a former discussion room (located on the First Floor and marked with number 19 in figure 16) had to be considered. A meeting room could perhaps host some visuals showing the history of the building, its memories and even the aims and solutions of the present Conservation and Adaptive Reuse Design. The only room, located on the second floor (marked with number 25 in figure 17) where the original wooden slab and flooring is still present and will be preserved by the present work intentions, seemed the most fitting choice according to the possible new functional layout design from the very early schemes and drafts. The upgrade of all implants especially the heating /cooling system and a new electrical and lighting system was also necessary, while the introduction of a lift, initially suggested, has been avoided due to local regulations impediments. The cafeteria and the creation of a reading garden between the considered building and an adjacent one possibly to be restored in the future were spaces intended also as connectors with external users: visitors, students, teachers or researchers from other departments may benefit from these spaces too, opening and not separating the new Chinese Literature Department Headquarters to Hunan University Campus life.

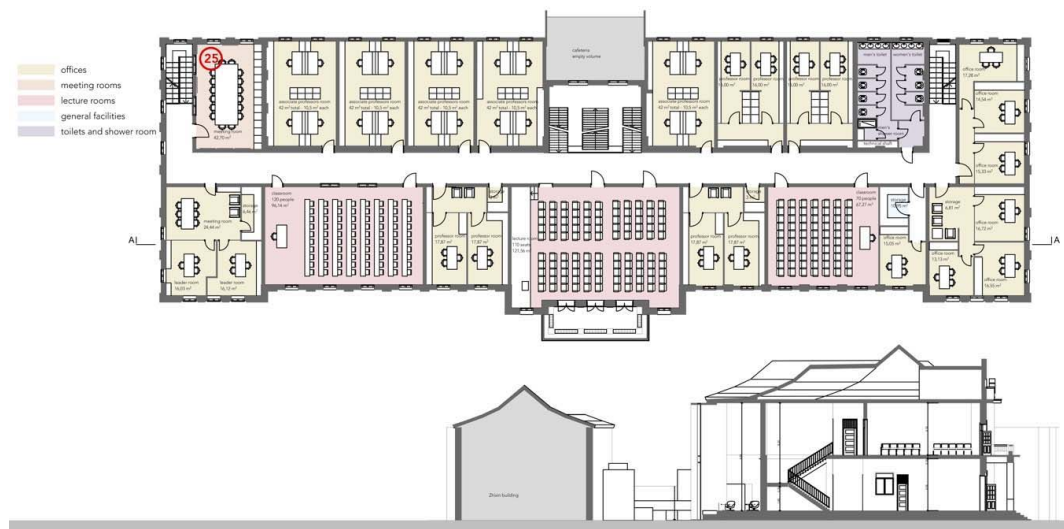
Figure 17: Adaptive Reuse Project Functional Layout – Second Floor
