# Integrated Use of Measurements for the Structural Diagnosis in Historical Vaulted Buildings

Giuliana Cardani \* and Grigor Angjeliu

Department of Civil and Environmental Engineering, Politecnico di Milano, Piazza Leonardo da Vinci 32, 20133 Milan, Italy; grigor.angjeliu@polimi.it

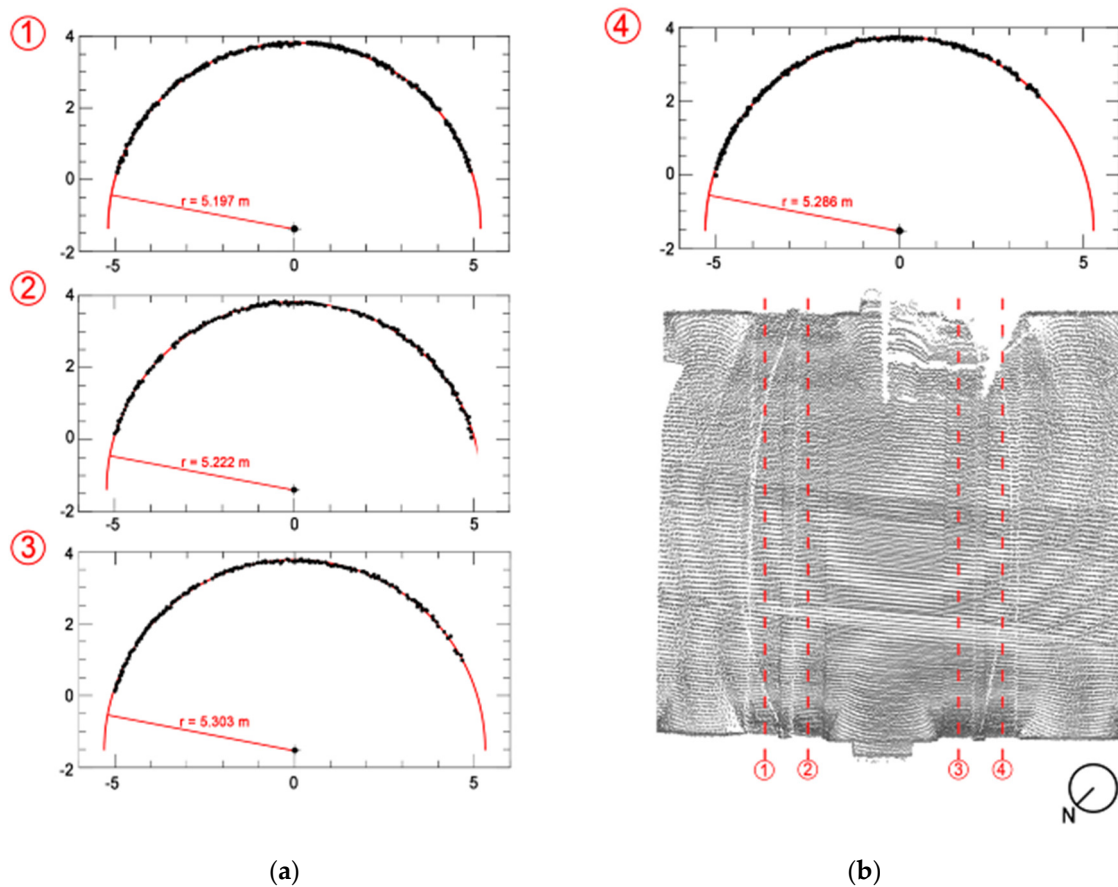
An example from the vaults of the church of St. Marta is shown in Figure 4. Four sections were extracted from the point cloud, in order to understand the geometric shape of the twin arches. It is noted that there is a difference of about 3 cm between the first and second arch, 8 cm between the second and third arch and 2 cm between the third and fourth arch (Figure 4). More advanced procedures involving classification algorithms are considered by other researchers to detect changes and anomalies in buildings [9–12].

**Figure 4.** Church of St. Marta: identification of geometric shape of the twin arches by least square minimization procedure: (a) four transversal sections of the arches extracted from the point cloud and (b) localization in a plan view of the extractions.

The procedure is based on a mathematical fitting of the equation of a circular or an elliptic arch in a subset of the registered point cloud [8]. The data can be used for manual geometric modeling of the vault or for understanding the structural deformations.

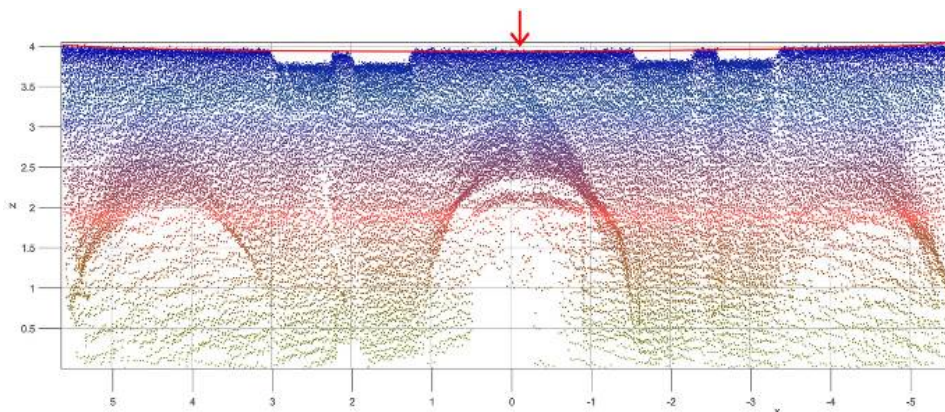
The differences between the identification of the real irregular geometric shapes and the supposed regular geometry can be attributed to a deformation. As in the case of St. Marta church, the small differences surveyed in the three vaults, which must be further investigated, can be probably related to construction irregularities, due to the subsequent addition of the vault, or to structural deformations. The average thickness of the barrel vault is 20 cm. A longitudinal section of the point cloud allows one to see a 3–4 cm deflection extended between the 1st and 2nd bay (Figure 8).

**Figure 8.** Side view of the point cloud with deformation indication.

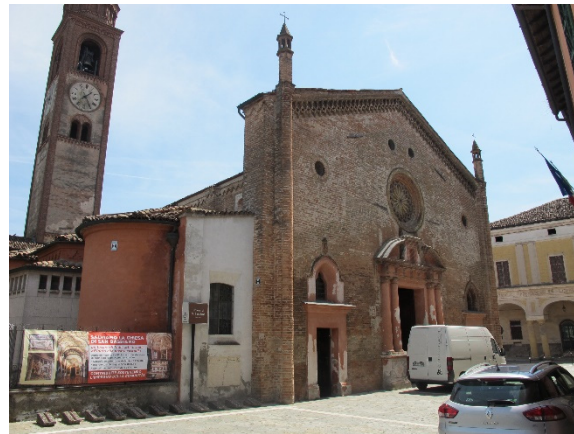
As an example of a very complicated construction history, we would like to mention the St. Bassiano church in Pizzighettone (Cremona). The structural evolution of the church of St. Bassiano is closely connected with historic events between the 15th and 19th centuries, when it was the object of many interventions [3] (see Figure 10).

**Figure 10.** Historical evolution of the St. Bassiano church: (a) façade photo (b) historical evolution plan and (c) historical evolution elevation.

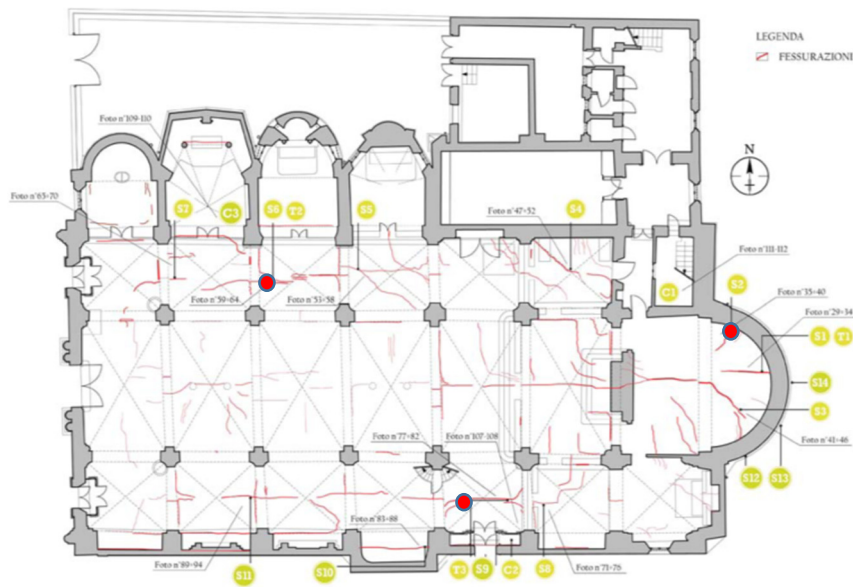
Some cracks have been selected and located in the unrepaired areas, as the groin vaults of the aisles. Some monitored cracks are located also in the apse both internally to verify the efficiency of the realized intervention and externally to verify the effect of the continuous vibrations caused by traffic (Figure 12).

**Figure 12.** Plan of the St. Bassiano church with representation of the crack pattern and sensor location. The three red points represent the monitored cracks reported in the next Figures 13 and 14.

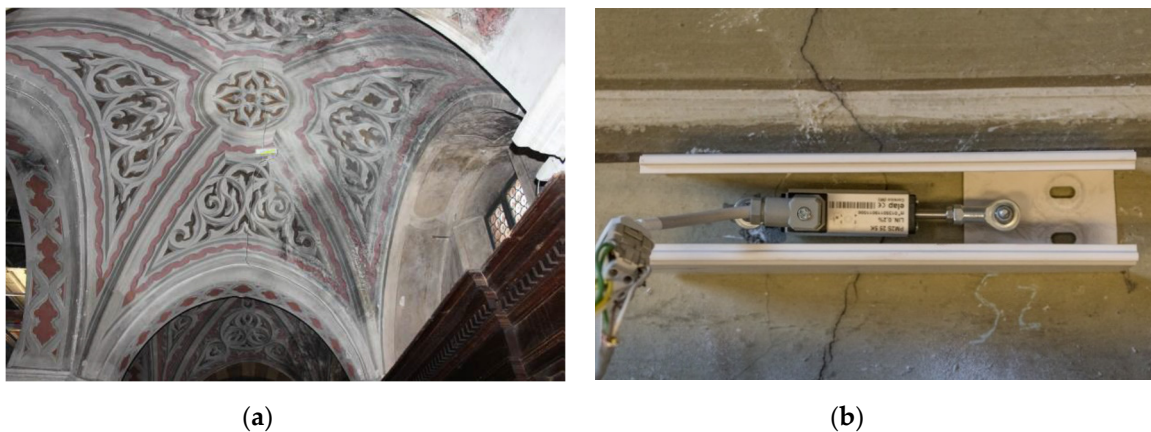
Cracks are monitored with linear displacement transducers (Figure 13), sending signals to a data logger, which converts signals and sends them constantly through the phone line. Measurements were recorded every minute and averaged to half an hour, since 2014. Usually, a period of at least 18 months is long enough to evaluate the active movements, their velocity, the effects of additional damage causes still unarrested, such as the soil settlements, and the daily thermo-hygrometric vibrations.

**Figure 13.** St. Bassiano: (a) monitoring of cracks in a masonry vault by means of (b) LVDT displacement transducers.

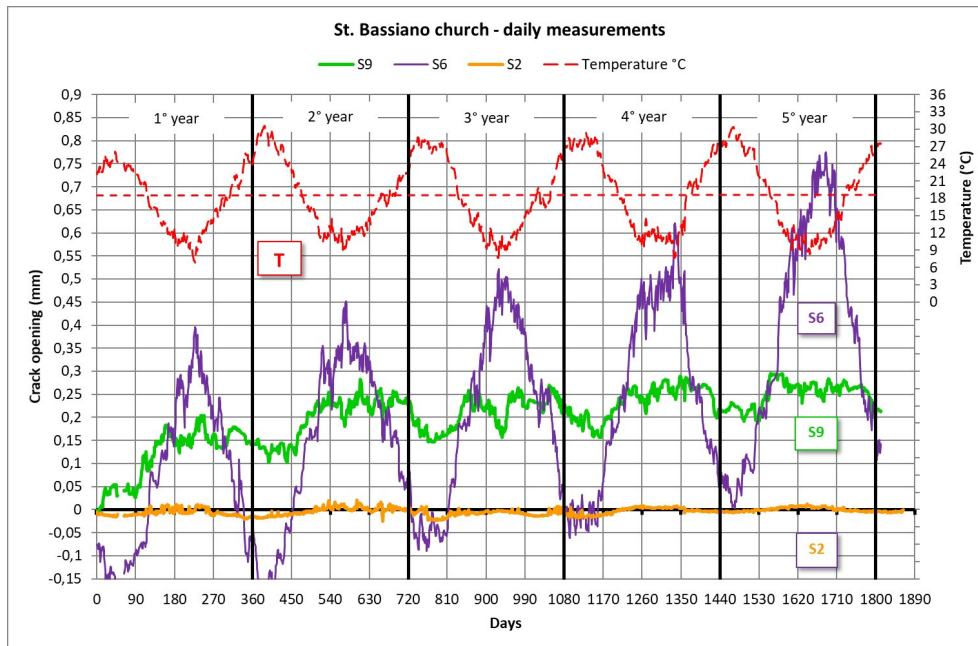
Although present large oscillations on the external side, the cracks monitored inside the apse are stable and confirm the strengthening intervention efficiency (S2 sensor). The monitored cracks on the aisles, due to the first phase intervention on the nave, decreased their opening, except for a couple of cracks in the south aisle (here only S9 sensor is reported) and one in the north aisle (S6 sensor; Figure 14). The trend of S6 against the temperature shows that this crack is passing through the masonry wing of the vault: as the temperature increases, the masonry dilates and the two edges of the crack come closer together; as the temperature decreases, the masonry shrinks and the crack opens. Unfortunately, this oscillating movement is not stable and, year after year, it shows a clear trend for the crack to open over time. On the contrary, S9 was very concerned for the first two years of monitoring and then seems to stabilize in the following years.

**Figure 14.** St. Bassiano church: plot of the 5-year crack monitoring, after the strengthening intervention on the nave vaults, apse and roof. Only some significant sensors are plotted.

The combined use of simulation model and a monitoring system is explained in this section. While most of the monitored cracks on the aisles, due to the first phase of the strengthening intervention on the nave, decreased their opening excepting a couple of cracks in the south aisle (S9, S10) and one in the north aisle (S6). In particular, the S9 measurement base, located near the south-eastward first pillar, has shown a constant opening increase over the time mainly due to a differential soil settlement, without showing a strong effect of seasonal variations. S6 on the north aisle, despite the great seasonal variations, continues to open up (Figure 14).

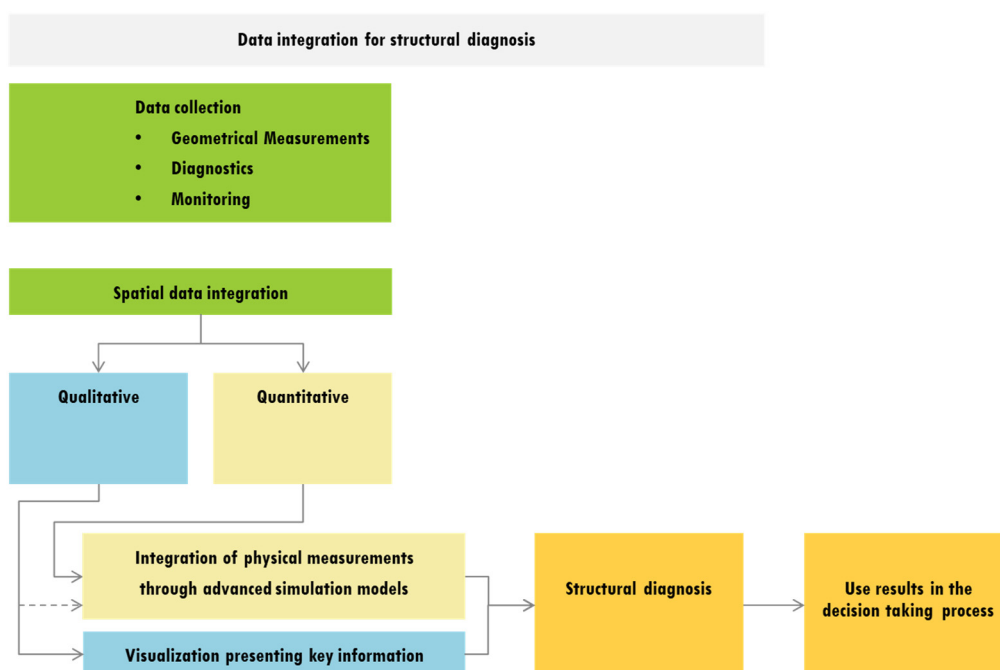
A summary of the considered methodological approach for data integration and its use for the structural diagnosis is shown in the form of a flow chart in Figure 19. The created set of data is of a multidisciplinary nature. After the creation of this database it is essential to divide them in two categories: qualitative and quantitative. As described in Section 3, each of the two categories can be integrated in a different manner. Qualitative data as historical analysis, crack pattern, material degradation, etc., can mostly be integrated in a geometrical model aimed for visualization purpose. Quantitative data, as geometry, deformations of structural elements, mechanical parameters or other can be integrated by means of a finite element model. In this aspect another contribution of this paper was to better use the qualitative data as the history of construction by integrating it in the finite element model.

**Figure 19.** Proposed methodological approach for data integration for structural diagnosis.
