# **CRITICAL INFRASTRUCTURES IN ITALY: STATE OF THE ART, CASE STUDIES, RATIONAL APPROACHES TO SELECT THE INTERVENTION PRIORITIES.**

Marco di Prisco

Department of Civil and Environmental Engineering, Politecnico di Milano, Italy

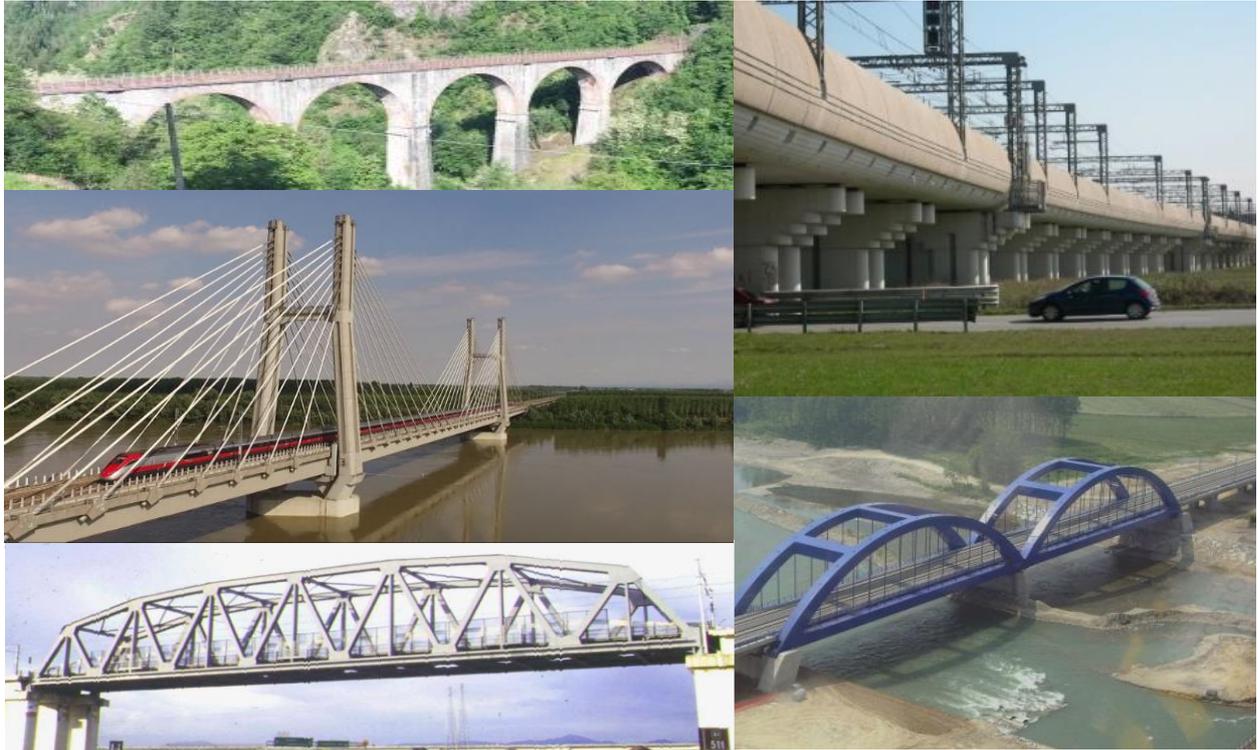
Figure 2. Bridges and viaducts maintained by RFI: several typologies made of masonry, r/c, p/c and steel (courtesy of ing. Andrea Vecchi shown in the Italian workshop organized by CTA, IIS, AICAP and CTE at Milan in 2019).

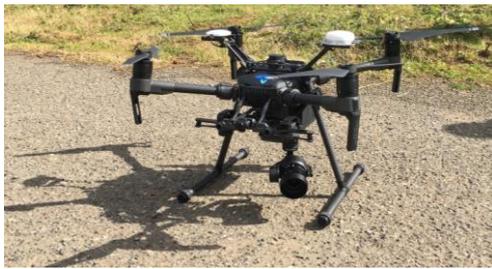
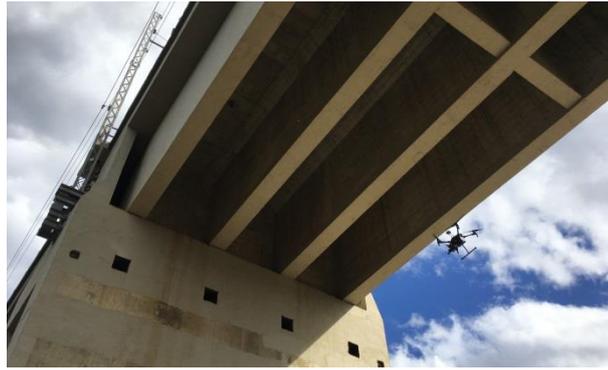
Figure 4. RFI procedures for control visits and relative recording: (a) use of drones; (b) operational drones; (c) reference standard procedures; (d) automatic catalog of defect and relative weighting.

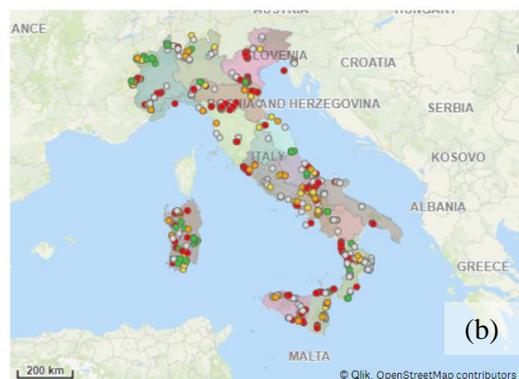
Figure 5. ANAS Bridge Manage System: (a) scheme of the procedure; (b) geolocation of structures with higher degradation rank (IRD).

The inspection procedure until 2016 followed the Ministerial Circular n°6736/61/A1, dated 19 July 1967: the main points are the execution of a quarterly inspection, carried out by technicians and an annual inspection on the most important artefacts performed by engineers. The Circular illustrates the procedures for its execution and provides for the compilation of an inspection report and a form with the data of the product and its main characteristics. In July 2016 a new business multi-year plan was presented for the period 2016-2020 with around 23 Billion€ of financing: the maintenance could be based in 5 years on about ten times the yearly resources available before. For the bridges and the viaducts a new inspection procedure and a new Bridge Management System (BMS) were introduced.

The renewed vision of road management overcomes the logic of episodic or emergency intervention and thanks to a correct reading of the characteristics of the infrastructure and of the events that occur on it, or around it, intervenes programmatically preventing security criticalities, functionality or network comfort (Fig.5a). The local RAM model classifies the need for intervention for each Bridge / Viaduct by calculating a Degree Relevance Index (IRD) and a Future Degradation Index (IDF), combining different information: artefact degradation, its intrinsic vulnerability, environmental parameters and serviceability parameters.

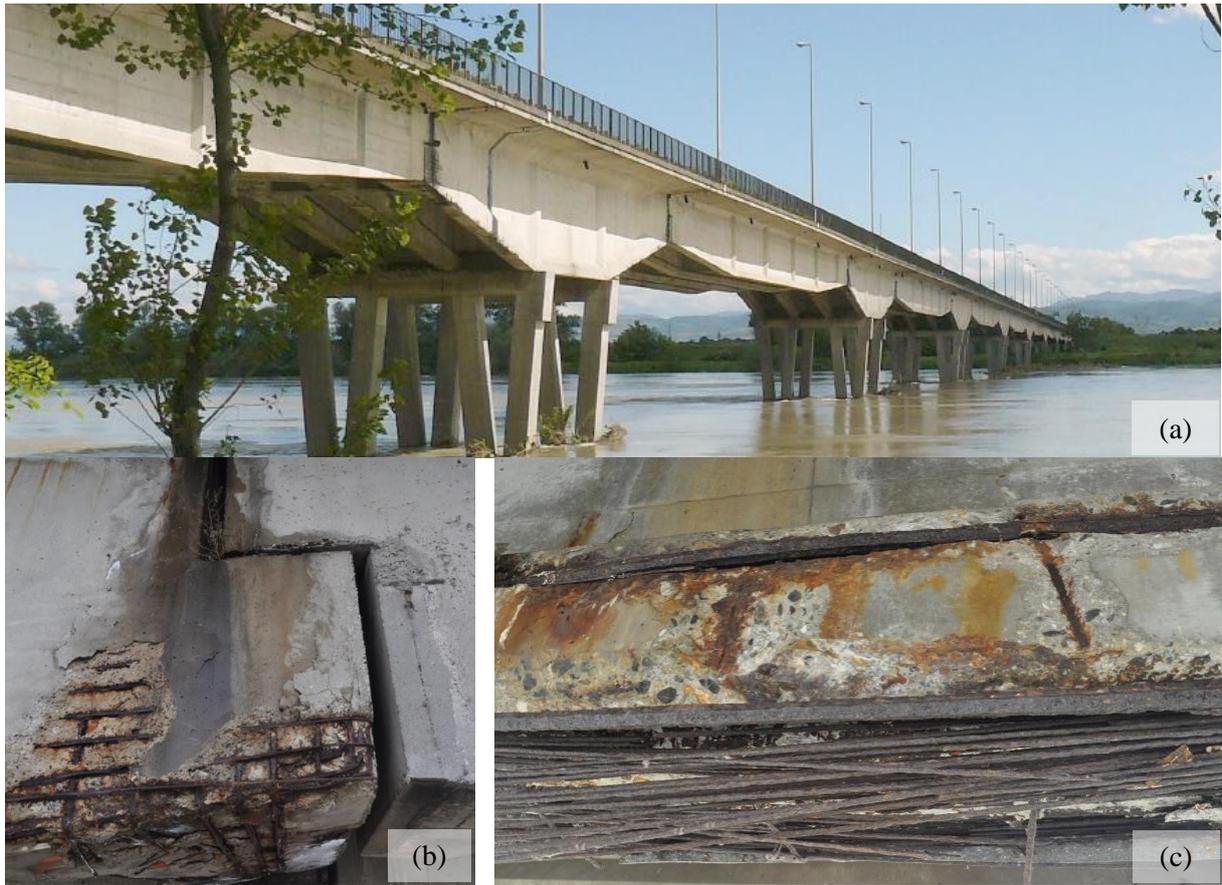
Figure 11. Pieve Porto Morone Bridge on Po river (1967) 1265 m long: (a) side view; (b) critical dapped-end view; (c) corrosion of prestressed reinforcement at the intrados of the beams.

The retrofitting design of modern-aged bridges presents many aspects that do not find a unique and clear answer in the taught civil engineering and in the scientific literature (Malerba, 2014). Looking for instance to two bridges located on Po river (Figs. 10a,b; 11a,b,c), analysed for the Public Work board in the last weeks, the following critical issues can be indicated: the choice of the confidence
