# The Treachery of Images: Redefining the Structural System of Havana's National Art Schools

**Keywords:** Havana's National Art Schools; hidden structure; reinforced concrete; documentary analysis; graphical documentation; infrared thermography

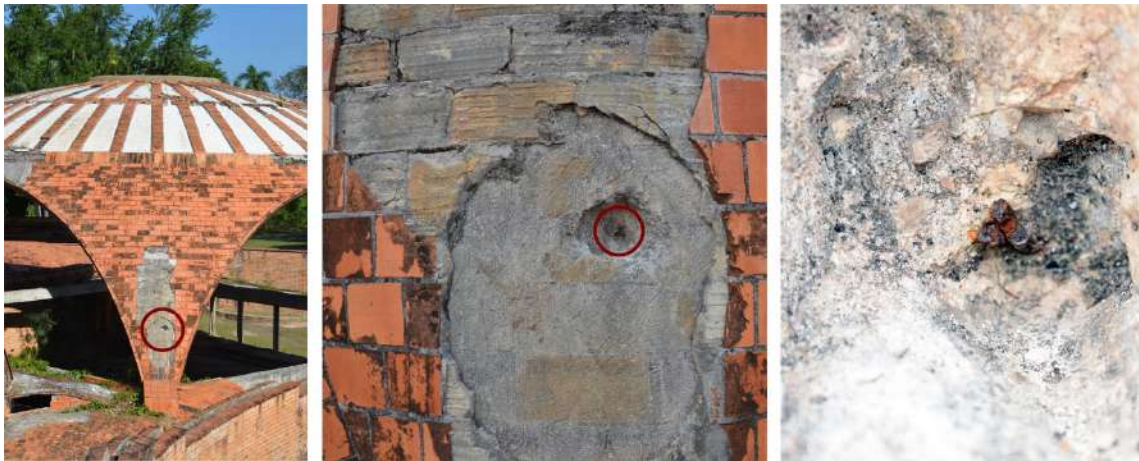
**Figure 3.** The pendentives of the dance pavilion’s dome. The loss of the outermost layer of tiles unveiled the presence of reinforced concrete. The picture on the right shows the visible tie wire.

Seeking further validation of these new findings, Princeton's scholars turned to the historical documentation at their disposal. In particular, they resorted to the oral testimony and photographic albums of school's builder José Mosquera, who carefully documented nearly all stages of the construction site. Piecing together information collected from direct and indirect sources, Douglas was finally able to redefine the construction system of Vittorio Garatti's School of Ballet, whose bearing structure turned out to be mostly made of reinforced concrete. The deceptive appearance of the building, which actually suggests otherwise, comes as a direct result of the construction process.

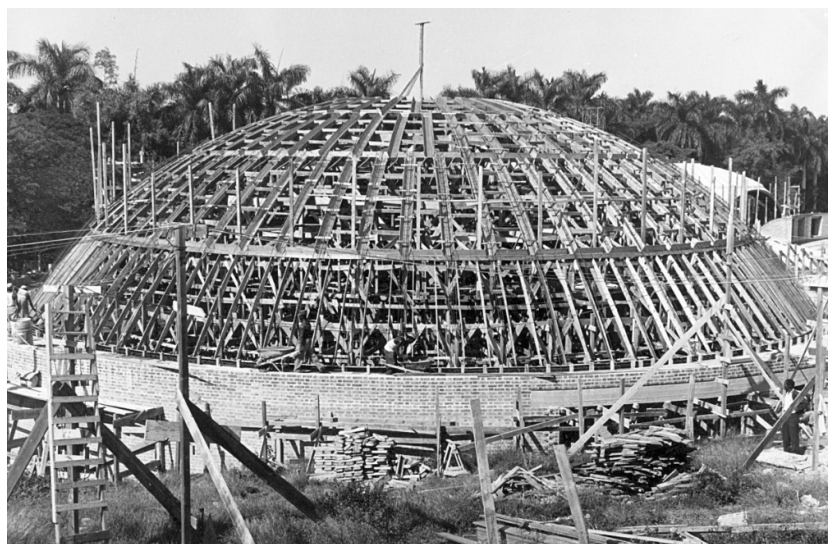
**Figure 4.** The School of Ballet’s choreography theater during construction. The photograph depicts the wooden formworks for the casting of the dome’s concrete ribs and rings (ISA archive).

As emerged from an attentive study of Mosquera’s pictures, the main criterion adopted throughout the building site was that of covering the inside of the wooden formworks with one or more layers of clay tiles before placing rebar and pouring the concrete inside of them (Figure 4).

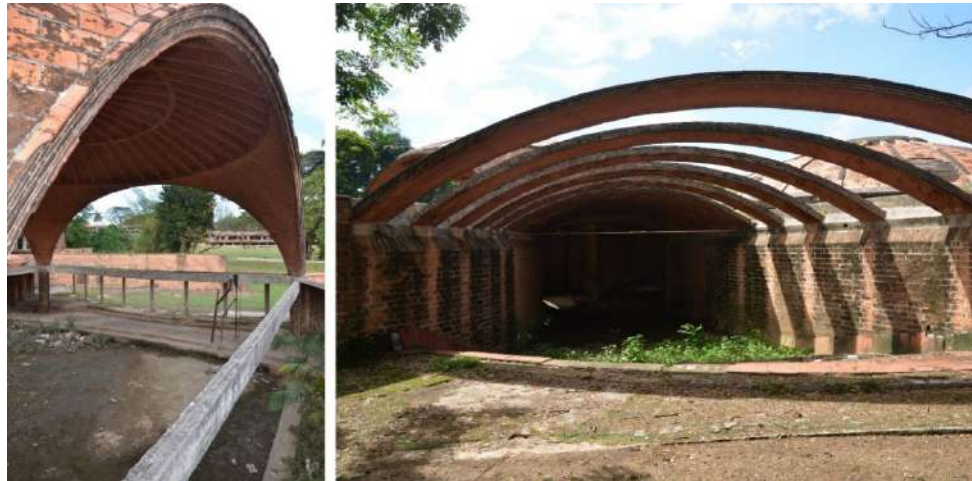
**Figure 5.** The deceptive appearance of the side finishing of the domes and vaults of the School of Ballet, displaying alternating layers of clay tiles and mortar (photo by the authors).

This way, once the concrete had set, the wooden formwork could be dismantled, leaving the tile coating in sight while hiding the core structure underneath. To complete the job, the extrados was also tiled, so that it would in fact appear as a thin-tile vaulted structure [22]. The side finishing of the arches is particularly misleading as it shows the typical pattern of this construction technique: alternating layers of tiles and mortar (Figure 5).

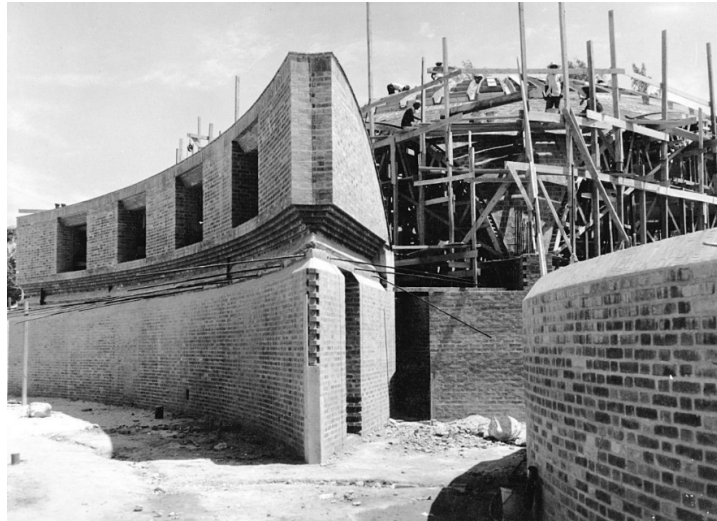
**Figure 7.** One of the pendentives of the dance pavilions' domes during construction. As can be noticed, the tiled intrados of the pendentive was configured as a work form for the subsequent concrete casting (ISA archive).

Once the scaffoldings were in place, masons proceeded to lay one or more layers of clay tiles to build the work forms. In particular, for the pendentives of the dance pavilions and the annular sector at the base of the choreography theater's dome, the intrados was shaped following the geometry of the supporting centering (Figure 7). On the other hand, the work form of the rings and ribs composing the grid of the upper spherical cap were basically made of wood and were then coated with tiles on the inside (Figure 8). Reinforcing bars were subsequently positioned (Figure 9) and finally the concrete was poured to create the main bearing framework (Figure 10). The next step was to fill the gaps of the concrete grid, which was achieved through the construction of narrow tile vaults.

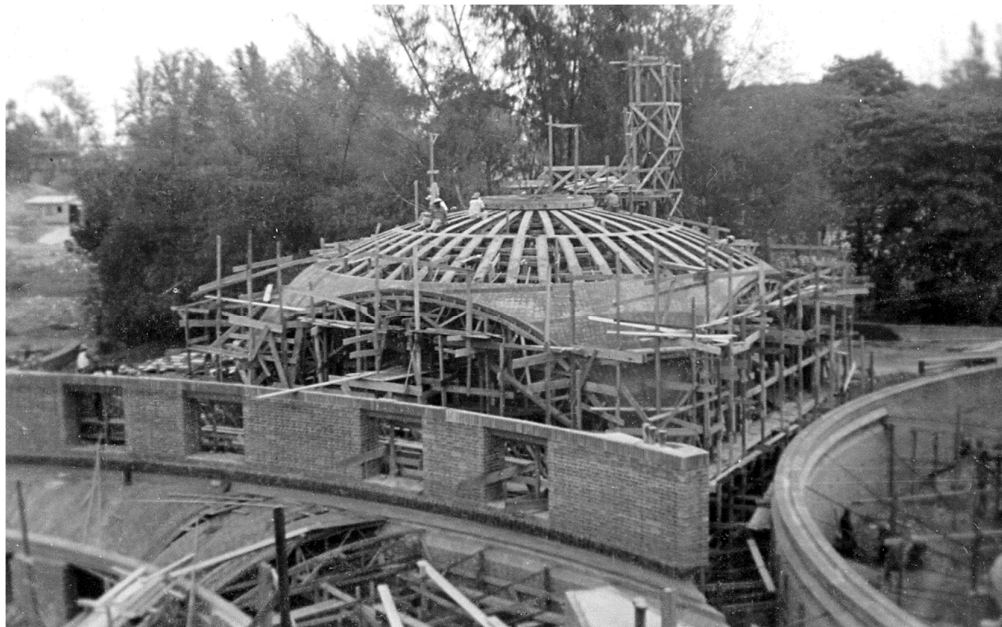
**Figure 10.** One of the dance pavilions after the concrete casting. The picture clearly shows the concrete framework hidden beneath the current clay tile covering (ISA archive).

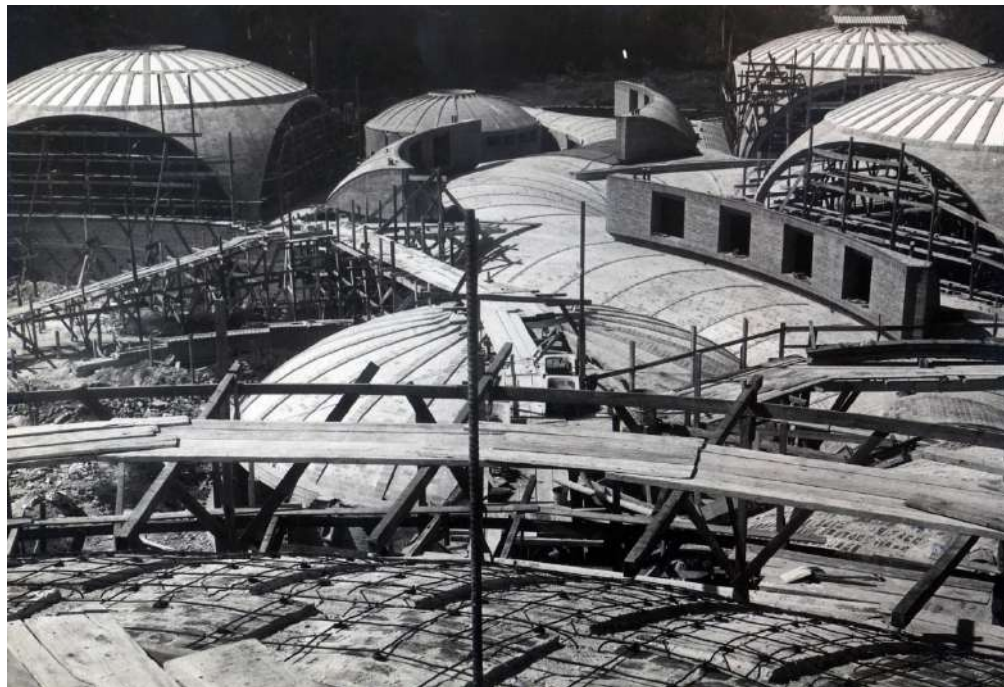
**Figure 12.** The reinforcing steel net positioned above the ribbed cap of the choreography theater before the second concrete casting (ISA archive).

Figure 12 displays a reinforcing steel net positioned above the ribbed cap of the choreography theater, indicating the intention of casting a further concrete layer, just as illustrated by the architect's original design. While no further pictures documenting the next

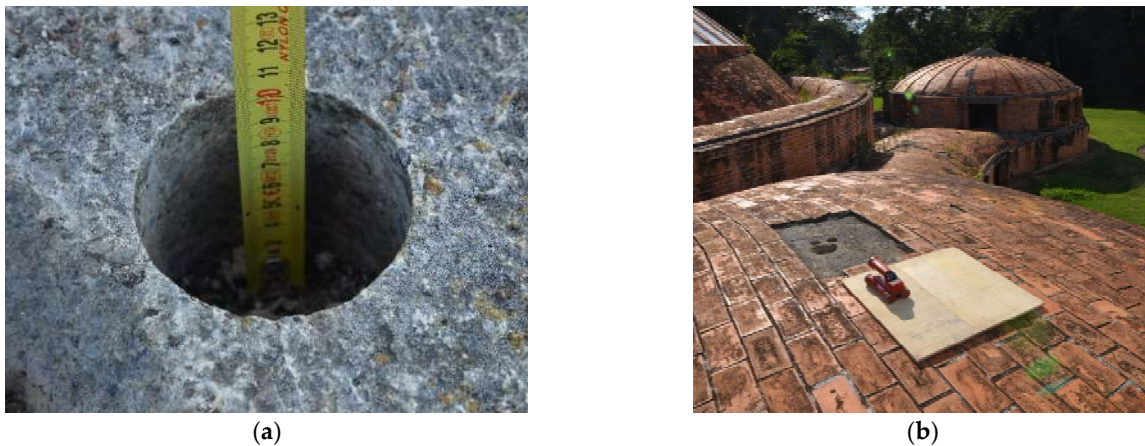
**Figure 16.** (a) The 10 cm hole left by previous core testing, proving the presence of a concrete slab (photos by the authors). (b) Pachometer testing performed to detect possible rebar in the same vault.

Further verification of rebar absence was offered by the outcomes of the pachometer testing performed at the extrados of the vault (Figure 16b), which did not highlight any iron presence within the detection range. These results do not come as a surprise since, as observed in the construction process of the previously described domes, rebar should be located in proximity of the intrados. Finally, a drawing by Vittorio Garatti reveals that the original intent of the architect was in fact to strengthen the pasillo's vaults with reinforced concrete (Figure 17). Even though the blueprint only focuses on the vaults covering the main entrance of the building, it is reasonable to think that the same technique was to be applied to all the larger vaults covering the pasillo.

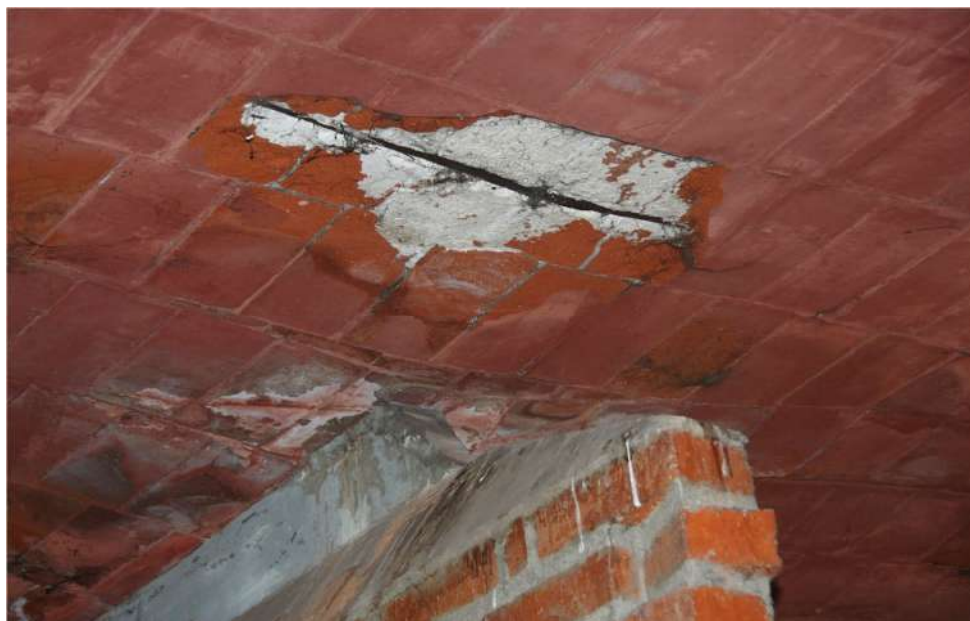
**Figure 19.** Exposed steel rebar at the intrados of the pasillo (photograph by the authors).

The thermographic survey performed on vaults with smaller spans also highlighted the presence of rebar (Figure 18). Although in this case the actual structural system is not reinforced concrete, it is still not possible to talk about pure Catalan vaulting but rather of a mixed technique, as suggested by Michele Paradiso [23]. The outcomes of the thermographic survey were also confirmed by visual inspection: Figure 19 shows a reinforcing bar located above the lower layer of tiles of the pasillo's intrados, which was made visible by current decay.

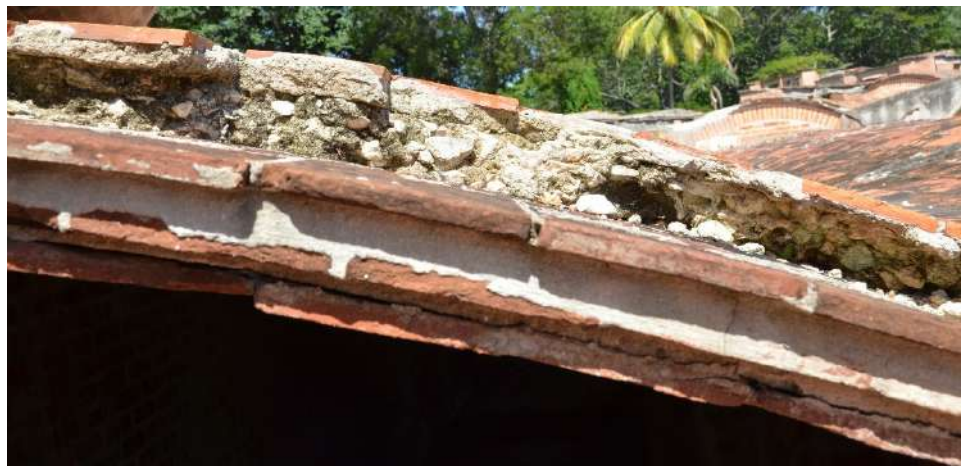
**Figure 21.** Current stratigraphy of the vault covering the lower corridor of the *gusano* building (photo by the authors).

The described ratio is faithfully reflected by the real building, as the vaults comprise, from top to bottom, one layer of clay tiles, one layer of cement, and three further layers of clay tiles held together by layers of mortar (Figure 21). The consistency between the original design and the current situation seems to suggest that, at least in the School of Music, the principle of favoring Catalan vaulting over reinforced concrete was actually put into action [1,2]. Nonetheless, further analyses were carried out to validate this hypothesis.

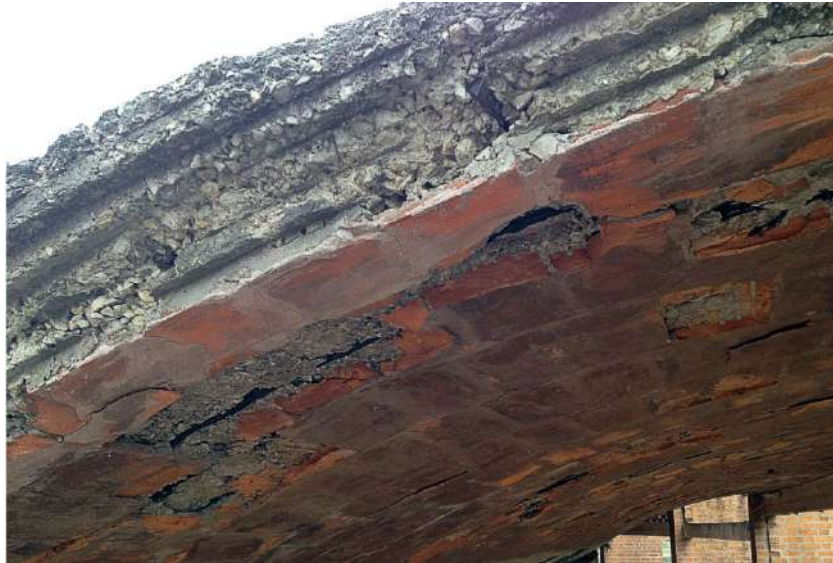
**Figure 23.** One of the vaults replaced with plain concrete vaults. The poor quality of the materials employed resulted in delamination and consequent exposure of steel rebar (photo by Luca Valisi).

While we had to acknowledge that, regardless of the original designs, some of the vaults were not built according to the Catalan technique, uncertainties still remained with regard to the structural system of the corridors' covering, with particular reference to the one on the upper floor. The direct inspection of the building offered some helpful insights on the topic: firstly, it was understood that some sectors of the vault, which had probably collapsed, were completely replaced with similarly shaped reinforced concrete ones. However, the poor quality of the materials employed caused their quick deterioration, and today, due to the diffused delamination of the intrados tiles (which could very well be a consequence of concrete spalling), rebar is largely visible (Figure 23).

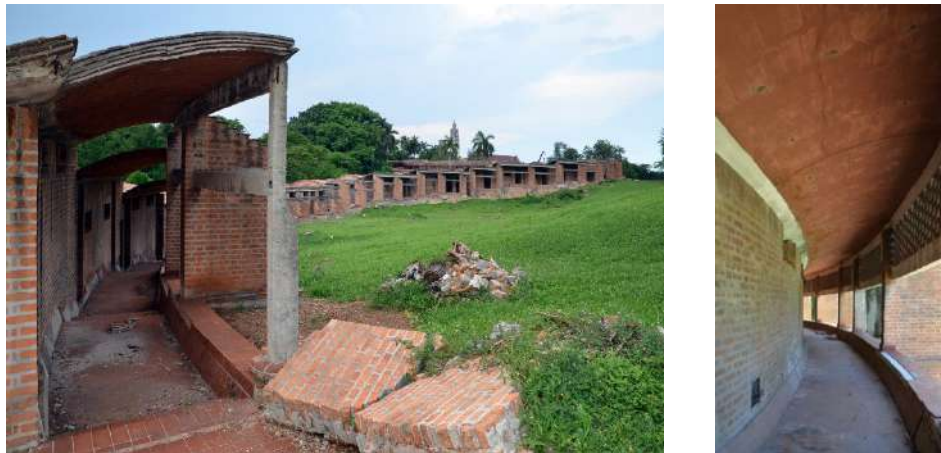
**Figure 24.** The cracks running along the crown of the vaults covering the upper corridor of the gusano building (photo by the authors).

On the other hand, the vaults that were not substituted are not affected by delamination phenomena but consistently show cracking along the crown (Figure 24). The latter represents the typical crack pattern of segmental masonry vaults [72], leading one to believe that the external hallway could in fact be covered—at least in the authentic portions—by true Catalan vaults. This hypothesis is however denied by the outcomes of the thermographic survey, which seem to display the presence of steel rebar along the vaults (Figure 25). The structural system should thus be similar to that of the smaller vaults of the pasillo of the School of Ballet, which, although not made of reinforced concrete, are strengthened by metallic bars, mostly located in proximity of the joints between adjacent sectors.

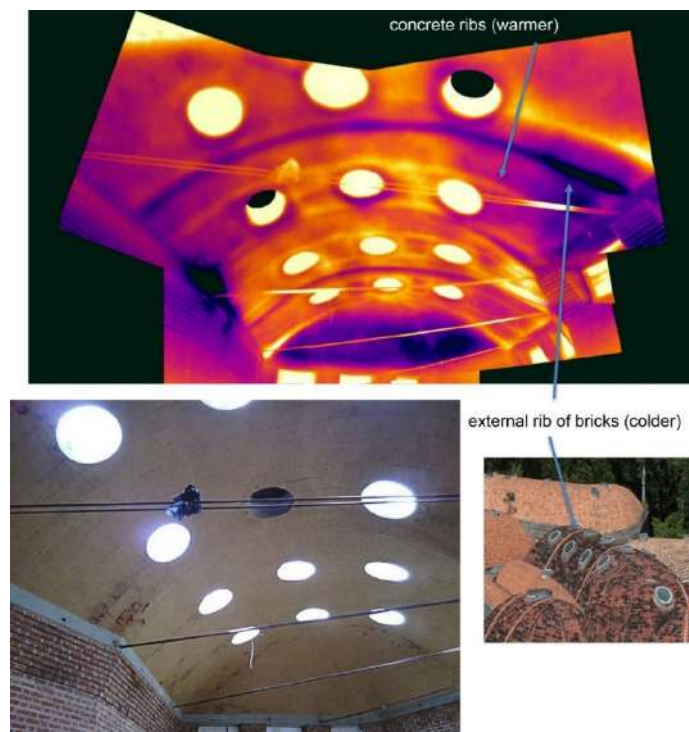
**Figure 29.** School of Dramatic Arts: Thermograph of a vault (thermal range 28.0–30.0 °C). 19 February 2020 at 1:00 p.m., 29.1 °C—RH 67.0% (Images by Luca Valisi).

run crossway, delimiting and strengthening the strips of the vault where the skylights are located.
