CONDITION MONITORING OF RAILWAY AXLES BASED ON LOW FREQUENCY VIBRATIONS

Paweł ROLEK, Stefano BRUNI¹, Michele CARBONI

Department Mechanical Engineering, Politecnico di Milano

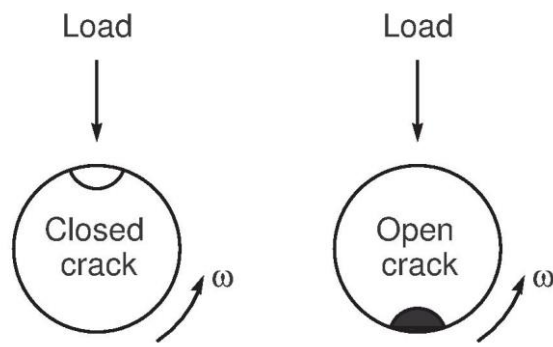
Fig. 1

- Figure 1: nx Rev vibration induced by: a) a non-axisymmetric bending stiffness of the axle; b) the crack breathing mechanism.
- Figure 2: The dynamic test bench for full-scale railway axles: a) scheme; b) view of the bench.

Finally, the crack breathing mechanism may occur. This consists of the cyclically opening and closing crack surfaces caused by the application of rotating bending. This phenomenon is illustrated

in Figure 1b: assuming the cracked rotor is rotating under the effect of a force that bends the axle downwards, compressive stresses are generated in the upper part of the axle section, whereas tensile stresses are generated in the lower part. Hence, when the crack is in the upper position, its surfaces are compressed so that the bending stiffness is the same or similar to that of a non-cracked section. When the crack moves to the lower position, the crack surfaces are separated resulting in a reduced bending stiffness. The breathing mechanism is therefore the result of the action of static loads (weight, reaction forces, etc.) and dynamical loads (i.e. unbalance, external excitation) combined with the axle rotation. Experimental results reported in [15] show that as long as static loads are predominant over the dynamic ones, the crack breathing is governed by the angular position of the shaft with respect to the stationary load direction. In this configuration, the crack opens and closes completely once per revolution.

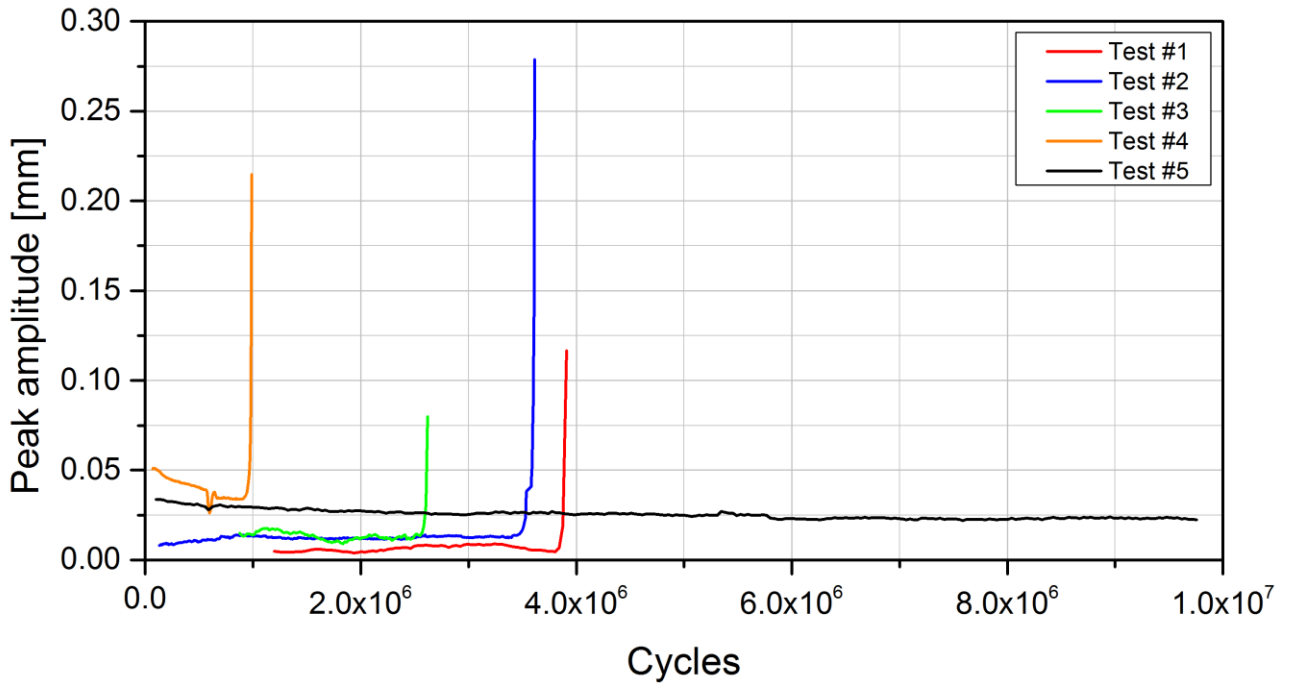
Fig. 7

Figure 7 compares the results of the trending analysis for the 1xRev (Fig. 7a) and 2xRev (Fig. 7b) harmonic components across the four tests ended in a crack propagation and for the one (test #5) in which no crack initiation occurred. A qualitatively similar trend is observed for tests #1-4, although the final amplitude of vibration is quite different. This can be explained noticing on one hand that the tests were carried out at different levels of applied constant amplitude rotating bending load and on the other hand that the final size of the crack was different for tests #1–#4. For test #5, the amplitude of the harmonic components (also those not shown in the figure) is approximately constant.

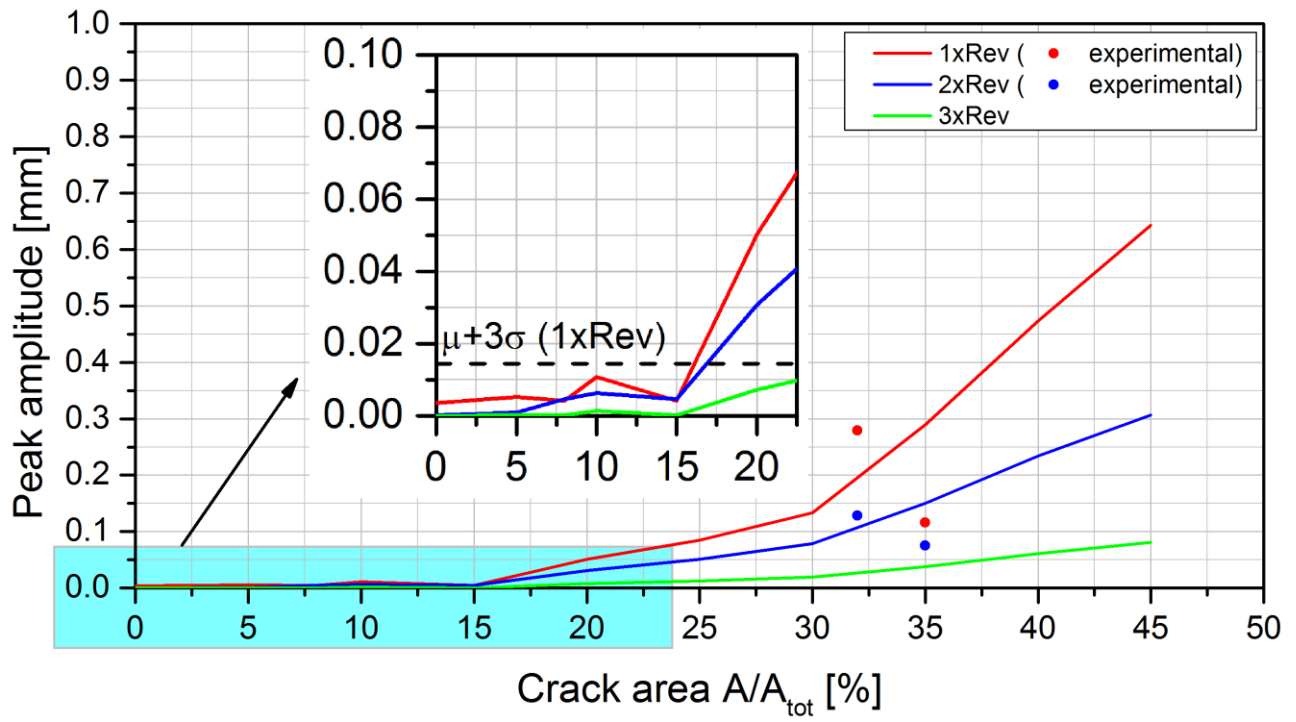
Fig. 10

- Figure 10: Results of simulations considering the “laboratory tests” scenario. Trends with crack depth of the 1xRev, 2xRev and 3xRev harmonics (peak amplitude). The warning threshold shown in the detail is calculated from 1xRev data.

In Figure 10, the trends of the amplitude of the 1xRev, 2xRev and 3xRev harmonic components are presented as a function of cracked area of axle cross section. For crack areas up to 15% the amplitude of all considered components is very small, showing that the presence of a crack in this size range is not affecting significantly the axle's dynamic behaviour. For crack sizes in the range 15% to 30%, the amount of nx Rev vibration starts to become significant and shows a slowly increasing trend with increasing crack size. For crack areas above 30%, the amplitude of vibrations generated by the crack is large and rapidly increasing with crack size, especially for 1xRev and 2xRev components.

Assuming, now, the numerical results for crack sizes up to 15% of axle cross section as baseline data (as mentioned above, the SHM procedure is insensitive within this range), the warning threshold was calculated for the example case of 1xRev components (detail in Figure 10). As can be seen, the SHM procedure issues a likely failure warning for a crack area equal to about 16% of axle cross section, which corresponds, for the considered case of hollow axle, to 2670 mm².
