Article

Autogenous Self-Healing Capacity of Early-Age Ultra-High-Performance Fiber-Reinforced Concrete

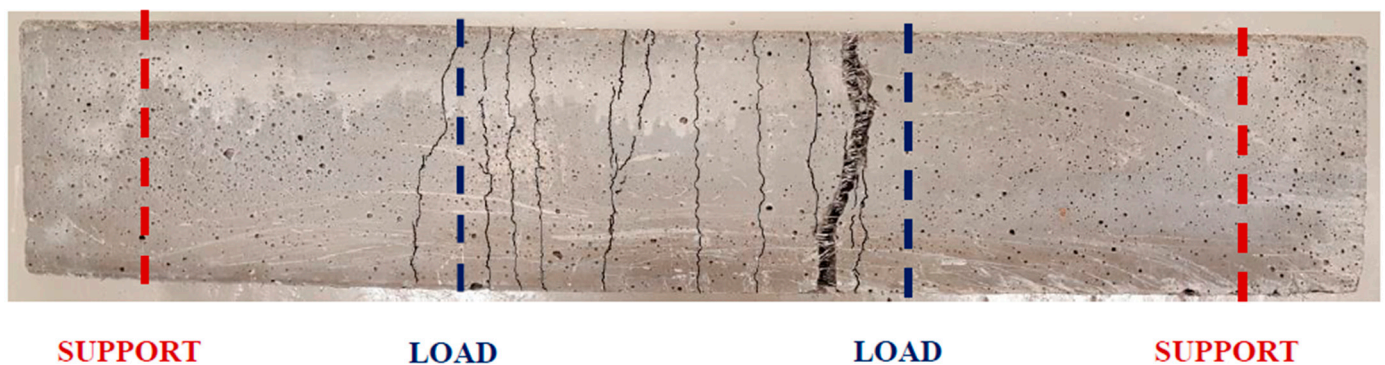
Figure 2. Typical final crack pattern observed on the bottom surface after 4-point bending test.

were carried out on notched cubic specimens ($100 \times 100 \times 100 \text{ mm}^3$) obtaining a main crack with an opening up to 0.4 mm. Crack widths were controlled by means of Linear Variable Differential Transformers (LVDTs). In the case of flexural tests, the LVDT measured the deflection in the center of the specimen and in the case of the notched cubes, two LVDT were placed on each side of the specimen measuring the crack width at mid-height of the cube. Figure 2 shows the aspect of the central span of one of the prismatic specimens tested up to failure. Well before the crack localization, microcracks are not visible without the digital microscope. Therefore, the cracks in Figure 2 have been retouched to facilitate the cracking pattern observation to the reader. In this way, in Figure 2 it is possible to observe the multiple instances of microcracking and the localized crack.

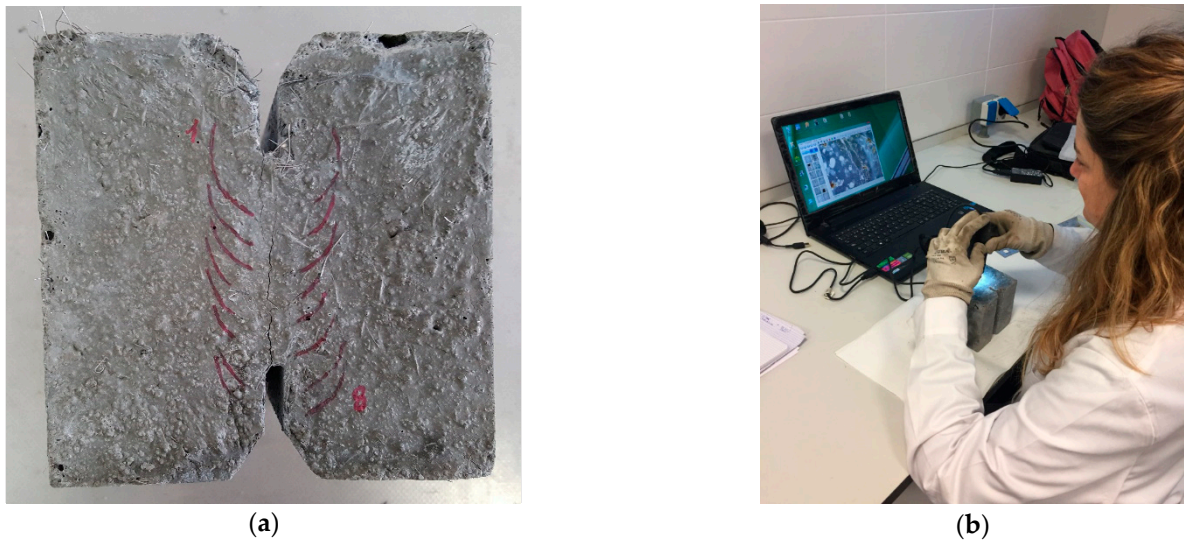
Figure 3. Crack observation by means of digital microscope: Specimens with circle marks for taking pictures with the digital microscope (a) and a picture during the crack evaluation (b).

Self-sealing of the cracks was observed after the different healing exposures by means of a digital microscope Dinolite® (NN Almere, The Netherlands). The digital microscope and its software allowed us to take pictures of the crack at different magnifications (Figure 3). With the microscope, eight pictures were taken for each crack before subjecting specimens to the several environments. These eight pictures allowed us to cover the whole crack. To analyze the same areas before and after the healing exposures, the contour of the microscope was marked into the specimens for each position selected for each picture, as showed in Figure 3a. Calibrating the microscope, it was possible to quantify all the parameters related to the geometry of the crack and the extension of healing products on the surface of the specimens, as shown in Figure 4. As already explained, microcracks were not visible to the naked eye, because of this they were retouched in Figure 4a to facilitate cracking pattern observation to the reader. On the other hand, macrocracks were visible to the naked eye, therefore, they did not need to be retouched in Figures 3 and 4b. It can be observed that, in the notched cubes appeared a localized crack surrounded by other cracks as expected considering the hardening behavior of this kind of concretes (UHPCFRC). A full description of the methodology can be found in [15]. In this case, crack width was measured before and after healing period and with these values, it was possible to calculate the crack closure (in %) as indicated in Equation (1):

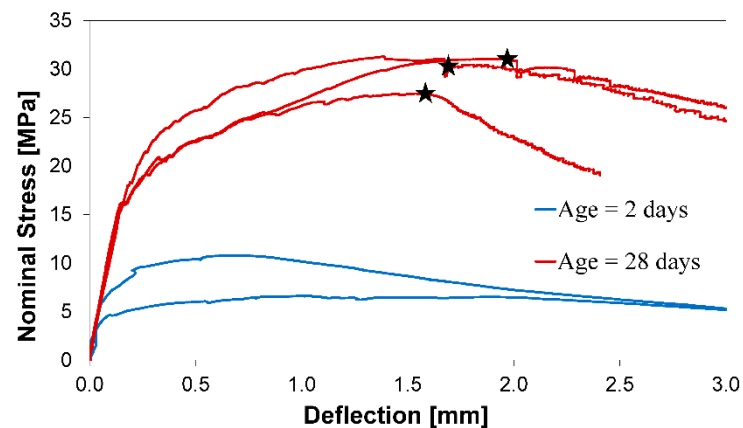
Figure 5. Stress (MPa) versus deflection (mm) curves obtained from flexural tests (the star indicates the initiation of the crack localization).

The procedures adopted to carry out the mechanical characterization of the UH-PFRC used in this research were described in Section 2.4. The slump flow obtained was 650 mm, which corresponds to a SF1 consistency class and the average compressive strength was 139.07 MPa at 28 days, with a coefficient of variation (CoV) of 7.7%. Flexural strength was evaluated by means of four-point bending tests in prismatic specimens ($100 \times 100 \times 500 \text{ mm}^3$). These prisms were tested up to failure 2 days after casting (two prisms) and 28 days after casting (three prisms). The early age of 2 days corresponds to the age selected for precracking the specimens and 28 days was selected to characterize mechanically the UH-PFRC used in this work. Figure 5 shows the stress-deflection curves and Table 4 shows the stress at first cracking and the stress at the peak value for both ages, 2 and 28 days. In Figure 5, the star indicates the crack localization initiation which is above

95% of the maximum strength. This is consistent with the findings of López et al. [14] who ensured, after analyzing a comprehensive database, that the analytical crack localization point ranged from 75 to 100% of the flexural strength. In 70% of the cases observed, the crack localization point was greater than 95% of the maximum strength, being the most frequent value at 97% of the maximum strength. In Table 4, it can be observed that at early age (2 days) the specimens showed higher coefficient of variation values than at 28 days.

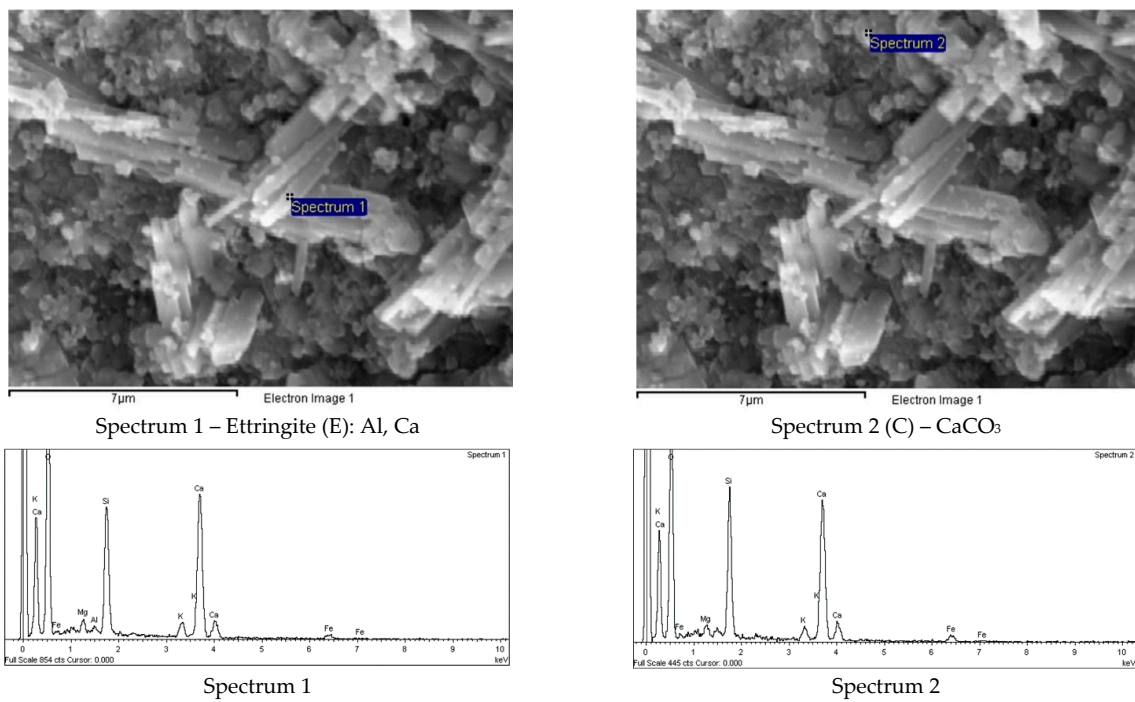
Figure 12. SEM and EDS analysis of a specimen cured in humidity chamber.

Figure 12 shows the SEM and EDS analyses of the sample belonging to a specimen cured in a humidity chamber where the needles of ettringite (Spectrum 1) and the formation of CaCO_3 (Spectrum 2) can be clearly observed. Moreover, the EDS analyses revealed a high peak of Si due to the presence of siliceous sand (SiO_2) in the mix design. On the other hand, healing products on specimens subjected to the most favorable conditions for sealing (immersion in water and heat curing) were also observed (Figures 13 and 14). From Figure 6 it was detected that heat curing and water immersion were the most favorable conditions for sealing cracks, however, in Figure 10, the healing process was not as successful as the sealing process. In order to understand in depth what was happening,
