The first Italian BIPV project: Case study and long-term performance analysis

This paper presents a detailed assessment of the testing campaign on the pilot PV plant at the Politecnico di Milano, which underwent 13 years of continuous operation; such period is particularly representative because it can be considered as about half of the supposed lifetime cycle of a photovoltaic system which is usually taken into account for technical-economic evaluations.

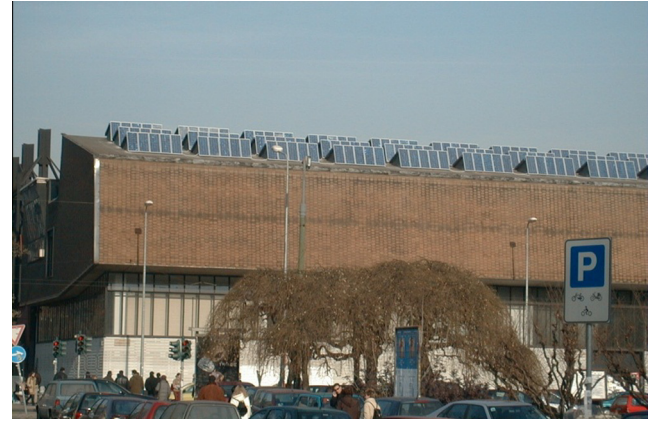
Fig. 1. View of the BIPV system.

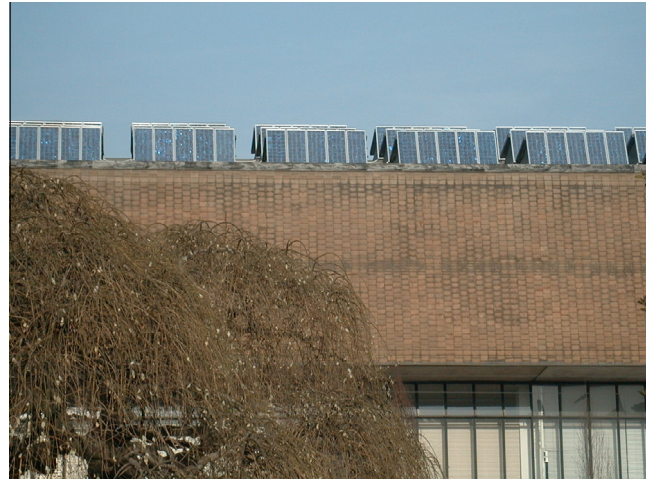
Fig. 3. Detail of the architectural look.

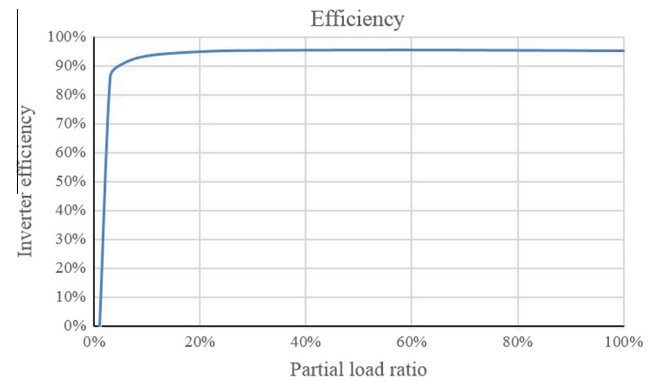
Fig. 5. Efficiency curve of inverters.
