Life cycle operating energy saving from windows retrofitting in heritage buildings accounting for technical performance decay

Giovanni Litti^{a,*}, Amaryllis Audenaert^a, Monica Lavagna^b

In this study, the Life Cycle (LC) operating energy saving potential allowed by different retrofitting options -from windows maintenance to total replacement- is discussed with regard to a heritage building in Antwerp. The study evidences that if taking into account the retrofitting interventions technical obsolescence, instead of assuming constant the technical performance throughout the retrofitting Service Life (SL), the results significantly vary. This adds a methodological concern to be considered during retrofitting design and evaluation.

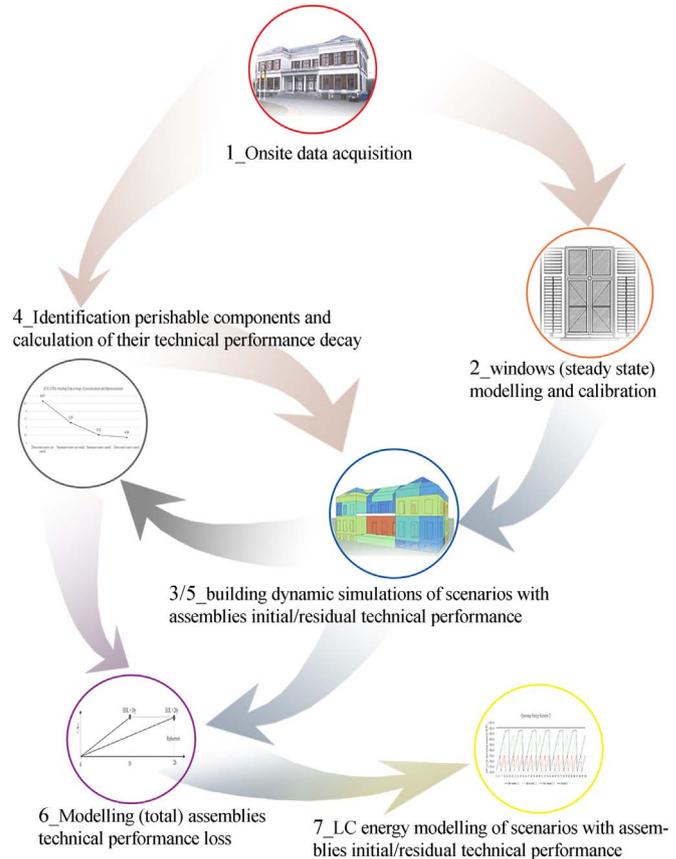
Fig. 1.1. Research flow chart; the arrows and numeration display respectively the activities interrelation and sequence.

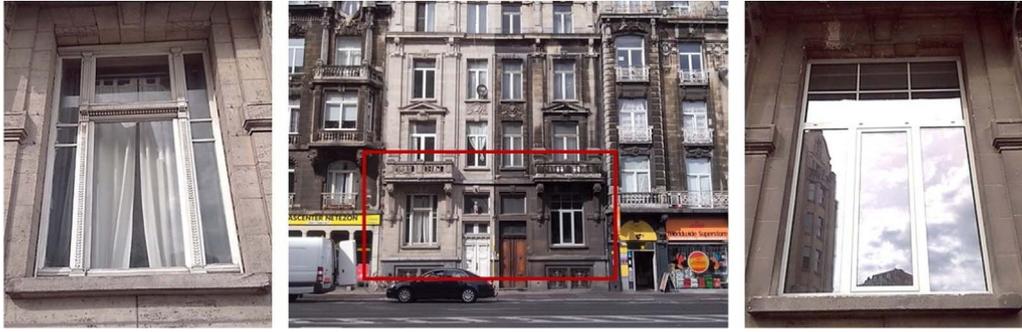
Fig. 1.1.1. Windows replacement in a not protected historic building, Antwerp (Litti).

An example of windows replacement in a historic non-protected building that, in the authors opinion, is likely to alter its market value is given Fig. 1.1.1. At the ground floor of an early XX Century building in Antwerp, a finely carved timber window was retained on the left ground floor apartment, while it was substituted by an aluminium window on the right one.

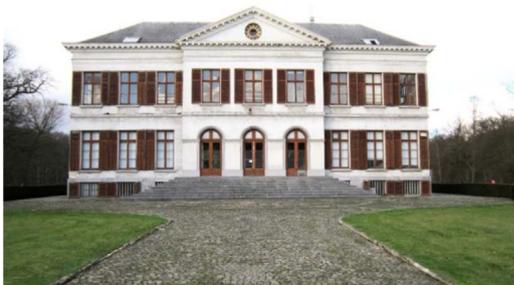
Fig. 3.1.1. Schoonselhof Kasteel, South façade.

The case study discussed in this contribution is the Schoonselhof Kasteel in Wilrijk, Antwerp (Belgium). The building was constructed in its current outlook between 1830 and 1840 in neoclassical style (see Fig. 3.1.1). The property, owned by the Municipality, will be renovated in the coming years for hosting new functions other than offices as in its present state. Although the building houses administrative offices, only a few rooms of the building are currently in use.

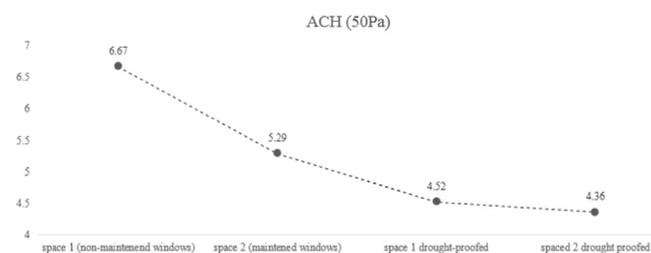
Fig. 3.2.1. Air change per hour of maintained (space 2) and non-maintained (space 1) windows before and after the draught proofing; on the y axis are reported the ACH values at 50 Pa.

From Figs. 7a and b and 8a and b in Supplementary material is possible to observe the correction of the air infiltration on the central and angular part during depressurization test of draught proofed windows in space 1. It can be seen that only radiative and conductive losses are present but not infiltrative ones. The BDT results are plotted in Fig. 3.2.1.

By looking at Fig. 3.2.1, it can be observed that windows maintenance, namely the re-putty of glass bars, allowed to decrease infiltration rate by up to 21% compared with non-maintained windows (comparison space 2 VS space 1). The addition of draught-proofing reduced infiltration rate of extra 16% (comparison mean draught proofed VS space 2). In other words, the sealing of the window sashes and edges allowed to reduce infiltration rates by up to 37% compared to non-maintained windows. Similar results were found by Basset and D'Ambrosio in [44,45].

It is worth considering that when the historic windows, in both the spaces, were completely sealed, the air change per hour was almost

identical: variation smaller than 4%. This confirms the findings from James et al. in [19]. The identical air infiltration rate in both the spaces, stands for the maximum air tightening improvement achievable by intervening on the windows tightness. The mean of the two values was considered in the study and standardized as mentioned above. It should be clarified that the obtained air change per hour after the windows sealing is not only the lowest one achievable if sealing the existing historic windows, but it is the lowest one achievable by any window installed in the measured spaces. For this reason, the obtained standardized mean value is used as input data in all the models from scenario 3–6, see Table 1.1.

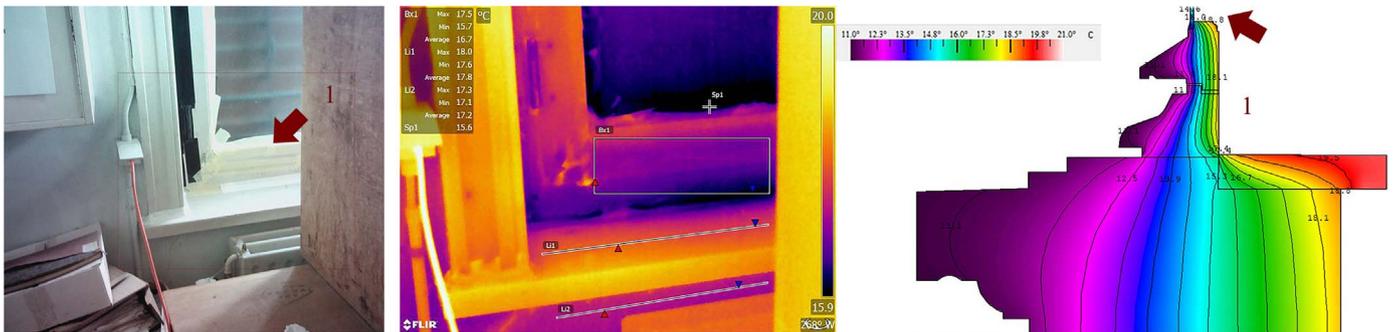
Fig. 3.3.1. (a)–(c) Inferior window frame connection; from the left (a) corner localization, (b) IRT imaging, (c) window model (THERM 7.4).

The results from the steady state windows model calibration are summarized in Table 3.3.1 and presented in Figs. 3.3.1(a)–(c), 3.3.2(a)–(c) and 3.3.3(a)–(c).

Although the model tends to overestimate the surface temperature of the lower part of the window frame and to underestimate the one of the upper part, the observed absolute deviations are only in one control point higher than 1 °C.

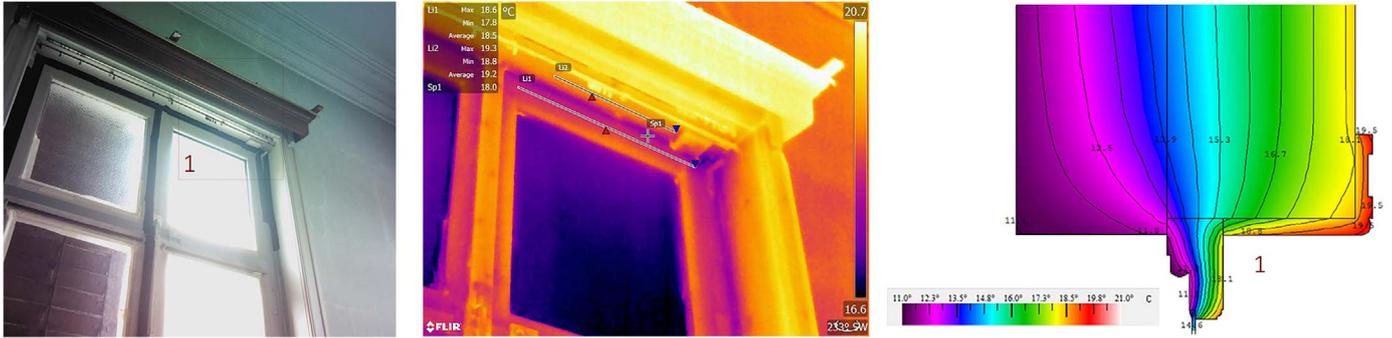
Fig. 3.3.2. (a)–(c) Superior window frame connection; from the left (a) corner localization, (b) IRT imaging, (c) window model (THERM 7.4).

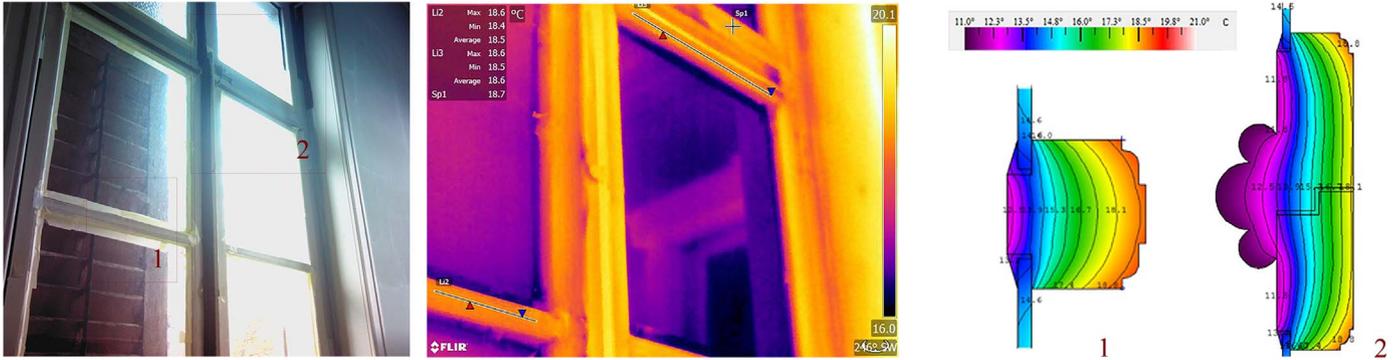
Fig. 3.3.3. (a)–(c) Central window frame connection; from the left (a) transom localization, (b) IRT imaging, (c) window model (THERM 7.4).

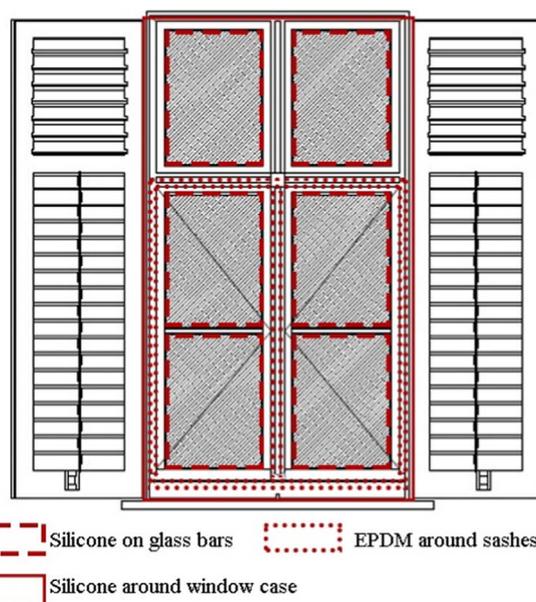
Fig. 3.5.3.1. Localization of the silicone-putty on the window sashes glass bars (scenario 2), EPDM sealing profiles on the sashes and silicone around the window edges (scenario 3).

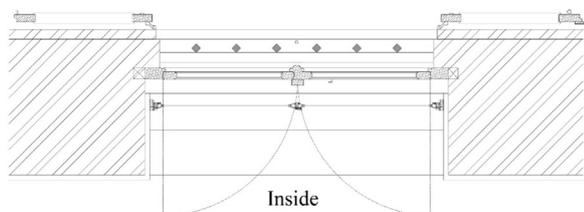
Fig. 3.5.4.1. Horizontal section window basement level; secondary glazing alternative 4.α.

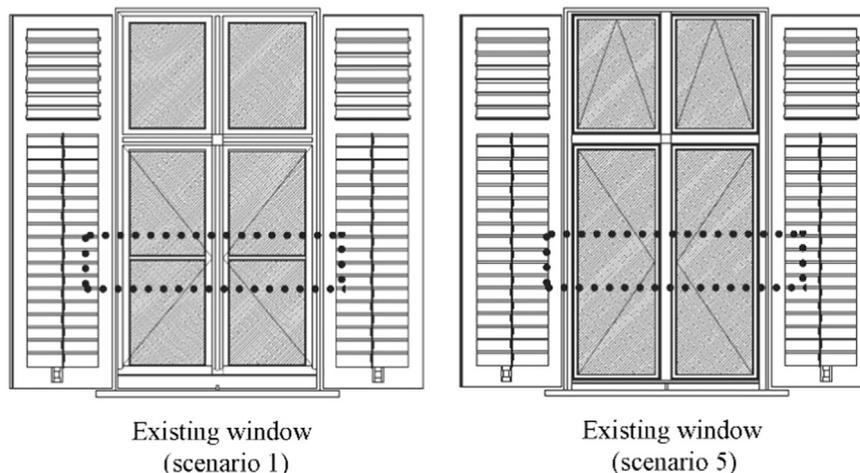
Fig. 3.5.5.1. Front view of existing window at the first floor (type A) in its existing state and after the implementation of scenario 5; the dotted rectangle localises the removed glass bars.

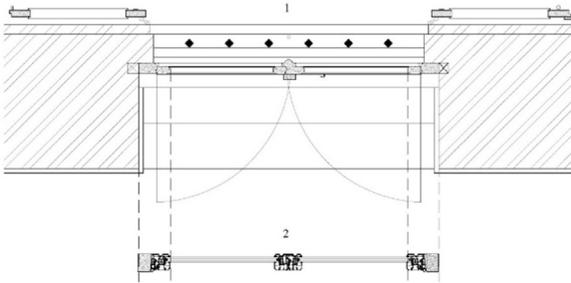
Fig. 3.5.6.1. Plan view of existing window at the basement level (1) and example of (aluminium) replacement window with timber sub frame (2); the dotted line indicates visual profiles alignment.

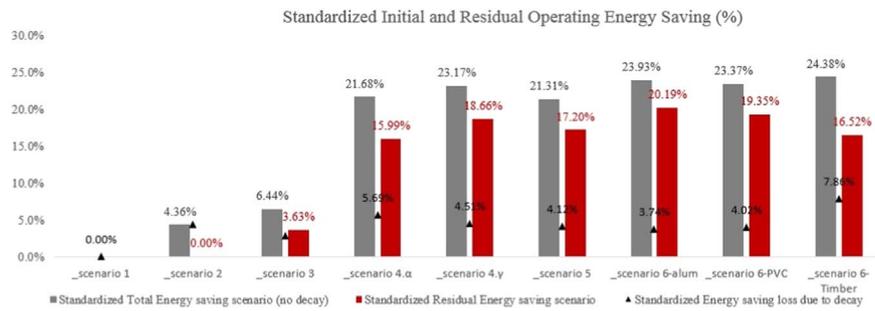
Fig. 4.1. Initial and residual operating energy saving (before and after the materials decay); not accounting for scenario iteration frequency and materials durability.

The initial energy saving allowed by scenarios 6.A and 6.PVC, is respectively 23.93% and 23.37%, while the residual energy saving is respectively 20.19% and 19.35%. The largest among the investigated scenarios; see Fig. 4.1 and Table 4.2. The initial energy savings allowed by aluminium or PVC replacement windows is attributable to the IGU (17.42% and 17.86% for scenarios 6.A and 6.PVC), to the frame (3.87% and 2.84% for scenarios 6.A and 6.PVC) and to the sealing profiles (2.63% and 2.67% for scenarios 6.A and 6.PVC). As mentioned in Section 3.5.6, for both the scenarios, the technical performance decay is attributable to the deterioration of the windows sealants and IGU, see Table 4.2.

With regard to the timber replacement window (scenario 6.T), there are other considerations. Although this intervention enables the highest initial energy savings (24.38%), it finally results in low residual savings (16.52%) at the end of the components SL, see Table 4.2 and Fig. 4.1. Among the modelled retrofit alternatives, hence excluding windows maintenance, scenario 6.T has the lowest residual energy saving ratio (67.77%) see Table 4.3. This occurs due to the large fraction of

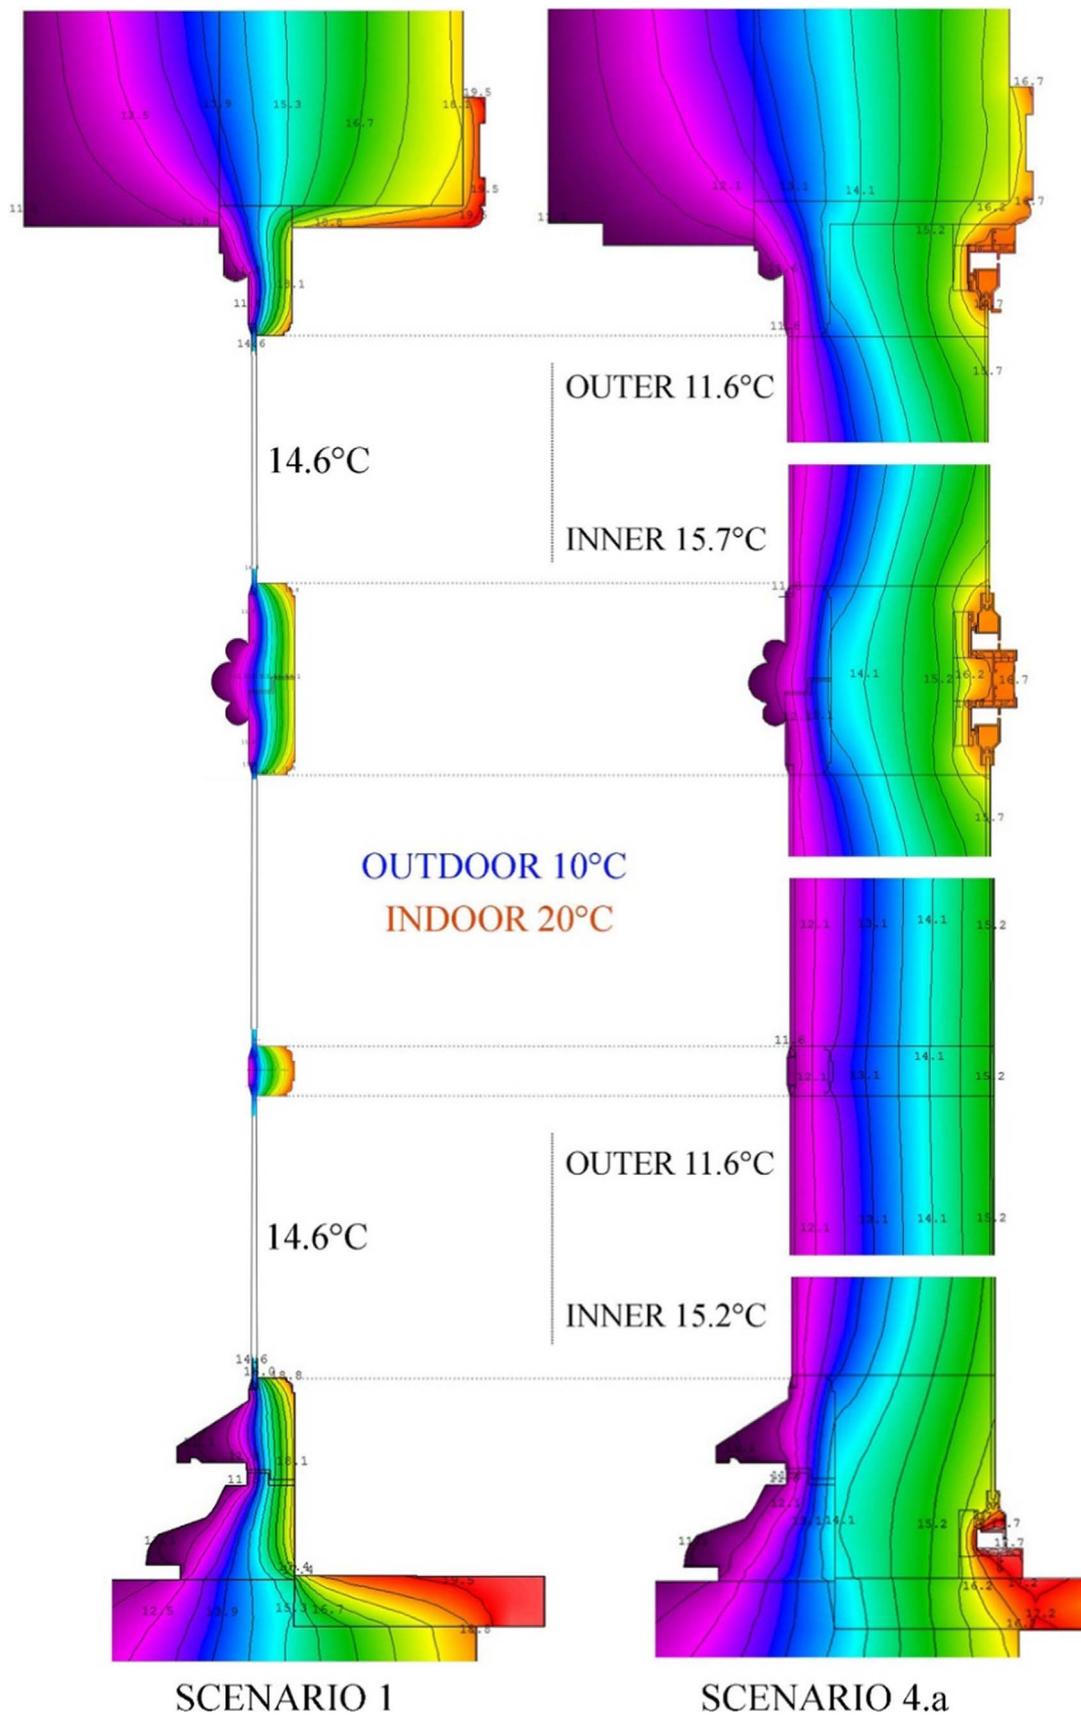
Fig. 4.4.1. Windows A ground floor in its initial state (scenario 1) and after the installation of a single glazed secondary glazing (scenario 4.a).
