# Comprehensive Evaluation Method of Historical Timber Structural Building Taking Fujiu Zhou House as an Example

Peixuan Wang <sup>1,2,\*</sup>

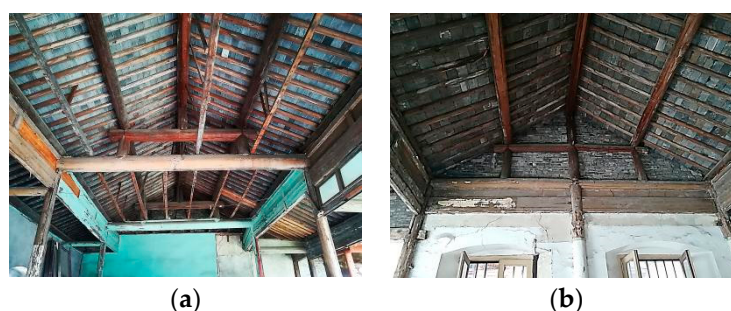
most of these timber buildings have been protected well because of the importance of their status and culture. Column and tie construction frame (Figure 2b) uses square beams to string up the columns, its purlins are placed directly on top of the columns. The weight of the roof is transferred to the columns through purlins directly. This kind of construction frame has smaller inner spaces, lower requirement of timber material, and lower cost. Column and tie construction frame has a high degree of acceptance among people, it is usually used in traditional residential buildings, and some of these buildings have not yet been adequately protected and valued.

**Figure 2.** Structure types; (a) post and lintel construction frame; (b) column and tie construction frame.

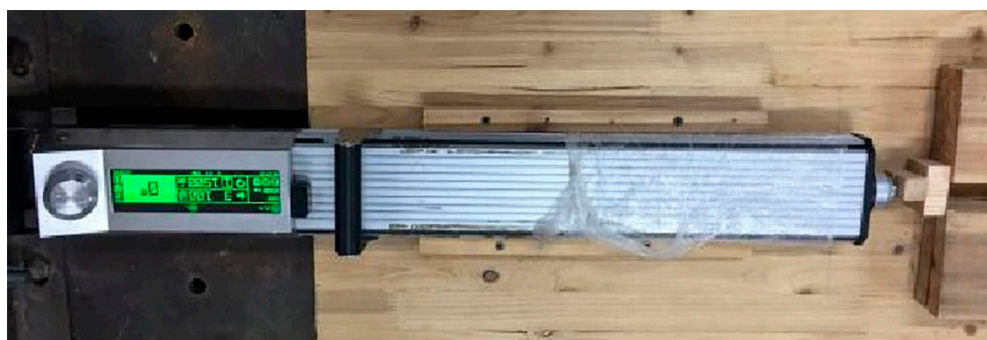
The micro-drill resistance instrument (Figure 5) can help us to complete the investigation of the internal condition of the component under the precondition of protecting the integrity of the timber component to the greatest extent. The working principle of it is to drive the drill needle into the interior of the timber at a constant rate through the motor drive, and the corresponding resistance is generated during the drilling process. According

to the micro-drilling resistance map, the internal damage of the component, the growth ring width (GRW) and other structural conditions can be quickly evaluated and judged.

**Figure 5.** Micro-drilling resistance instrument IML PD400.

The micro-drilling resistance instrument is IML PD400 (Figure 5). The decay position and grade of each frame are shown using red color in Figures 12b–22b. The specific detection process takes F5-C4 and F5-B9 as examples (Figure 16b).

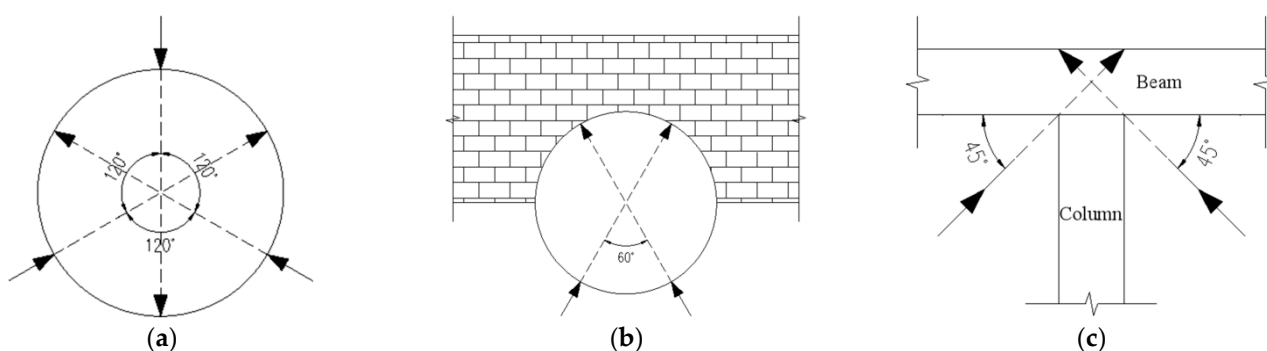
When doing a micro-drilling resistance test of the columns, the columns should be divided into two categories. For the same inspecting section of the columns that are completely exposed to the outside, select three different drilling directions separated by an angle of  $120^\circ$  from each other (Figure 6a). For the columns that are half exposed, one or two directions are selected according to the specific situation (Figure 6b). For the same column, take the 5 cm distance from the ground as the first testing section. If damage is detected, continue detecting by moving the same scheme upward by 5 cm or 10 cm until no damage is detected. The beam detection method refers to the column detection method. The condition of the timber structure at the beam-column joints needs attention, and the inspection is usually carried out at the angle of  $45^\circ$  between the beam-column joint (Figure 6c). Currently the resistographic analysis is used to investigate the internal decay of timber structures, based on the evaluation of the resistance profile during the needle perforations. The registration of resistance profiles permits also to quote the decay, based on the percent of soundness or decay in it.

**Figure 6.** Internal damage detection method; (a) fully exposed column; (b) half exposed column; (c) beam-column joint.

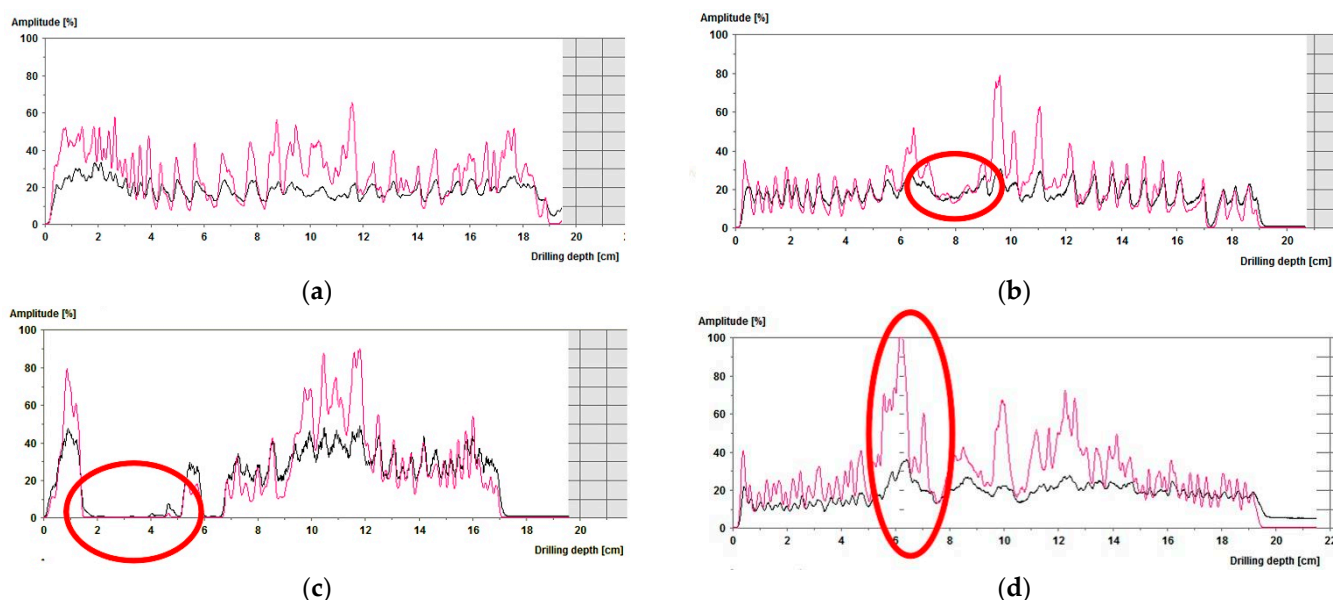
After the end of the test, the internal damage of the timber components can be determined by the instrument display spectrum. The resistance maps of the timber components without damage are more stable and uniform, the frequency is faster, the cycle is stable, and the peak-wave trough phenomenon continuously appears. At the crest of the curve, the density of the timber is higher, and it is latewood. At the trough of the curve, the timber density is smaller, and it is earlywood (Figure 7a). When there are decayed areas in the timber, the mechanical properties change, the strength and hardness decrease to varying degrees, and the resistance to the needle also decreases. As a result, the resistance map of the area appears to fluctuate and it declines more obviously with a slower slope area in the process (Figure 7b). If there are hollows or cracks in the timber structure, the needle suddenly receives no resistance in this area, the curve drops steeply, and the map appears

as a cliff (Figure 7c). The resistance curve of the micro-drill suddenly rises from the normal level when there is a knot in the timber, and the overall level is equivalent to several times the normal level. The knots affect the following resistance maps, resulting in the rise of the map, and even the curve of the decayed part may show a normal level (Figure 7d).

**Figure 7.** Method for judging micro-drill resistance maps; (a) map with good internal structure; (b) map with internal decay; (c) map with internal hollows or cracks; (d) map with internal knots.

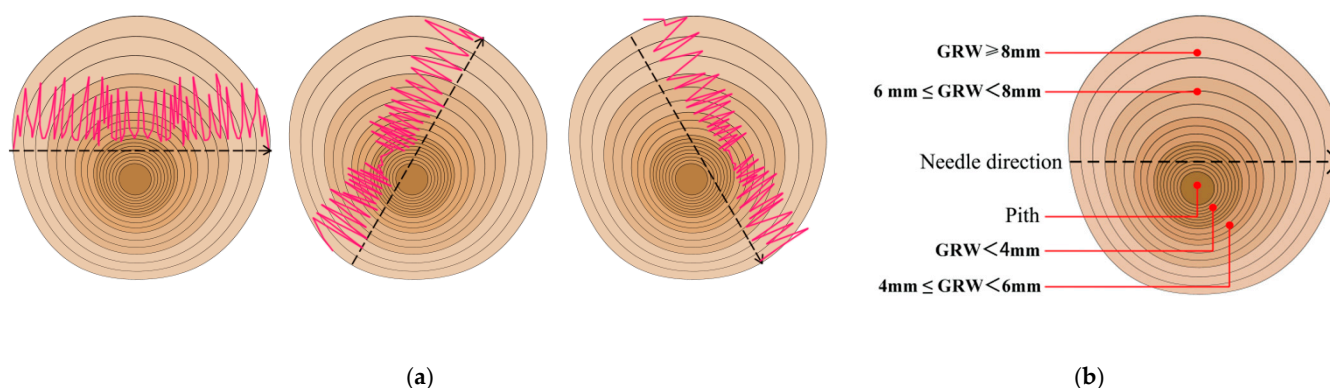
**Figure 8.** The method to divide different GRW areas in the components; (a) multiple direction judgment atlas; (b) partition area.

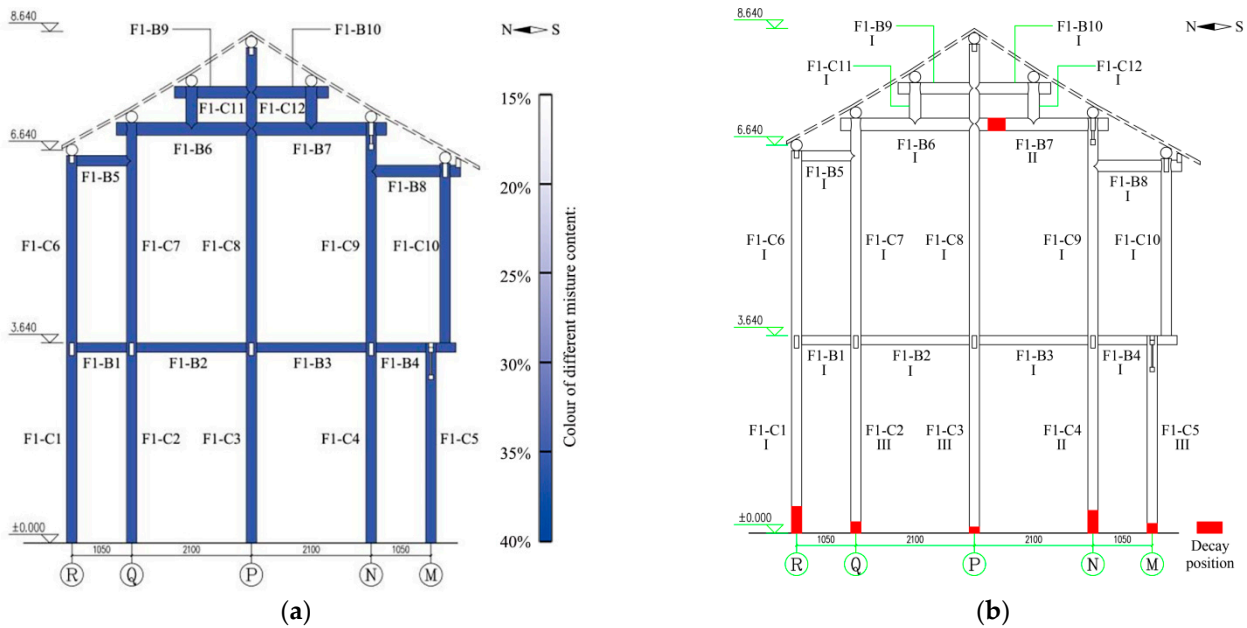
The moisture content of frames F1, F6 and F11 (Figures 12a, 17a and 22a) is higher than that of other frames, and there is little difference in the moisture content of different components. These three frames are located at the edge of the whole structure, and the half of their components are buried in the brick wall. The bricks commonly used in buildings in the Jiangnan area have good water absorption properties and can absorb water from the rain and air for a long time. These bricks transfer water to the frame embedded in the wall, which leads to a higher moisture content.

Figure 12. Moisture content and decay of F1 in Fujiu Zhou house; (a) schematic diagram of moisture content; (b) schematic diagram of decay position and decay grade.

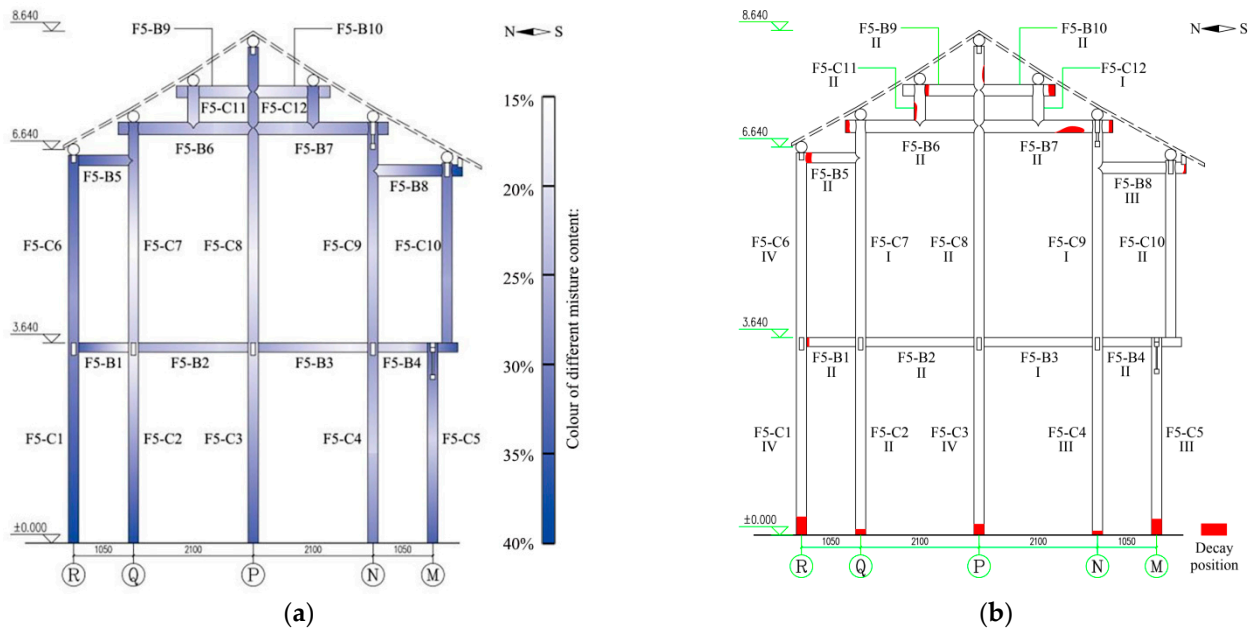
different. Take F5 as an example to elaborate (Figure 16a). The columns embedded in the wall (F5-C1, F5-C6) and the columns near the courtyard (F5-C5, F5-C10) have higher moisture content. For the same column, the base in contact with the ground or floor can absorb water. So, the base part shows a higher moisture content than the middle part. Similarly, the two ends of the beams that are in contact with the roof are also wetter than their middle parts. That is because the rain brings water to the beams' ends through the roof.

**Figure 16.** Moisture content and decay of F5 in Fuji Zhou house; (a) schematic diagram of moisture content; (b) schematic diagram of decay position and decay grade.

In the frame F5, the bases of some columns (F5-C1 to F5-C5) appear to have decay, and the ends of some beams (F5-B1, F5-B5 to F5-B7, F5-B9 to F5-B10) also have damage. While the rest of the components are in good condition. The decay grades of components in F5 were determined according to GB/T13942.2-1992 [1] and testing data (Figure 16b). Comparing the moisture content schematic diagram of the F5, the moisture content of the place where the decay occurs is higher, which further proves the correlation between the two. However, when the moisture content is more than 30%, the component reaches the so-called wet protective state. Comparing F1, F6, and F11, it can be found that although the moisture content of components in these frames is high, the decay only occurs in a few parts. Therefore, it cannot be believed that the parts with high moisture content of the components will decay. At the same time, the moisture content of the components fluctuate with the season, weather, and other objective factors, which causes a certain degree of difference in detection. The detection time was summer, the Yangzhou area is hot and rainy in summer, and the air humidity is high. Therefore, the moisture content of the component tested during this time must be higher than its annual average value.

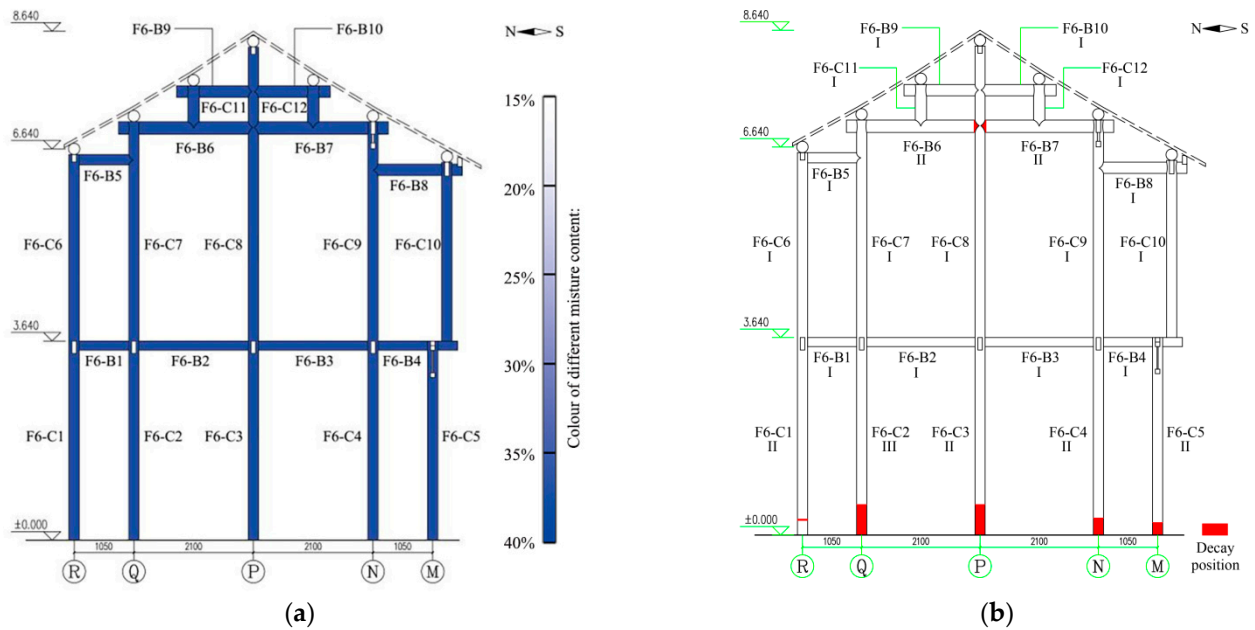
**Figure 17.** Moisture content and decay of F6 in Fuji Zhou house; (a) schematic diagram of moisture content; (b) schematic diagram of decay position and decay grade.

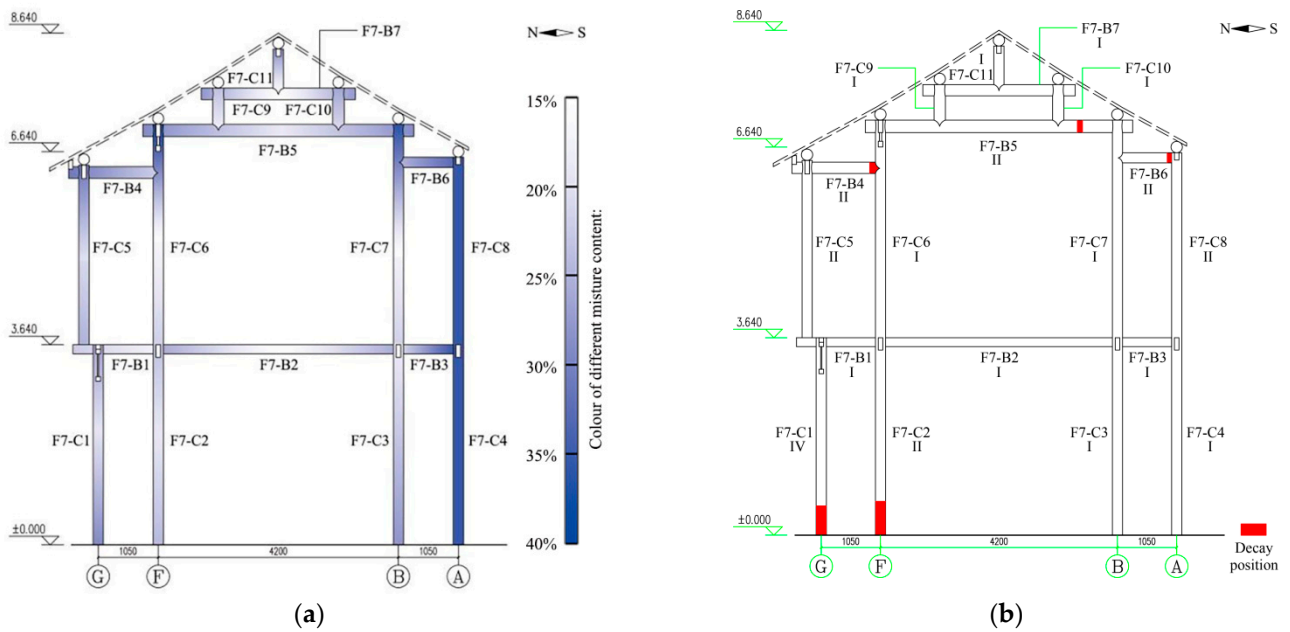
**Figure 18.** Moisture content and decay of F7 in Fuji Zhou house; (a) schematic diagram of moisture content; (b) schematic diagram of decay position and decay grade.

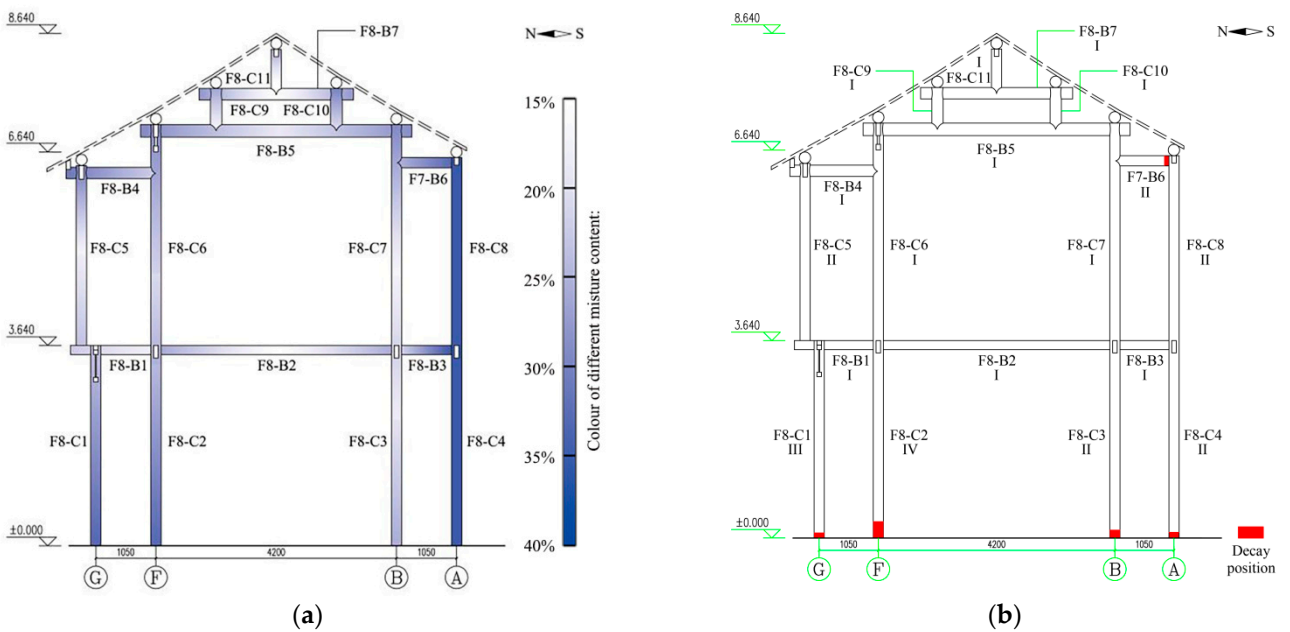
**Figure 19.** Moisture content and decay of F8 in Fuji Zhou house; (a) schematic diagram of moisture content; (b) schematic diagram of decay position and decay grade.

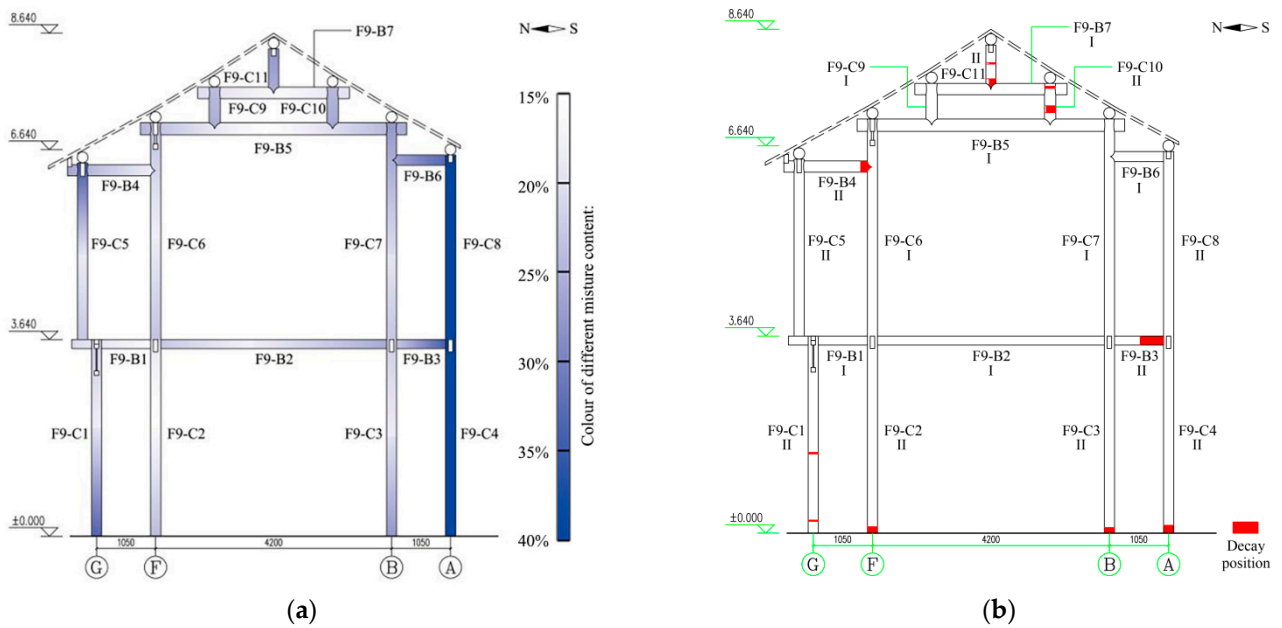
**Figure 20.** Moisture content and decay of F9 in Fujii Zhou house; (a) schematic diagram of moisture content; (b) schematic diagram of decay position and decay grade.

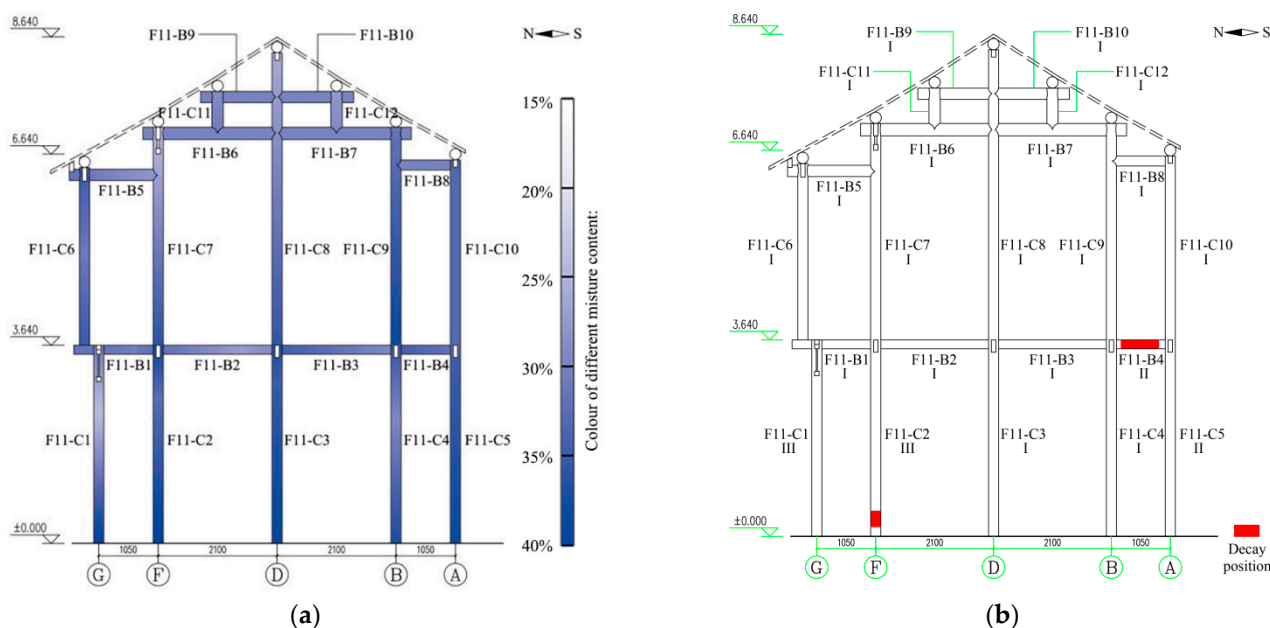
**Figure 22.** Moisture content and decay of F11 in Fujizu Zhou house; (a) schematic diagram of moisture content; (b) schematic diagram of decay position and decay grade.

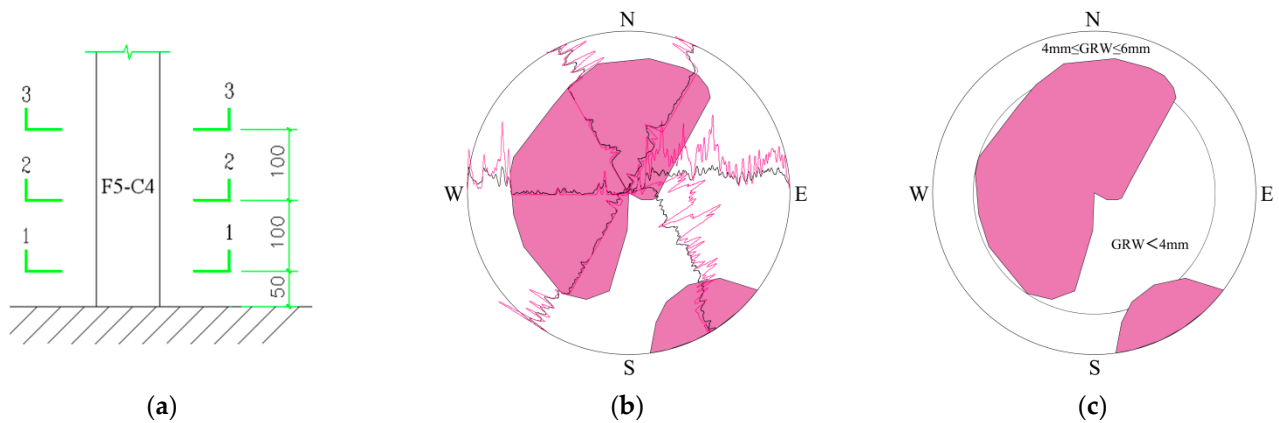
In F5-C4, the cross section 1-1 (Figure 23a) which is 5 cm above the ground was chosen as the first micro-drilling test section. With the resistance map from three different directions, the approximate internal decay was determined (Figure 23b,c). Then, the same testing method was used to survey cross section 2-2 (Figure 23a) (15 cm above the ground) and cross section 3-3 (Figure 23a) (25 cm above the ground), the resistance maps depict good internal condition. Because the higher the part of the column is from the ground, the lower the moisture content, and it is less likely to decay. Therefore, the upward detection is no longer.

**Figure 23.** Micro-drilling test of F5-C4; (a) testing sections; (b) decay area determined by micro-drilling maps; (c) different GRW areas.

The diameter of F5-C4 is about 180 mm, and the overall condition of the component is good. According to the micro-drilling resistance map, the effective section area ( $S = 15209 \text{ mm}^2$ ) can be determined by connecting the decayed area in a specific way. Corresponding to the resistance map, the area ranges of different GRW are divided (as shown in Figure 23c:  $S_1 = 6906 \text{ mm}^2$ ,  $S_2 = 8303 \text{ mm}^2$ ,  $S_3 = 0 \text{ mm}^2$ ,  $S_4 = 0 \text{ mm}^2$ ). According to Formula (1) and (2), the mechanical parameters of components can be calculated:  $MOE_{F5-C4} = 10,435.25 \text{ MPa}$ ,  $MOR_{F5-C4} = 47.05 \text{ MPa}$ .

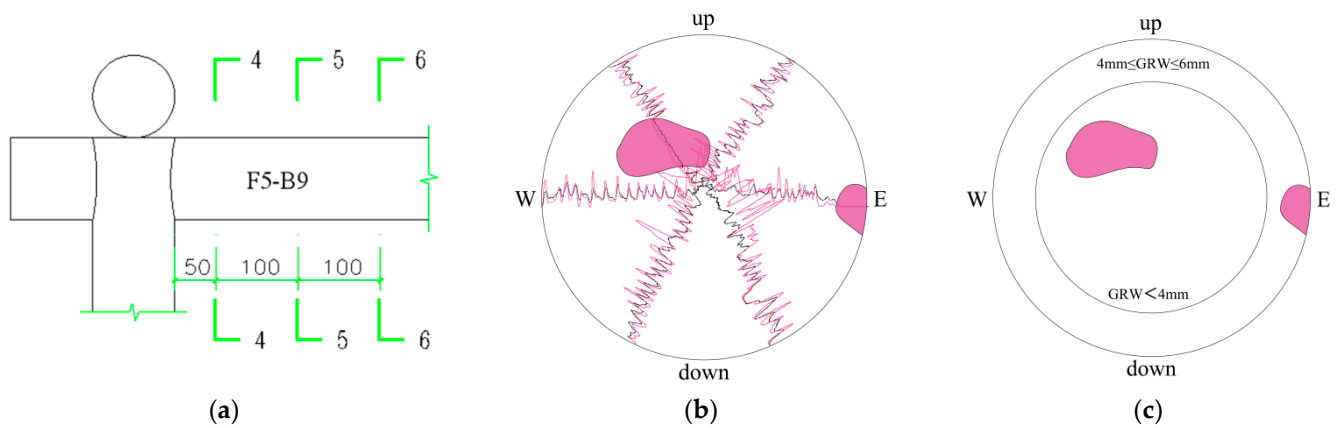
In F5-B9, the cross section 4-4 (Figure 24a) which is 5 cm away from the north joint, was selected as first test section. (Figure 24b,c) expresses the internal damage with the help of three different directions' resistance maps. Next, move to the south 10 cm to select the detection section. Because there is no internal decay in cross section 5-5 (Figure 24a) and cross section 6-6 (Figure 24a), the test can stop here.

**Figure 24.** Micro-drilling test of F5-B9; (a) testing sections; (b) decay area determined by micro-drilling maps; (c) different GRW areas.

The diameter of F5-B9 is about 180 mm, and the surface of the beam is soft and without obvious decay. Its effective section area is  $S = 23,873 \text{ mm}^2$ , and  $S_1 = 12,215 \text{ mm}^2$ ,  $S_2 = 11,658 \text{ mm}^2$ ,  $S_3 = 0 \text{ mm}^2$ ,  $S_4 = 0 \text{ mm}^2$  (Figure 24c). According to Formula (1) and (2), the mechanical parameters of components can be calculated:  $MOE_{F5-B9} = 10,460.02 \text{ MPa}$ ,  $MOR_{F5-B9} = 47.41 \text{ MPa}$ .

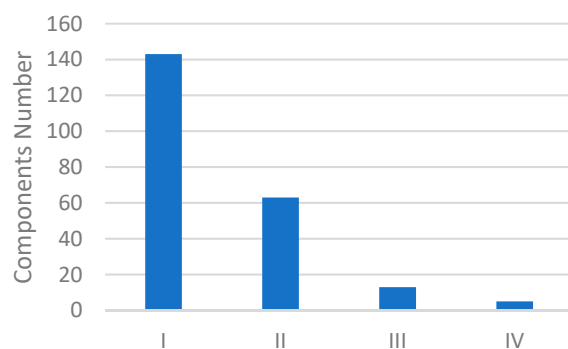
For the overall structure, more than half of the columns on the ground floor have visible decay, but the degree of decay is not high. The beams' condition is basically intact, and there is no obvious surface decay. Most of the components in the structure are in decay grades I and II, only a few of the components around the courtyard or buried in the walls belong to grades III and IV (Figure 25).

**Figure 25.** The number of components in different decay grade.
