One Year Static Monitoring of the Milan Cathedral

A. Saisi, A. Ruccolo, C. Gentile

ONE YEAR STATIC MONITORING OF THE MILAN CATHEDRAL

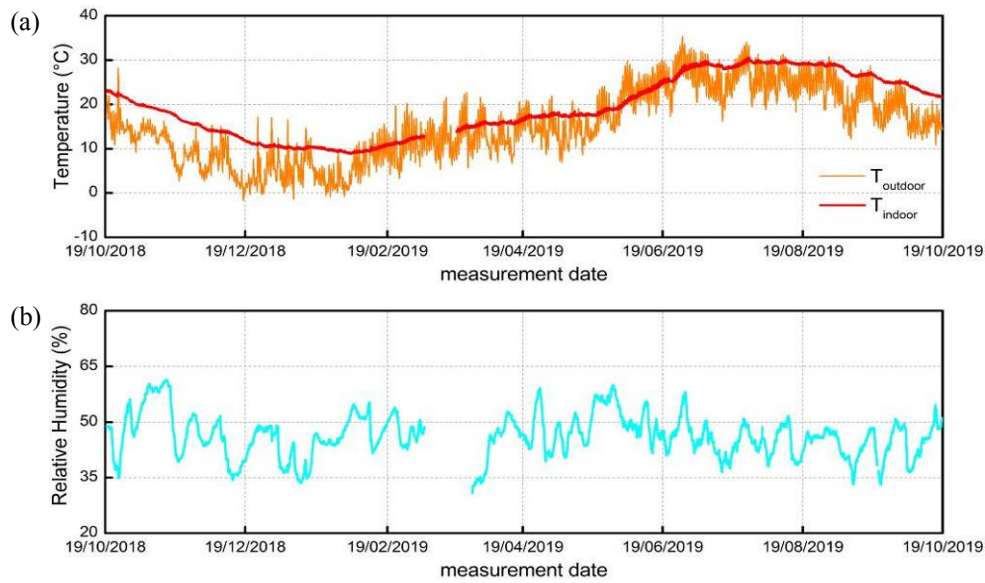
Figure 5: Evolution in time of: (a) average indoor temperature and outdoor temperature; (b) average indoor relative humidity.

As previously pointed out, a quite extended grid of temperature sensors and hygrometers has been installed inside the church, with the objective of supporting both the SHM program and the preservation of statues, paintings and decorative elements, which are kept inside the monument. The variation in time of the average indoor temperature and the outdoor temperature (measured by the weather station) is shown in Fig. 5a, whereas Fig. 5b refers to the average indoor humidity.

The orange line in Fig. 5a presents the evolution of the outdoor temperature and highlights changes between -1.7°C and $+35.4^{\circ}\text{C}$, with remarkable daily variations in sunny days. The corresponding variation of the average indoor temperature is represented by the red line in Fig. 5a and ranges between $+8.8^{\circ}\text{C}$ and $+30.6^{\circ}\text{C}$: it is further noticed that the availability of a large number of temperature sensors in the church allows to verify [6] a low temperature gradient in space, with the difference between the extreme values not exceeding 0.5°C .

Consequently, the low temperature gradient and the correlation coefficients (always larger than 0.99) between the measured temperatures allow to assume the average indoor temperature (Fig. 5a) as a representative quantity for the SHM correlations. A similar conclusion is drawn for the relative humidity, whose time series are highly correlated [6], [8] and exhibit correlation coefficients of the order of 0.90 or larger.

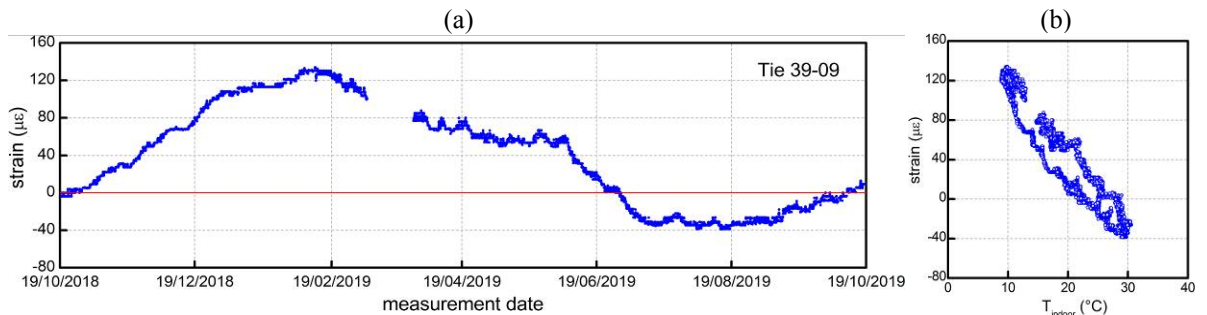
Figure 7: Tie-rod 39-09: (a) Evolution in time of measured strain; (b) Strain vs. indoor temperature.

The time series of measured strain on tie-rods 28-62, 39-09 and 39-40 are plotted in Figs. 6a, 7a and 8a, with a sampling time of 60 min. It should be observed that, although the tension bars 28-62, 39-09 and 39-40 are located in the north and south side aisle of the limb (Fig. 4a), the strain variation trend is very similar. The inspection of Figs. 6a, 7a and 8a shows that: (a) the tensile strain increases in winter and the maximum increment is attained on all tie-rods on February 2019, in correspondence with the minimum values of both outdoor and indoor temperature; (b) the strain condition at the beginning of the monitoring (i.e., zero strain increase) is recovered almost simultaneously in all instrumented ties at the end of June 2019 and approximately at the end of the first year of monitoring (Figs. 6a, 7a and 8a).

Figures 6b, 7b and 8b reveals a high correlation between measured strains and (average) indoor temperature, with the coefficient of determination R^2 being larger than 0.90 for tie-rods 28-62 and 39-09. Trends and correlation values similar to the ones exemplified in Figs. 6-8 are observed for all instrumented tie-rods, whose long-term behavior is significantly affected by the indoor temperature. Furthermore, the strain-temperature plots (Figs. 6b, 7b and 8b) highlight a fairly regular trend with slight deviation of the regression line from linearity. Concerning this aspect, it is worth mentioning that the outdoor temperature also affects the strain variation, whereas almost negligible effects are due to the (average) relative humidity. In addition, the observed non-linear correlations might depend on delayed temperature-induced effects, caused by thermal inertia of the massive masonry church.

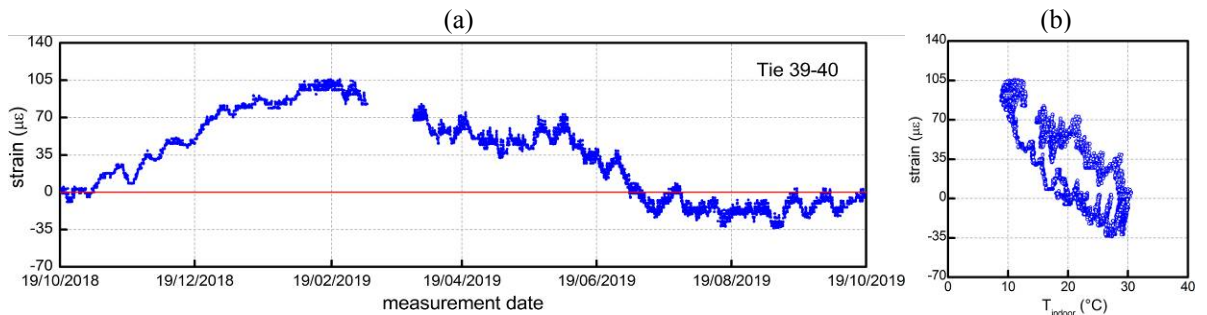
Figure 8: Tie-rod 39-40: (a) Evolution in time of measured strain; (b) Strain vs. indoor temperature.

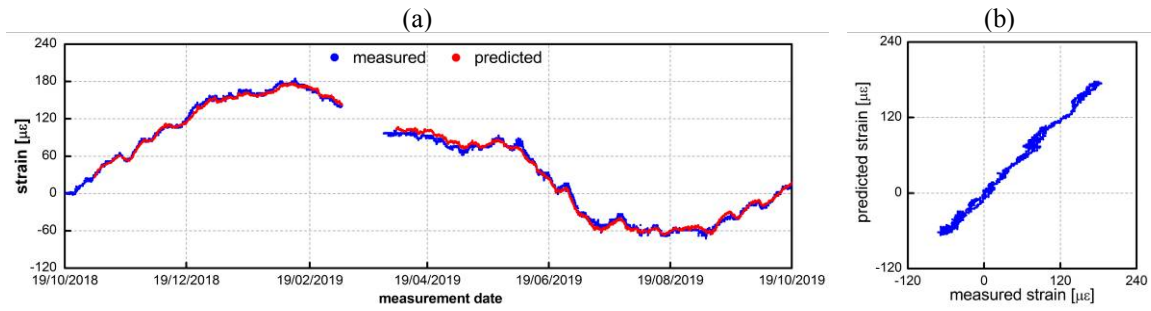
Figure 9: Tie-rod 28-62: (a) Statistical reconstruction of the measured strain; (b) Correlation between measured and predicted strain.

In the present case, a satisfactory statistical reconstruction of the measured strains (Figs. 9-11) was obtained by using: (a) the current indoor temperature and observations of the preceding 2 weeks, sampled at 36 hours; (b) the current outdoor temperature and a varying number (12-24) of past observations sampled at 1 hours; (c) the current relative humidity.

To exemplify the quality of the dynamic regression predictive models, Figs. 9a, 10a and 11a shows the time series of measured and predicted strains, considering the entire period of monitoring as training period. Furthermore, Figs. 9b, 10b and 11b show the correlation between measured identified and predicted observations. It is worth noting that Figs. 9-11 clearly demonstrate that the adopted statistical technique is capable of re-constructing both daily and long-term variations and, hence, to remove the environmental effects from monitoring data so that damage sensitive features are defined.

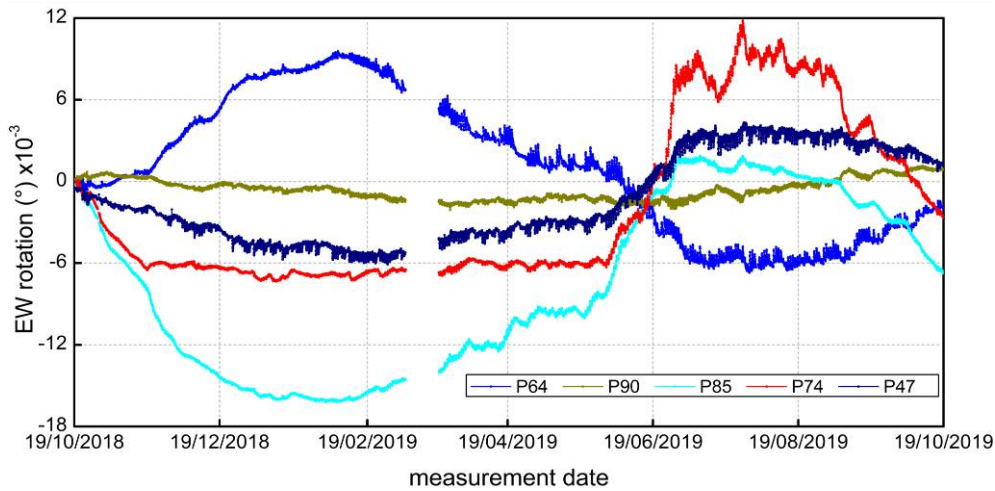
Figure 13: (a) Variation of E-W rotation of selected piers from 19/10/2018 to 18/10/2019.

The indoor temperature turns out to be the main driver of the changes observed in the piers rotation as well. Fig. 13 shows the evolution of the E-W rotation of selected piers: inspecting the tilt data shows that pier 64 (façade) tends to lean towards east (positive direction) from October to June, whereas all other piers are leaning towards west in the same period, with pier 85 (*tiburio*) exhibiting the maximum tilt. As previously observed for the strain variation in the tie-rods, the rotation cumulated during Winter and Springs tend to be recovered (zero crossing) after mid June.

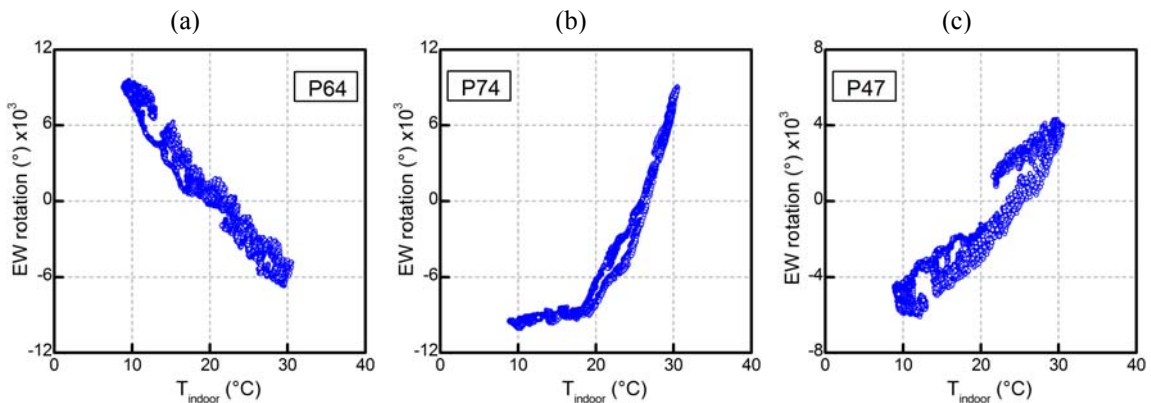
Figure 14: Rotation-temperature correlation for: (a) pier 64 (façade); (b) pier 74 (*tiburio*); (c) pier 47 (apse).

The correlation between E-W tilt and indoor (average) temperature for piers 64 (façade), 74 (*tiburio*) and 47 (apse) is shown in Figs. 14a-c. The correlation is approximately linear for most piers (Figs. 14a and 14c) but a non-linear correlation between E-W rotation and indoor temperature is observed for pier 74.
