Anomaly detection and localization on masonry arch bridges using frequency data

Paolo Borlenghi¹, Antonella Saisi¹, Carmelo Gentile¹

¹ Department of Architecture, Built environment and Construction engineering (DABC), Politecnico di Milano,
Piazza Leonardo da Vinci 32, 20133 Milan, Italy
email: paolo.borlenghi@polimi.it, antonella.saisi@polimi.it, carmelo.gentile@polimi.it

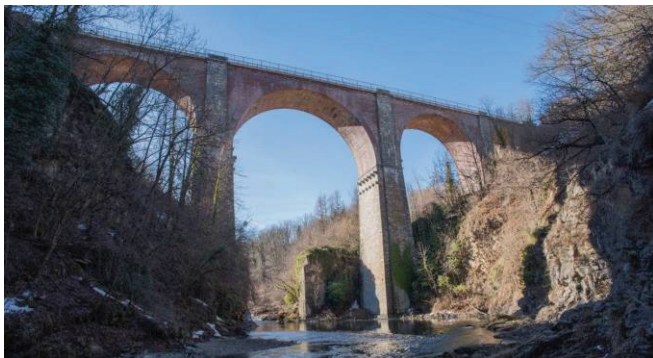
Figure 1. The *Olla* bridge, view from the Stura river.

The 19th-century *Olla* bridge (Figure 1) is used to exemplify the proposed approach. The bridge, 117 m long, comprises five arches, four piers and two abutments; the arches are built in solid brick masonry, whereas piers and abutments are made of a good-quality ashlar stone masonry. The bridge crosses the Stura river along the National Road S.S. 21, connecting the French border with the South-West part of Piedmont region, throughout the Stura di Demonte valley. The development and the calibration of a numerical model of the historical bridge, based on ambient vibration tests, is firstly reported: the investigated structure turns out to be of particular interest because the use of just 14 sensors allows the identification of a relatively large number of natural frequencies (so that the installation of a dynamic monitoring system on the bridge has been scheduled). Pseudo-experimental monitoring data are then generated from the updated model and employed to assess the reliability of the proposed algorithm in identifying the damage location.

The *Olla* bridge (*Ponte dell'Olla* in Italian, Figure 1) is a multi-span masonry arch bridge built in the second half of the 19th century over the Stura river. It carries the State Route no. 21 (SS21, i.e., the roadway connecting the city of Cuneo with the French border) between the municipalities of Gaiola and Borgo San Dalmazzo in the northwest part of Piedmont, Italy. Due to its localisation, the bridge has a strategic role for the economy of the area since it is the only entry to the Stura di Demonte Valley for trucks and commercial vehicles.

The structure is approximately 117 m long and has a maximum height over the river of about 42 m. It is composed of five masonry arches, symmetrically distributed, with spans of 10, 20, and 25 m, respectively. Piers and abutments are in a good quality ashlar stone masonry while arches and spandrel walls are in brick masonry. The documentary research started in the archive of the Local Authority responsible for the design (*Genio Civile*), but the original drawings were not found. Therefore, various construction details on the internal morphology of the structure were initially assumed according to the historical construction handbooks of Curioni [11] and then eventually modified in establishing the FE model.

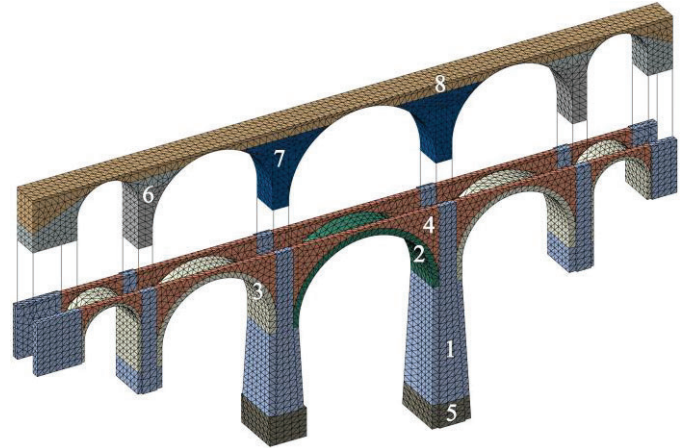
Figure 6. FE model with the indication of different materials: 1. Piers; 2. Central arch; 3. Lateral arches; 4. Spandrels; 5. Pier foundations; 6. Backing; 7. Central backing; 8. Fill.

The 3D model of the *Olla* bridge was developed with the FE code ABAQUS using the ten-node tetrahedral elements (C3D10). A relatively large number of elements were employed to obtain a regular distribution of masses, a good description of geometrical details, and to avoid frequency sensitivity to mesh size. Overall, the numerical model consists of 45604 tetrahedral elements with 211818 degrees of freedom and an average mesh size of 1.15m (Figure 6).

Overall, 8 regions with constant material properties were identified based on visual inspections and coring tests (see Figure 6): 1. piers and abutments; 2. the central arch (reconstructed in 1945); 3. lateral arches; 4. spandrels; 5. the base of central piers; 6. the backing over the abutments and the lateral piers; 7. the backing over the central piers (partially reconstructed in 1945); (8) the fill.

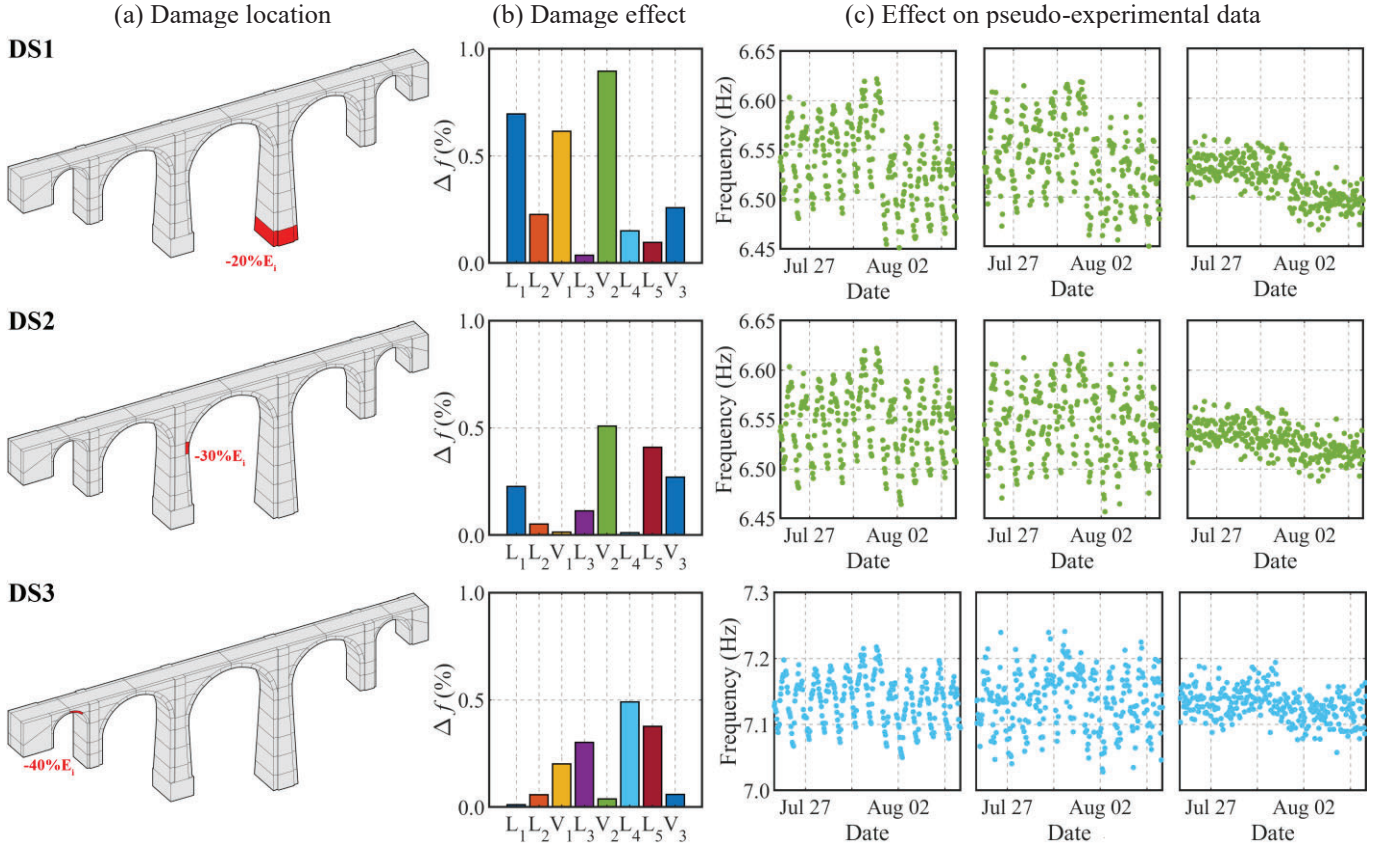
Figure 9. Simulated damage scenarios (DS): actual location, percentage variation of natural frequencies and 12-days zooms of the natural frequencies most affected by the damage.

Subsequently, three damage scenarios (DS) were simulated (Figure 9a). The FE model was used to define the expected frequency decay (Figure 9b) while the DS were simulated on the pseudo-experimental data as permanent shifts in the natural frequencies (Figure 9c). In particular, the frequency shifts were obtained decreasing the elastic modulus of selected regions belonging to different parts of the structure: the first arch (DS1), the central arch (DS2) and the third pier (DS3). In more details:

- DS1 corresponds to 20% decrease in the Young's modulus of the basement of the third pier – the highest one – generating a maximum frequency shift of about 0.9% in the 5th mode (V_2);
- DS2 corresponds to 30% decrease in the Young's modulus of the skewback of the central arch, involving a maximum frequency reduction of about 0.5% in the 5th mode (V_2);
- DS3 corresponds to 40% decrease in the Young's modulus of a masonry portion belonging to the upper part of the first arch and induces a maximum frequency decrease of about 0.5% in the 6th mode (L_4).

generated data, hiding the sharp changes of natural frequencies in the daily variations caused by environmental effects (Figure 9c); it is indeed impossible to recognize the frequency shifts inspecting the diagram.

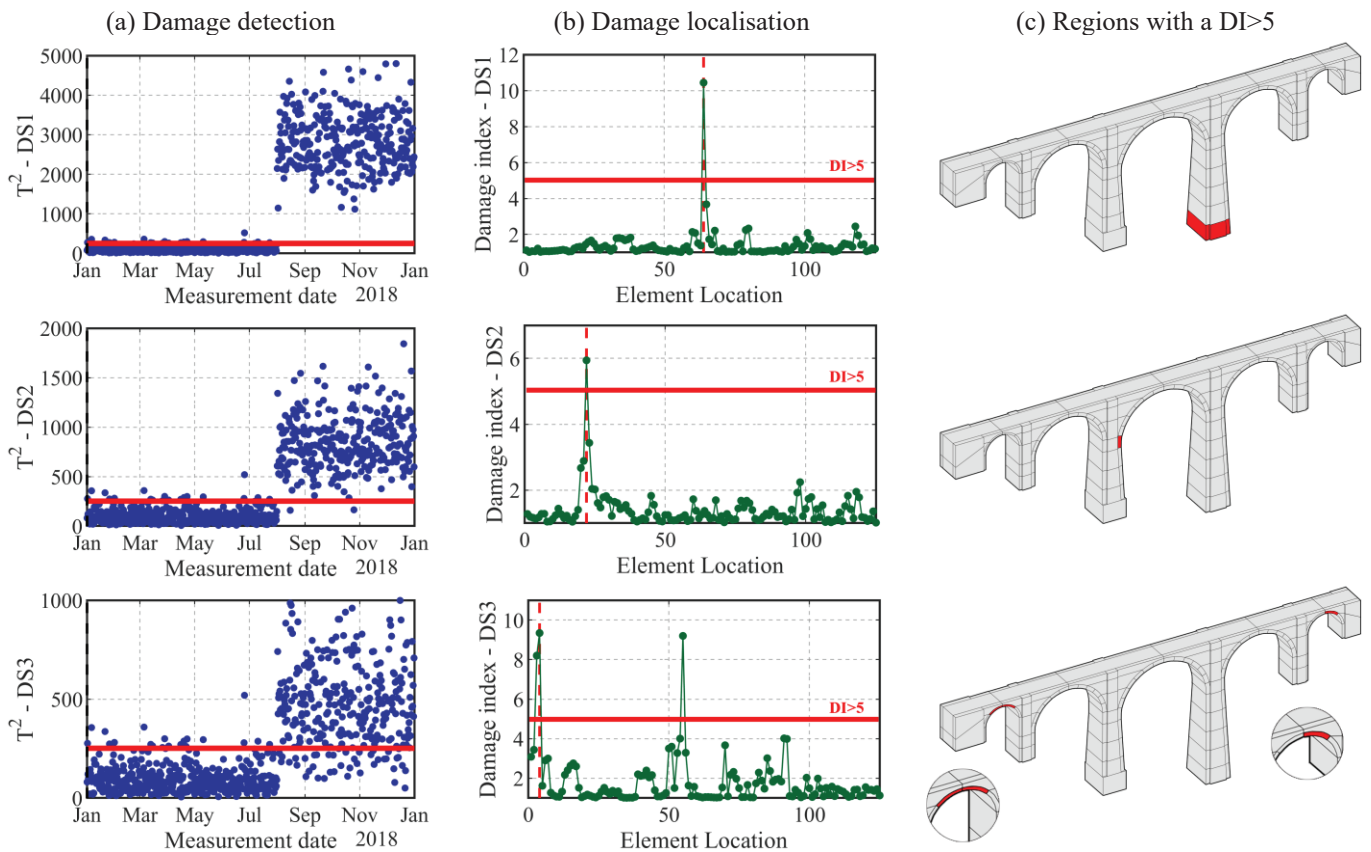
Figure 10. Damage detection and localisation for the three simulated damage scenarios.

As reported in Figure 10b and Figure 10c, the damage is correctly localised in the three cases. In Figure 10b the red dashed lines represent the correct damage locations, the green dots are the DI of each region, and the red continuous horizontal line identifies the DI higher than 5. In addition, Figure 10c highlights the regions with a DI higher than 5, showing the excellent localisation for DS1 and DS2 and a less effective localisation for DS3. As a consequence, the following comments can be drawn:

- The DS1 and DS2 are univocally localised in their exact location (Figure 10c);
- The DS3 is localised in both lateral arches (Figure 10c): the structure is quasi-symmetric longitudinally; consequently, it is not easy to distinguish between the contribution of the two lateral arches.
