# Italian Middle Byzantine Churches: A Comparison Through Masonry Quality Analysis

The work focuses on the structural properties of two Byzantine churches built during the 11<sup>th</sup> century in Torcello (Venice Laguna) and Stilo (east coast of Calabria). Despite the large distance between the two religious buildings and deep differences in the building typology, some common features are detectable, recalling the construction solutions of the Byzantine structures. Both churches, well known from an historical and artistic point of view, represent two important examples of the Byzantine period. The authors, involved in a vulnerability analysis of these buildings, had the opportunity to investigate some structural characteristics of the masonry walls through non-destructive tests (NDT). The results of the experimental campaign are pre-sented here in order to contribute to the knowledge of Byzantine constructive systems.

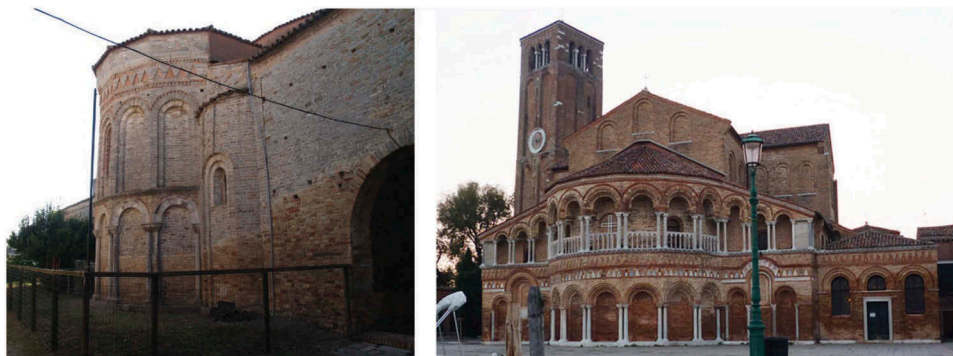
Figure 3. Santa Fosca apse (on the left); Santi Maria e Donato apse (on the right).

On the eastern side, deeper than the others, a longer barrel vault covers the main apse, and two groin vaults cover the two aisles. All the three apses end with semi-circular walls and hemispherical niches. Outside, the lateral Eastern naves remain circular, while the main apse becomes polygonal (Figure 3-left). Very peculiar external ornaments characterise this part of the church: tooth-dogs, triangular motives, little columns and blind arches embellish the masonry brickwork. This decoration easily recalls the triangular ornaments present on the apse of the closer church of Santi Maria and Donato on Murano Island (Figure 3-right) as well as those characterising, for instance, some churches on Chios Island (Spagnesi 2008) (Figure 4).

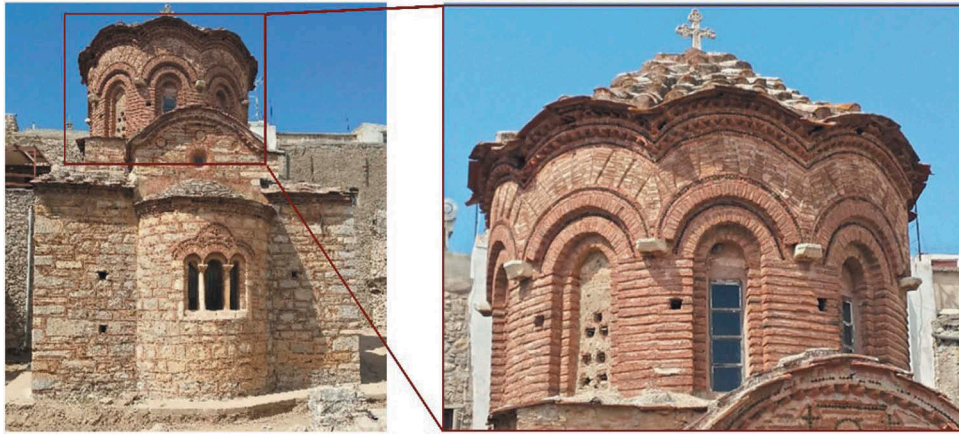
**Figure 4.** The Church of Agioi Apostoloi at Pyrgi on Chios Island with the detail of the drum characterised by arches decorated with triangular motives and toothdogs).

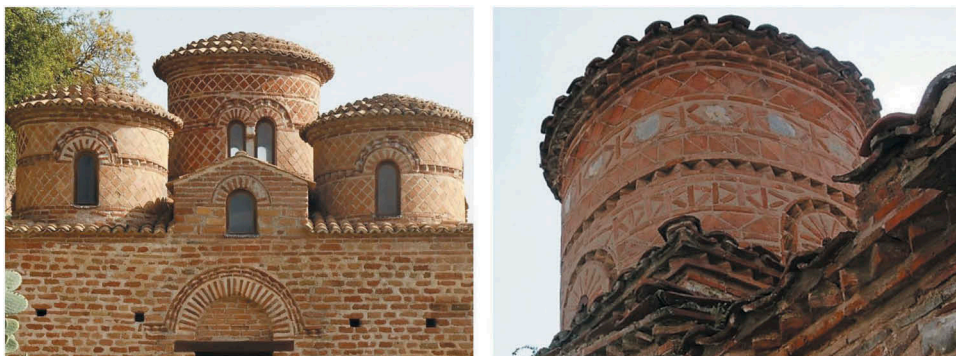
**Figure 7.** The lozenge decoration motive on the domes of the Cattolica di Stilo (left) and the dome of the 10th century church of Panagia Koumbelidiki in Kastorià (right).

The space distribution of the quincunx plan characterizes several examples of five-domed byzantine churches built in Laconia and Arcadia between the Tenth and Eleventh century. In addition, the external features of the domes present a decorative motif (Figure 7) that is well documented in this period in the Balkan Peninsula (Megaw 1964).

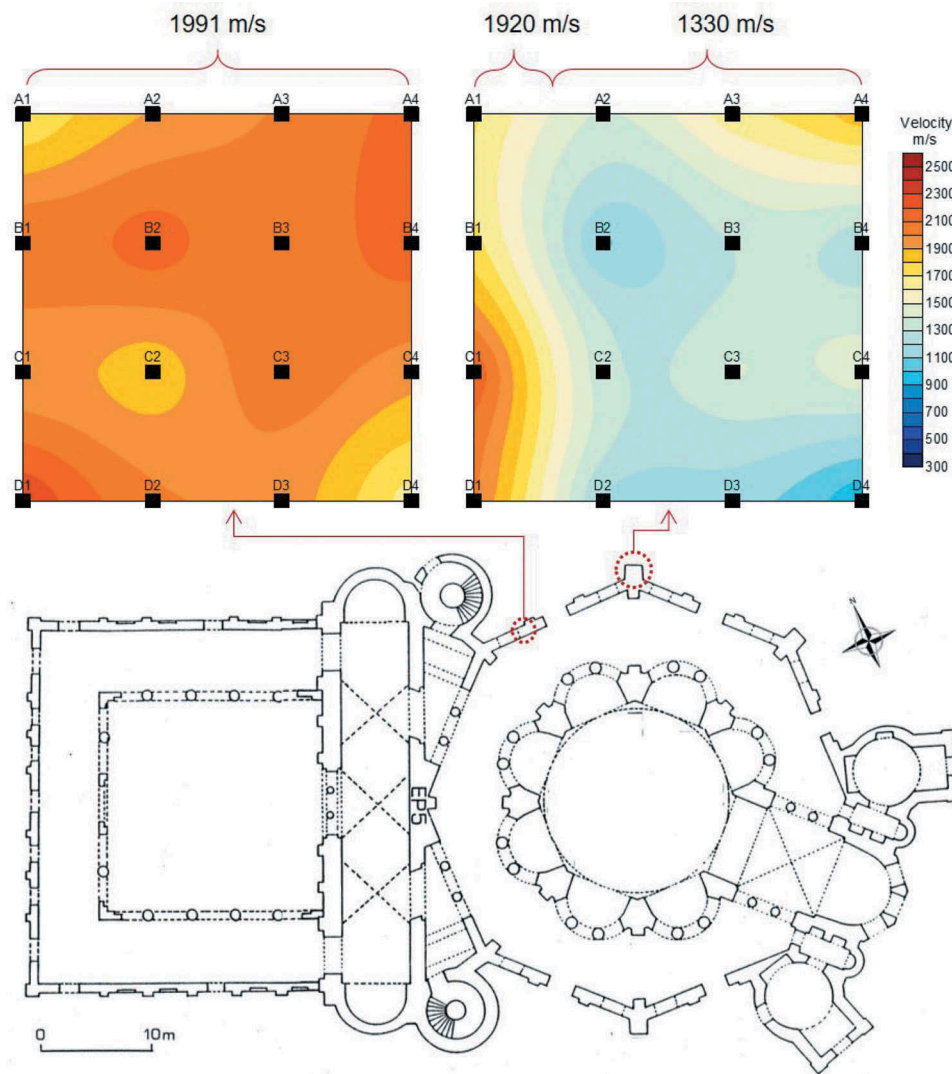
**Figure 9.** Comparison between sonic tests carried out on the north wall and on the north pillar of the San Vitale Basilica in Ravenna (data were a courtesy of professor Luigia Binda and the elaboration was made by the authors).

Using a sonic tests campaign carried out on the San Vitale Basilica in Ravenna as a reference for a first qualitative assessment of the masonry characteristics for a Byzantine building, a layout of the tests position and

their results is further described. Two different masonry structures were investigated by direct sonic tests. The north façade wall, tested by internal-external trajectories, covering a distance of 93 cm, showed a uniform distribution of the sonic velocities (see Figure 9). The north-east pillar, tested by using east-west trajectories, covering a distance of 156 cm, was characterised by not uniform values (see Figure 9). In the first case, the mean value of 1991 m/s can be assumed as reference velocity of a Byzantine brickwork presenting a solid connection among the internal nucleus and the external layers. In the second case, two ranges of velocity can be associated to a different composition of the massive pillar: the external bricks coating maintains a velocity similar to the previous case, equal to 1920 m/s, whereas the rest of the tested area presents a mean sonic velocity of about 1330 m/s, indicating a different organization of the masonry section. According to the building techniques used for massive structure, the masonry section could be composed of multiple leaves.

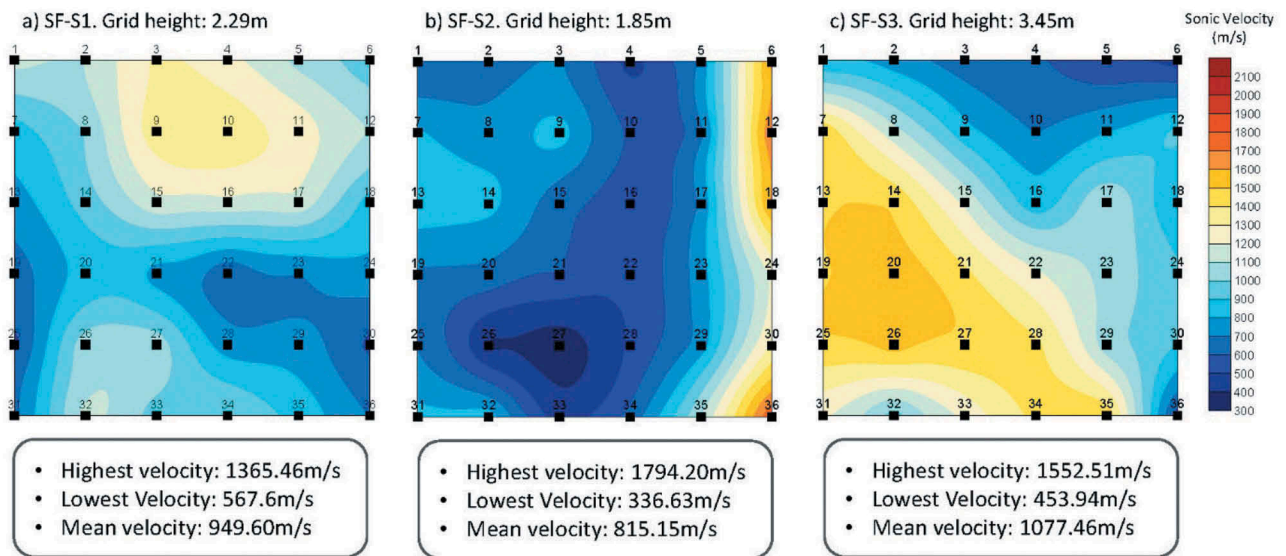
**Figure 14.** Map velocity distribution of the three areas of the south wall investigated by direct sonic tests with the obtained main results.

wall section) varies between 520 and 1325 m/s. Especially the values between 520 and 800 m/s indicate a masonry section composed of stone elements, not well connected to each other (see Figure 14a).

5 and 6 the velocity is close to the sound propagation velocity in the air (see Figure 14c). Most of the tested area is characterized by high velocity values close to 1400 m/s, which can be explained assuming that the material is compact and the elements are well interconnected. By observing the masonry pattern, values increase next to the changing of the supposed stratigraphic unit, as a result of a recent intervention.

The results indicate that the wall presents significant discontinuities. A velocity range of about 567–1365 m/s characterizes the areas where the masonry section maintains a load bearing function. The velocity distribution with values close to 400 m/s, found in the second test, can be associated to the presence of a cavity inside the wall. The vertical path followed by

the low velocities describes a precise geometry, observing the grid reported in Figure 15b, that can even indicate the inclusion of a different material in the masonry wall. Thanks to this qualitative indication, a further and localized direct inspection can verify the characteristics of the structure: in this case, a vertical cavity hosting the traces of a timber element was discovered.

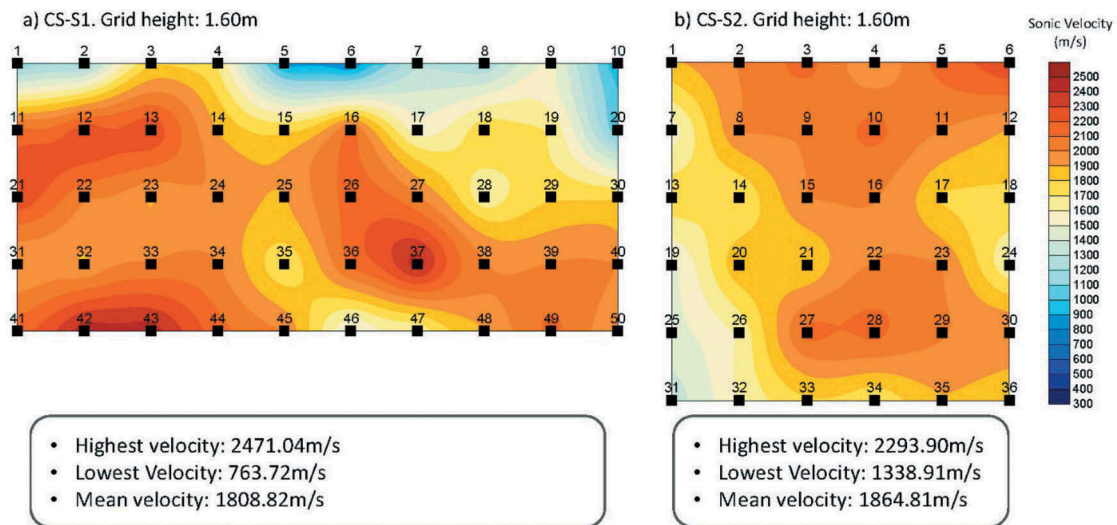
**Figure 19.** Distribution of the sonic velocities obtained by two direct sonic tests carried out on the south façade of La Cattolica church.

As shown in Figure 19, the main values of both tests are similar, indicating that the masonry cross section of the main façade presents homogenous characteristics. The velocities are close to those observed for regular

masonry sections composed of bricks and mortar. In this case, the tests identified a wall section presenting a correct connection among its component materials. Moreover, the results indicate that, in terms of state of conservation, the masonry wall maintains its original properties and damage is limited to thin cracks.

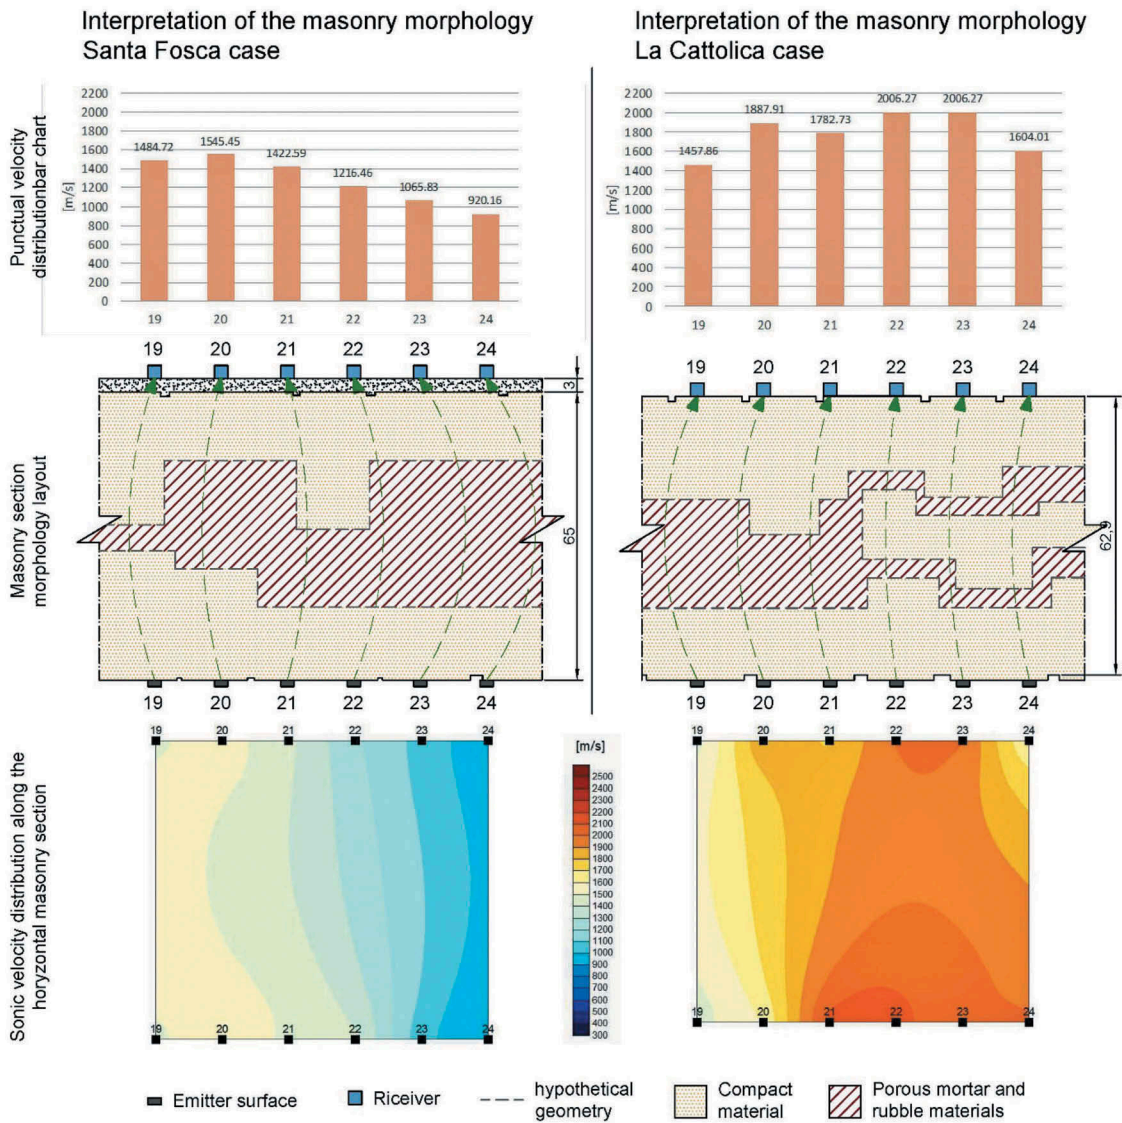
**Figure 20.** Interpretation of the results obtained for a specific row of the grid of points used for the tests: hypothetic layout of the masonry horizontal sections.

and a direct inspection of the brick dimensions (at least 20 measurements) can be carried out, a hypothetical layout of the masonry section can be proposed. Figure 20 shows the possible masonry typologies identified in Santa Fosca and in La Cattolica according to these parameters:
