Article

Improving the Corrosion Resistance of Wrought ZM21 Magnesium Alloys by Plasma Electrolytic Oxidation and Powder Coating

Citation: Ballam, L.R.; Arab, H.; Bestetti, M.; Franz, S.; Masi, G.; Sola, R.; Donati, L.; Martini, C. Improving the Corrosion Resistance of Wrought ZM21 Magnesium Alloys by Plasma Electrolytic Oxidation and Powder Coating. *Materials* **2021**, *14*, 2268.

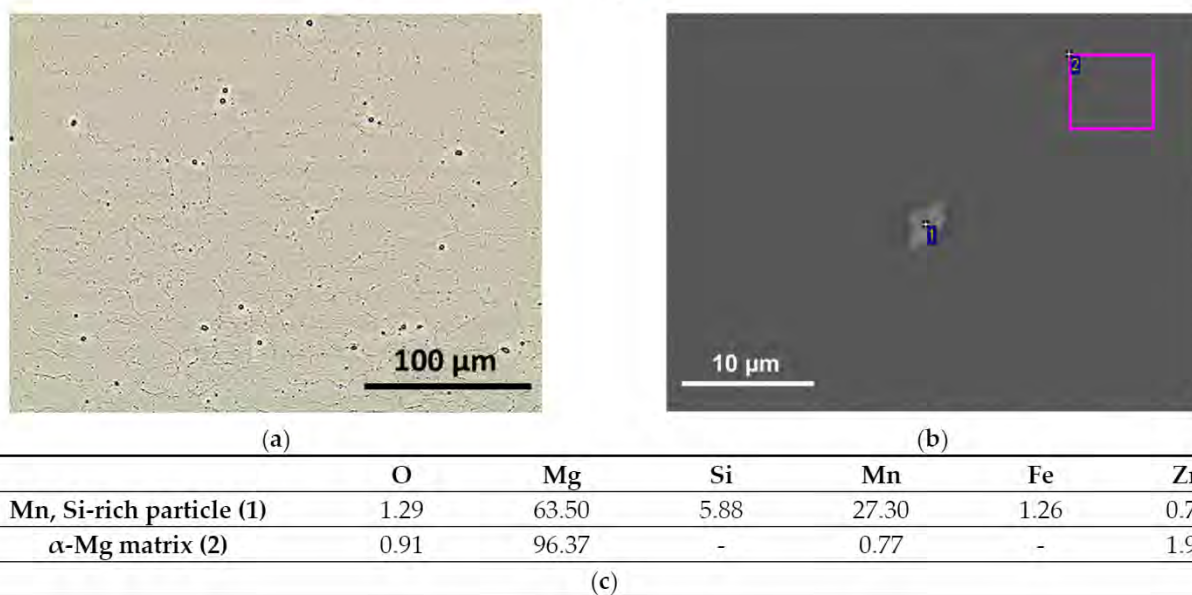
Optical and SEM images showing the microstructure of the ZM21 alloy are shown in Figure 1a,b: a fully recrystallized microstructure was observed in the plane perpendicular to the extrusion direction. Equiaxed grains displayed an average size of $9 \pm 5 \mu\text{m}$ and a bimodal grain size distribution was observed, consisting of both relatively coarse grains ($15 \pm 4 \mu\text{m}$) and fine grains ($3 \pm 1 \mu\text{m}$), as already reported by other authors for ZM21 after extrusion [26]. Relatively small Mn,Si-rich particles ($<5 \mu\text{m}$, as shown by high magnification SEM image in Figure 1b, accompanied by localized EDS analysis results, Figure 1c) were also detected in the α -Mg matrix (with Zn and Mn in solid solution, as indicated by EDS data in Figure 1c). Mn,Si-rich particles also contained Fe, a common impurity in Mg alloys. Similar observations were reported for the same alloy in the extruded condition, also by Bian et al. [6]. The formation of the Zn-rich β phase was not observed, due to the balance between Zn and Mn in the alloy [27].

Figure 1. Microstructure of the ZM21 substrate: (a) optical image and (b) higher magnification SEM image with (c) EDS analysis (wt.%) of the unetched alloy.

The small Mn,Si-rich particles described in Section 3.1 (Figure 1b) do not appear to have any significant influence on the overall growth of the PEO layer at this scale, and the ZM21 alloy basically responds to oxidation as a single phase material. As for the elements from the electrolyte, elemental maps show that Na-rich species are mostly located in the outer areas of the coating, while Si and P are more homogeneously distributed throughout the whole layer. The distribution of these elements in PEO layers is influenced by ionic mobility of different species, as discussed by Monfort et al. and Matykina et al. in [30,31].

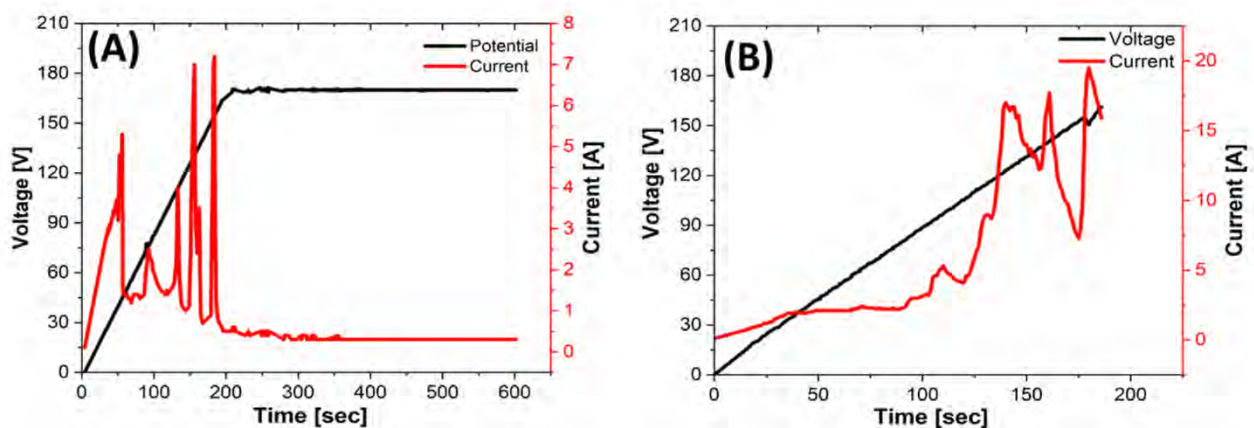
The chronopotentiometric and chronoamperometric curves recorded during the PEO of the sacrificial samples (Figure 2A) showed a typical current profile characterized by randomly distributed peaks corresponding to discharge avalanches on the anodic surface. The current peaks did not exceed 7 A during the PEO of the sacrificial samples (Figure 2A). This induced lower energy dissipation and a better temperature control. During PEO of the extruded profiles (Figure 2B), the current peaked at 20 A, probably because of the higher anodic surface area. Correspondingly, a more intense sparking and gas evolution was observed, with significant electrolyte temperature increase, inducing the operator to interrupt the treatment at the beginning of the potential plateau. The discrepancy on the chronoamperometric profiles reported in Figure 2A,B can be ascribed to the different ratio of anodic to cathodic exposed area. This issue would deserve a dedicated development stage, which was out of the scope of this work.

Figure 2. Potential (black) and current (red) curves as a function of the PEO processing time for the ZM21 sacrificial specimen (A) and for the ZM21 extruded profile (B).

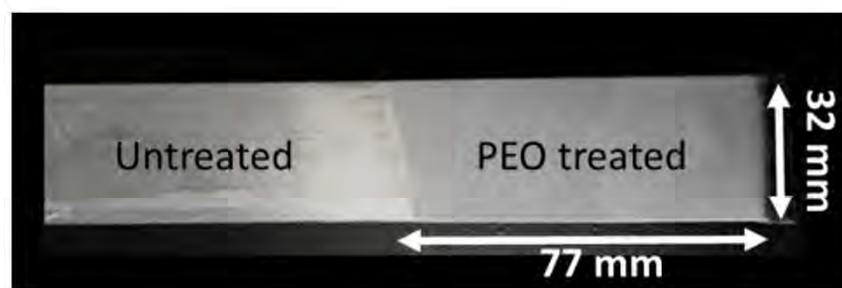
As shown in Figure 3, at visual examination the oxide film formed on the surface of the anodized ZM21 extruded profile appeared homogeneous.

Figure 3. Representative image of a PEO-treated ZM21 extruded profile.

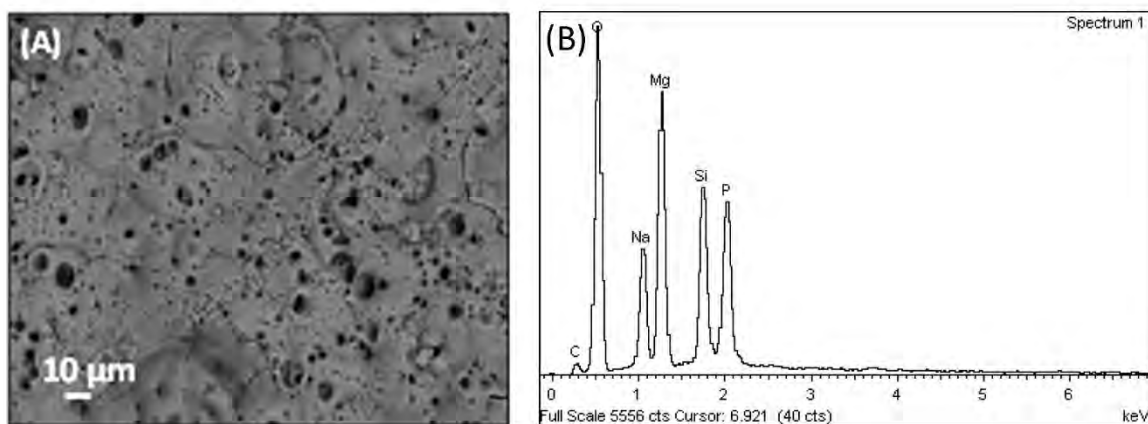
After anodizing, the surface of sacrificial samples exhibited a micrometric and sub-micrometric porosity; however, the typical cracks often resulting from PEO of Mg alloys [16] were not observed (Figure 4A). The EDS analysis of the surface (Figure 4B) revealed that the PEO layer contained O, Zn, Na, Mg, Si and P, with Zn and Mg from the ZM21 alloy and Na, Si and P incorporated from the electrolyte.

Figure 4. PEO-treated surface: (A) SEM image and (B) EDS surface spectrum of the oxide layer obtained onto a ZM21 sacrificial sample at 170 V, 188 s, 30 °C in 100g/L $\text{Na}_3\text{PO}_4 \cdot 12\text{H}_2\text{O}$, 20 g/L Na_2SiO_3 , 25 g/L $\text{Na}_2\text{B}_4\text{O}_7 \cdot 10\text{H}_2\text{O}$.

The surface morphology of PEO-treated profile and the corresponding cross-section image are shown in Figures 4A, 7 and 8, respectively. The surface morphology appeared rough and porous with typical craters generated by local discharge events occurring during the growth of the anodic oxide layer [15,29]. A few microcracks, derived from thermal stresses, and a pancake morphology, formed by molten oxide erupted from discharge channel and rapidly cooled by the electrolyte at the room temperature, were also observed

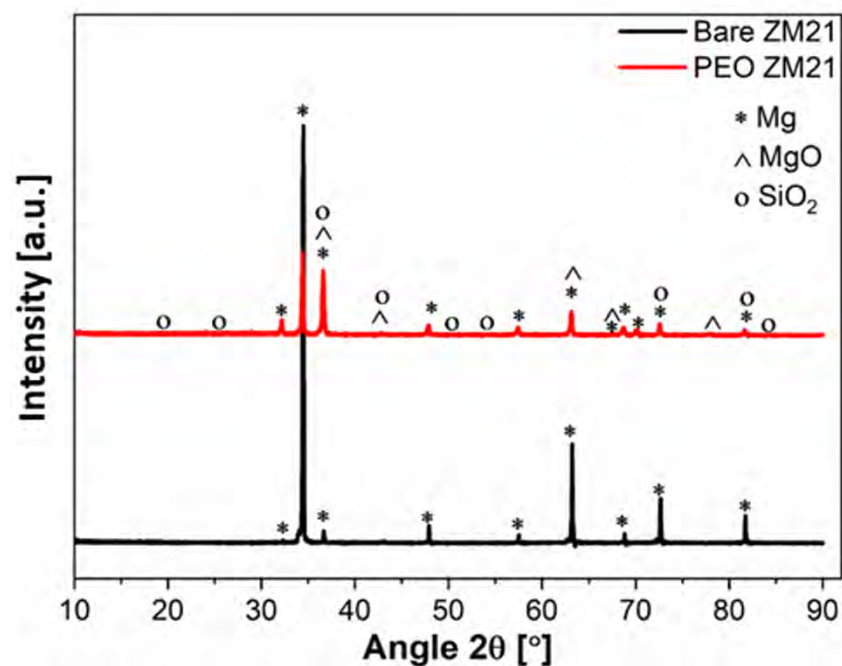
XRD patterns shown in Figure 5 demonstrate that the PEO film consisted of a mixture of MgO and SiO_2 .

Figure 5. XRD pattern of the bare ZM21 alloy (black) and of the anodic film (red) obtained onto ZM21 at 170 V, 188 s, 30 °C in 100g/L $\text{Na}_3\text{PO}_4 \cdot 12\text{H}_2\text{O}$, 20 g/L Na_2SiO_3 , 25 g/L $\text{Na}_2\text{B}_4\text{O}_7 \cdot 10\text{H}_2\text{O}$.

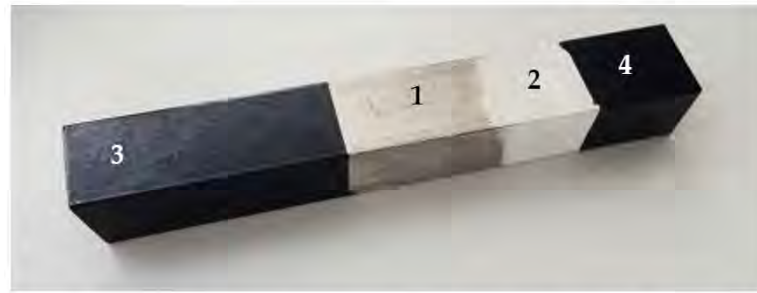
A general view of extruded profiles, with indication of the investigated conditions is shown in Figure 6: (1) bare ZM21 (reference), (2) PEO-treated ZM21, (3) powder-coated ZM21 (without PEO interlayer), (4) PEO-treated ZM21 with powder coating top layer.

Figure 6. General view of extruded profiles ($30 \times 30 \text{ mm}^2$, length: 170 mm), with indication of the investigated conditions: (1) bare ZM21, (2) PEO-treated ZM21, (3) powder-coated ZM21, (4) PEO-treated ZM21 with powder coating top layer.

Surface roughness parameters (R_a , R_q , R_z , R_t and R_{max} according to [28], measured in the areas highlighted in Figure 6) are reported in Table 2.

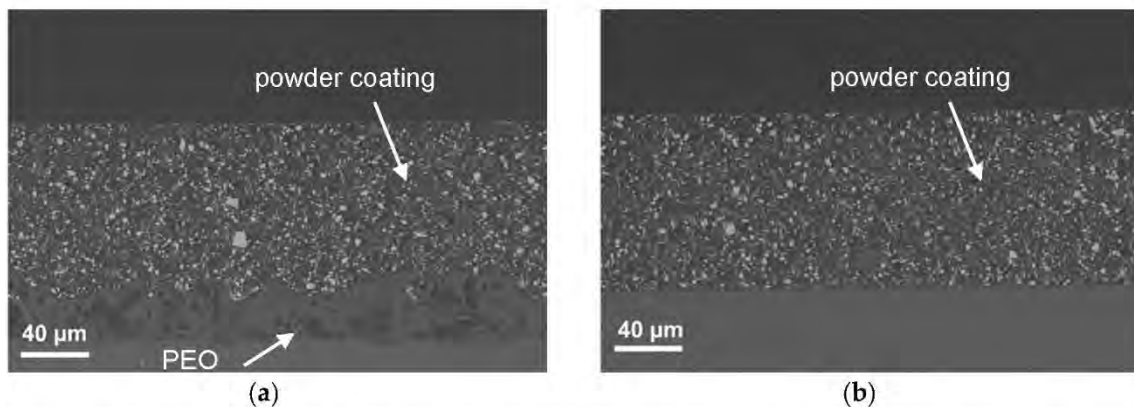
Figure 7. Cross-section BSE images of (a) PEO-treated and powder-coated ZM21 and (b) powder-coated ZM21 (without PEO interlayer).

The cross-section images (Figures 7 and 8) showed that the PEO layer/substrate interface is slightly undulated, due to local thickening of the anodic oxide following breakdown events [11]. The pores are unevenly distributed throughout the specimen cross-section and the average thickness of the film is about 30 μm . Typical discharge channels, pores and cracks, bigger and larger in the outermost region, were also observed. The characteristic anodic oxide morphology afforded mechanical interlocking of the powder coating top layer (Figure 7a), an important prerequisite for satisfactory bonding strength. Additionally, the deposition of the powder coating top layer allowed to obtain a smoother surface (as shown also by surface roughness data in Table 2), levelling out the rough PEO surface. The average thickness of the PEO layer was $39 \pm 4 \mu\text{m}$, while the powder coating top layer was $118 \pm 9 \mu\text{m}$ thick (Figure 7a,b), regardless the presence of the PEO interlayer (as expected, since the powder coating was applied in a single painting session). The coating thickness was fairly uniform in both cases (PEO layer alone and PEO with powder coating top layer). EDS analysis of bright spots in the BSE cross-section images of the powder coating showed the presence of Ba- and Ca-based compounds, typical inorganic fillers added to the powder coating top layer (such as BaSO_4 and CaCO_3).

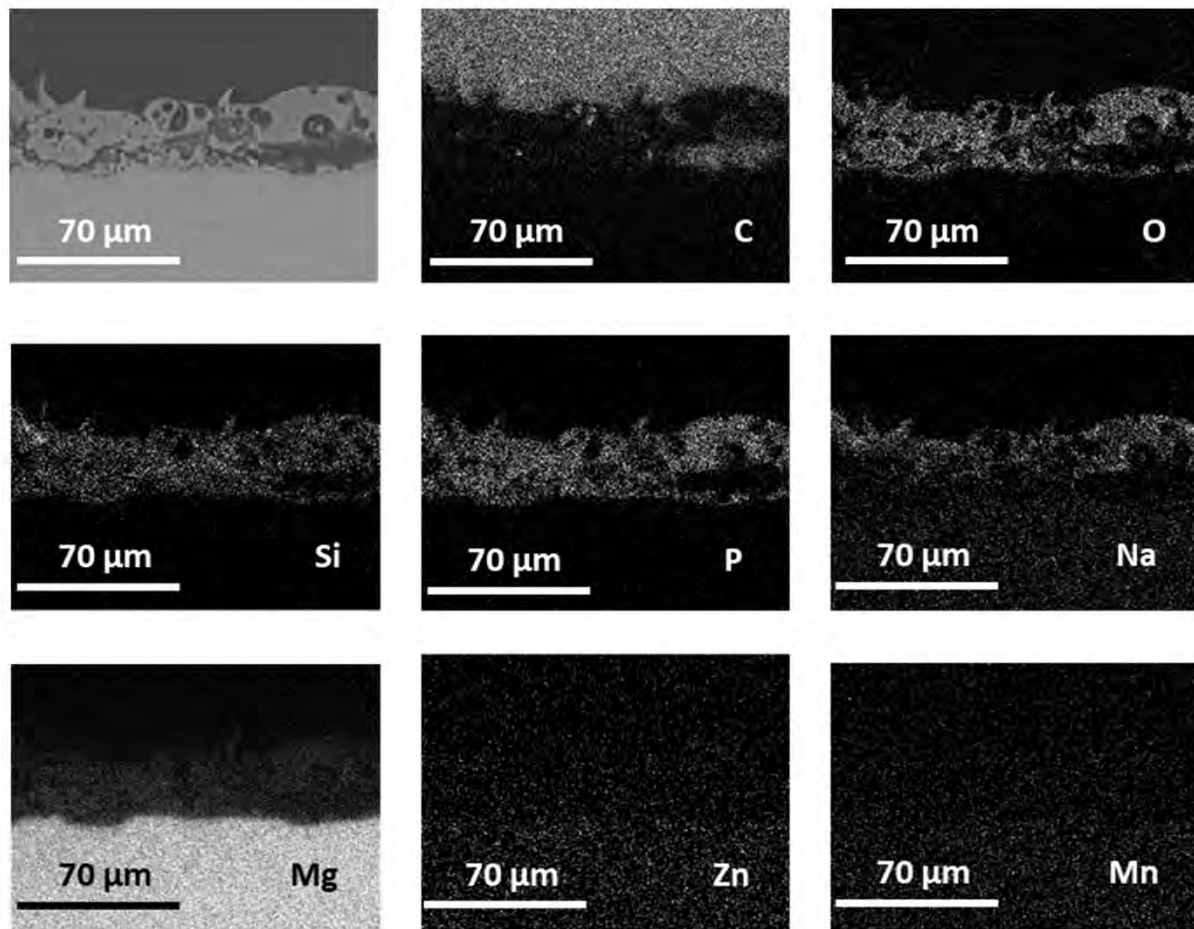
Figure 8. BSE image (top left) and X-ray EDS elemental maps of the PEO-treated ZM21 extruded profile (polished cross section; the presence of C is due to the mounting resin).

Elemental X-ray maps recorded by EDS on polished cross sections of PEO-treated samples (Figure 8) showed a homogeneous distribution of alloy elements (Mg, Zn, Mn) as well as of elements incorporated from the electrolyte (O, Si, P).

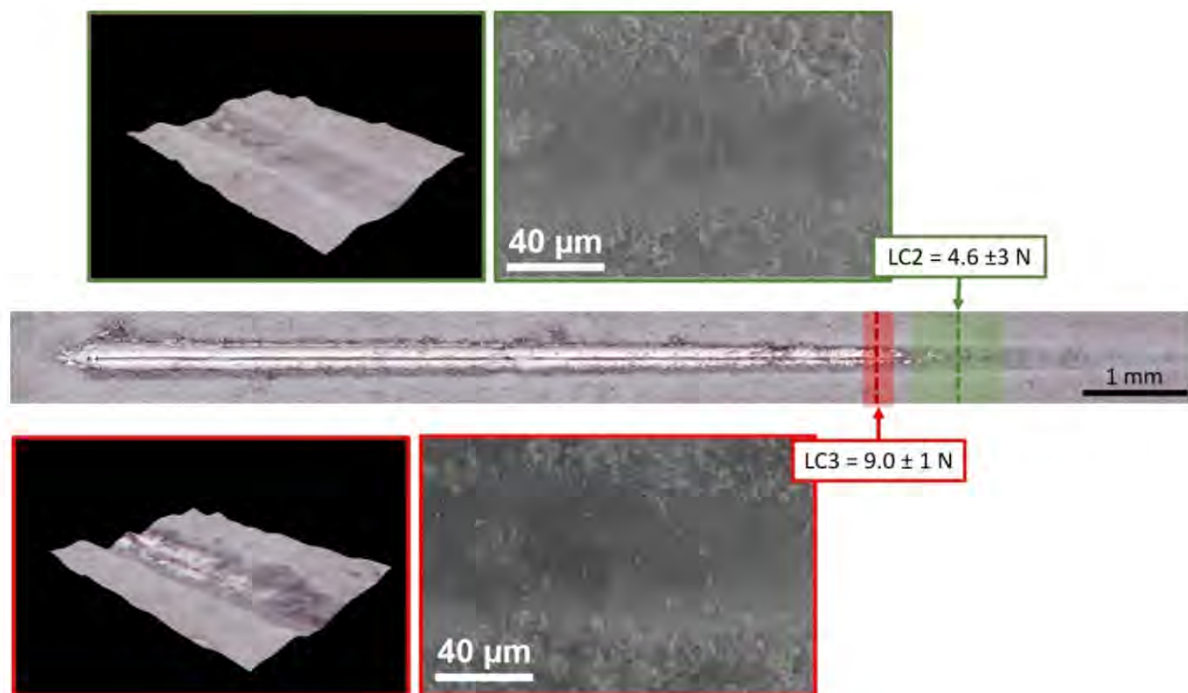
Representative images of scratch tracks with indication of critical loads Lc2 and Lc3 for adhesive failure of PEO layer, estimated according to ISO 20502:2016 [32] are reported in Figure 9.

Figure 9. Overview of a representative scratch track on PEO-treated ZM21 extruded profiles (optical image), with indication of critical loads Lc2 (first coating detachment) and Lc3 (full delamination). Each critical load for adhesive failure of the PEO layer is accompanied by the corresponding SEM image (SE) and 3D-digital microscopy image of the scratch track (black background).

The measured average value of Lc2, indicating when the coating detachment begins, and Lc3, corresponding to penetration of the coating to the substrate at the center of the track, were 4.6 ± 3 N and 9.0 ± 1 N respectively, comparable to those measured in a previous work on PEO-treated EV31A Mg alloy, where scratching was carried out in the same conditions [29]. Substrate and coating properties influence the failure mode during scratch testing [33]: PEO-treated Mg alloys can be considered as hard coating on soft substrate even though the hardness difference may not be notably high. Therefore, PEO layers were bent into the track as a consequence of substrate plastic deformation. The SEM image corresponding to Lc2 in Figure 9 (top right) shows buckling failures (cracks and patches of coating detachment) appearing in the scratch track, in the areas where the indenter movement generates pile-up deformation. After full delamination of the PEO layer, only substrate plastic deformation was observed, together with scattered micro-fragments from the anodic oxide (bottom right SEM image in Figure 9).

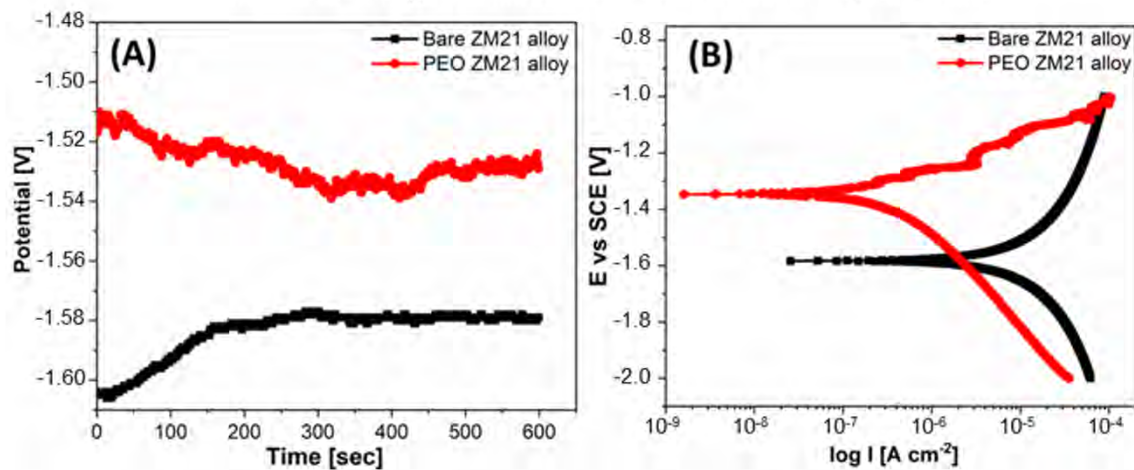
Corrosion tests were carried out on sacrificial specimens. Open circuit measurements in 3.5% NaCl solutions (Figure 10A) showed that the immersion potential of the anodized

According to the potentiodynamic tests (Figure 10B), after anodization the corrosion current density decreased by one order of magnitude, i.e., from $2.5 \cdot 10^{-8} \text{ A cm}^{-2}$ to $1.5 \cdot 10^{-9} \text{ A cm}^{-2}$ and the corrosion potential increased by about 300 mV, i.e., from -1.6 V vs. SCE (untreated ZM21 alloy) to -1.3 V vs. SCE (anodized alloy). Correspondingly, the polarization resistance of the alloy increased by two orders of magnitude after the PEO treatment, rising from about $9837 \Omega \text{ cm}^2$ to about $145,848 \Omega \text{ cm}^2$.

Figure 10. Open circuit voltage as a function of immersion time (A) and potentiodynamic curves (B) of ZM21 before (black curve) and after (red curve) PEO. Tests carried out in 3.5% NaCl aqueous solutions.

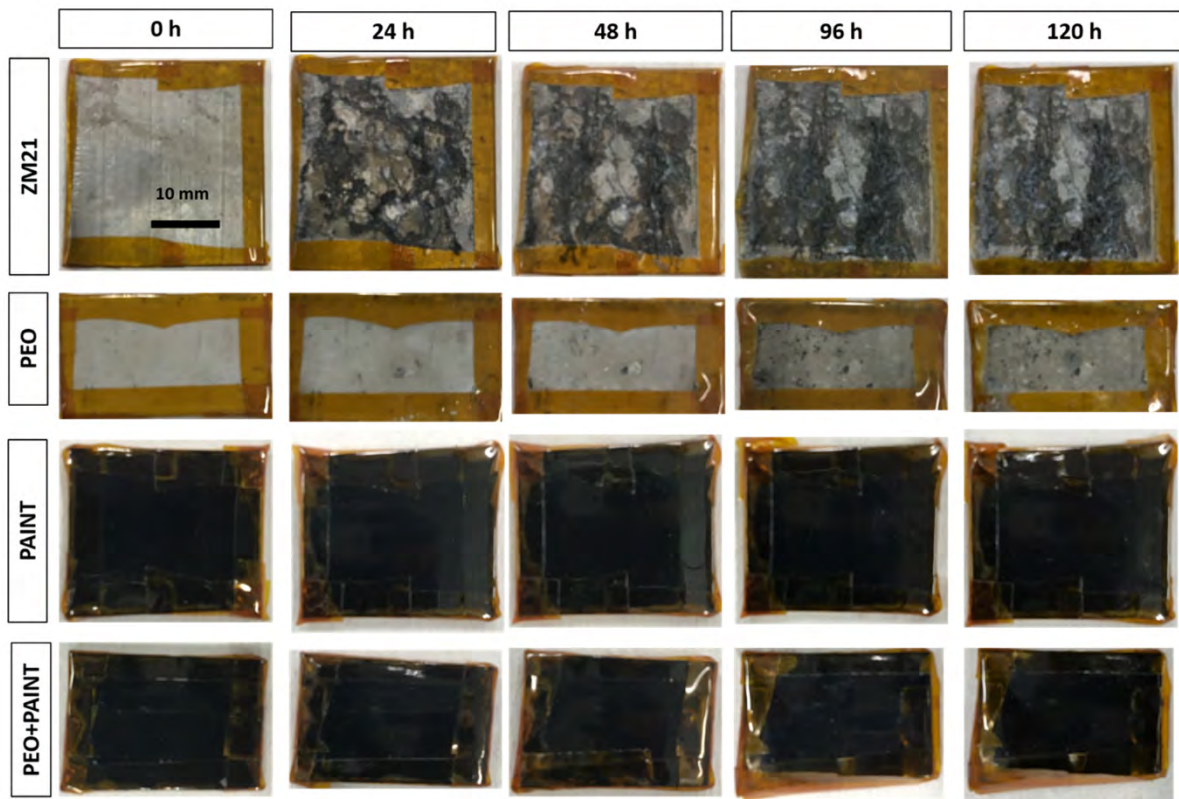
The results of the visual inspection of the samples during and at the end of NSS test are reported in Figure 11. Already after a few hours of exposure (>6 h), ZM21 alloy exhibited corrosion products on the surfaces, indicating the high reactivity of this material in NaCl solution. At the end of the exposure, the reference ZM21 samples showed a strongly damaged surfaces characterized by the precipitation of uniformly distributed corrosion products, as highlighted in micrographs of Figure 12. The PEO-treated samples showed localized corrosion attacks for short exposure time (>6 h) that are clearly visible after 24 h. However, these corrosion attacks on PEO surfaces did not significantly evolve with time. This is probably due to the initiation of the localized corrosion attacks in correspondence with PEO treatment defects (e.g., porosity). In addition, corrosion products continuously precipitated inside the localized corrosion sites, mitigating the corrosion rate of the process. However, at a longer exposure time (>96 h), a localized acceleration of the corrosion process was observed with a consequently leaching of the corrosion products, as shown in Figure 12. Conversely, for both the painted samples, no corrosion attacks and/or painting damages were observed within the 120 h NSS test, indicating an increased performance for both the

Figure 11. Visual observation of the samples before and during the NSS test.

Painted samples. However, longer NSS test exposure will be necessary for discerning the performance of the painted samples on the ZM21 alloy or on the PEO-treated surfaces.

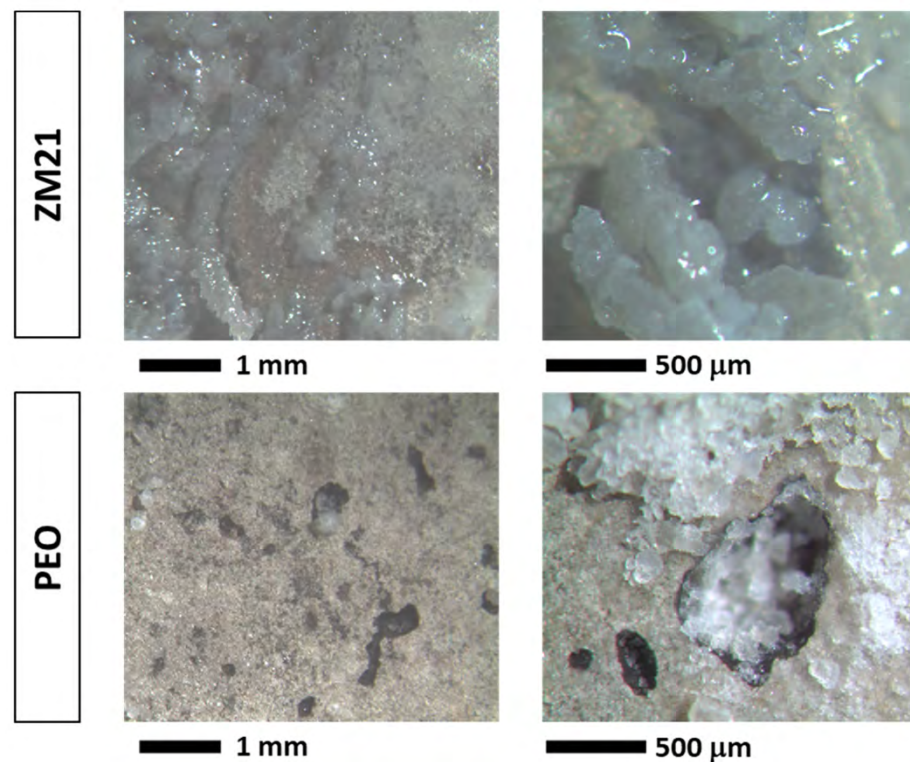
Figure 12. Macroscopic images of corroded surfaces (bare ZM21 and PEO-treated ZM21) at the end of the NSS test (120 h).

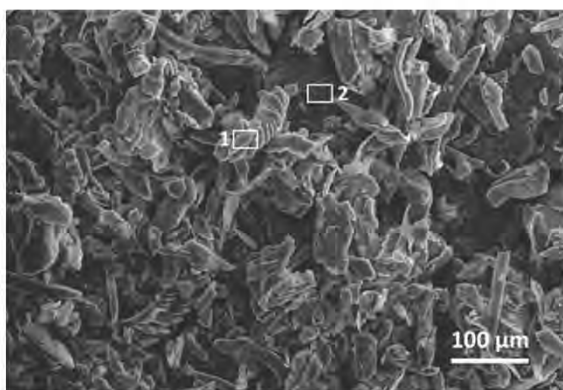
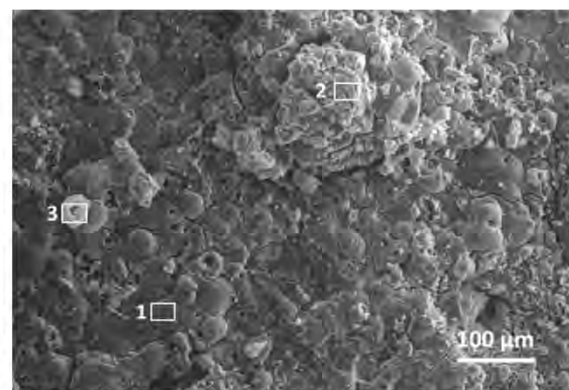
The corroded surface as well as the polished cross section of the bare and PEO-treated ZM21 were also analyzed by SEM/EDS at the end of the NSS test (120 h). Figure 13 shows the morphology of corroded surfaces and further demonstrates that the PEO layer contributed to limit the formation of corrosion products on ZM21: a more extensive formation of Cl- and O-rich crystalline corrosion products was observed on bare ZM21 (Figure 13a) than on the PEO-treated surface (Figure 13b). However, some localized corrosion attacks are also visible on the PEO-treated surface (areas 2 and 3 in Figure 13b), with increased amounts of elements from the aggressive environment (namely Cl and O) by comparison to the less corroded areas of the anodic oxide (area 1 in Figure 13b), which still retains its typical surface morphology with volcano-like features (as shown before corrosion by Figure 4A).

O	Na	Mg	Cl	Mn	Zn
1	28.1	0.4	68.9	0.1	0.7	1.8
2	56.1	4.3	36.7	2.1	0.2	0.6

O	Na	Mg	Si	P	Cl	Mn	Zn
1	60.4	5.3	17.8	7.7	7.2	0.6	0.3	0.7
2	63.7	5.0	16.9	7.0	5.3	1.1	0.3	0.7
3	66.7	4.5	17.4	5.5	3.5	1.8	0.3	0.3

Figure 13. SEM images (secondary electrons) and localized EDS analyses (wt.%) of corroded surfaces (bare ZM21 (a) and PEO-treated ZM21 (b)) at the end of the NSS test (120 h).

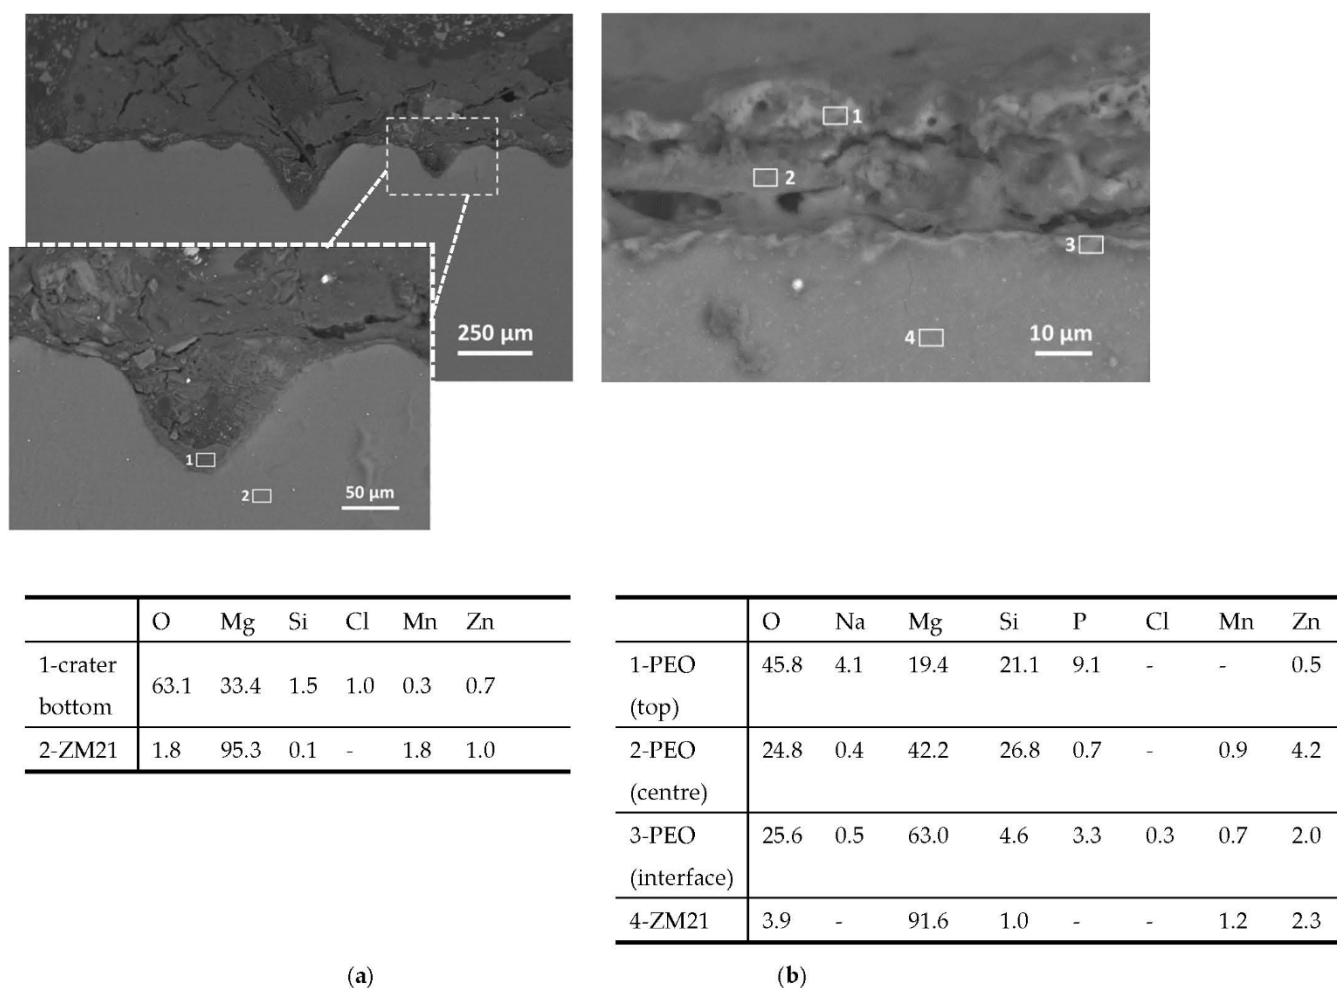
Figure 14 compares the polished cross section of the bare and PEO-treated ZM21, showing that while the bare alloy underwent remarkable localized corrosion, with the formation of several craters (Figure 14a), the PEO-treated samples still showed the presence of the anodic oxide layer, even though with a slight increase of defects (cracks and pores), which favored the previously mentioned localized corrosion phenomena. Cl from the aggressive environment was always detected at the interface between the corrosion products and the alloy, as expected.

Figure 14. SEM images (backscattered electrons) and localized EDS analyses (wt.%) of polished cross sections through corroded samples (bare ZM21, with general view and high magnification detail (a) and PEO-treated ZM21, high magnification detail (b)) at the end of the NSS test (120 h).
