Shrouded by time and tile: a structural investigation for preservation of Cuba's historic School of Ballet classroom and theatre domes

Moriah HUGHES*, Camille HEUBNER, Sofia CELLI^a, Maria GARLOCK, Federica OTTONI^a,
Davide DEL CURTO^b, Branko GLIŠIĆ

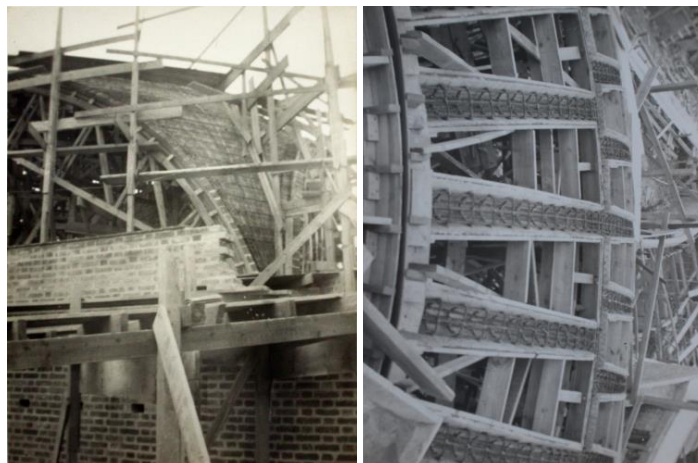
Figure 3. Rebar in the Classroom pendentives (left) and the domes' ribs and rings (right). Courtesy of ISA archives.

Several extent construction drawings show the design for the pendentive reinforcing, which, from the construction photographs (Figure 3, left), appears to have been realized. These also indicate a layer of reinforcing steel within the thin concrete shell covering the ribs in the uppermost, spherical dome shells.

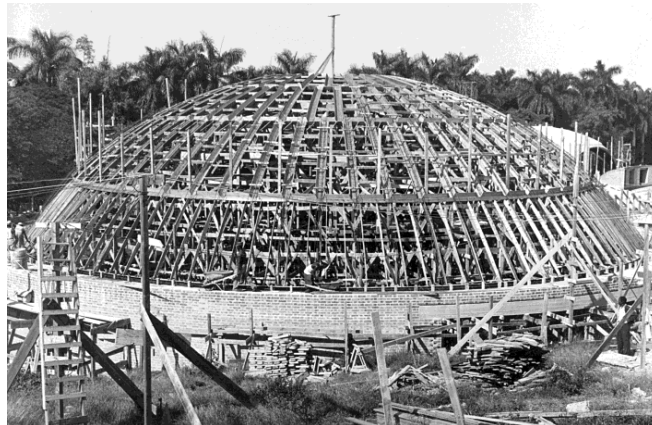
Figure 4. Theatre dome under construction, with scaffolding and wooden formwork visible. Courtesy of ISA archives.

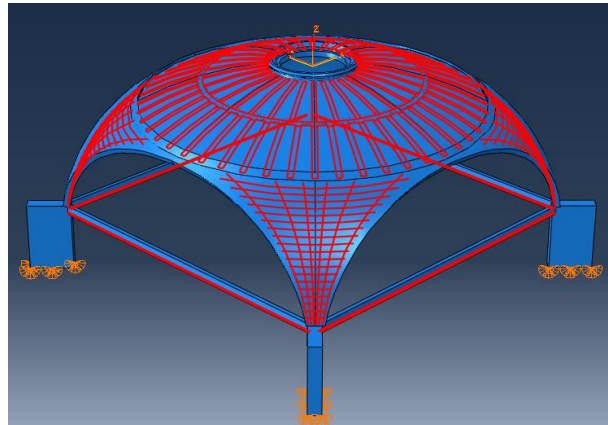
Figure 6. Geometric model of Classroom showing pinned supports on pillars. Embedded reinforcing elements are highlighted red.

For the Choreography Theater, the 3D model was created from 2D drawings provided by project partners based on site and archival data. The Classroom model was created from a laser scan of the structure also performed during the site investigation. For both structures, rotational symmetry was assumed to simplify the models, and representative cross-sections and profiles were defined from the provided drawings to create the solids and shells, respectively. All members were modeled as homogeneous solids, except for the upper dome shell, which was modeled as a shell element. Reinforcing elements were modeled as typical for Abaqus: wire or shell elements were assigned the properties of the reinforcing steel and then embedded in the solids. The resulting models are shown in Figure 5 and Figure 6.

The boundary conditions for the finite element models of the two structures are shown in Figure 5 and Figure 6. For the Choreography theater, the pillars and mezzanine were omitted from the model for computational efficiency and pins defined around the perimeter in place of the pillars. The pillars were included in the Classroom model (the full analysis included studies of the efficacy of the tie beams and the pillar demand), and their bottoms were supported with pins.

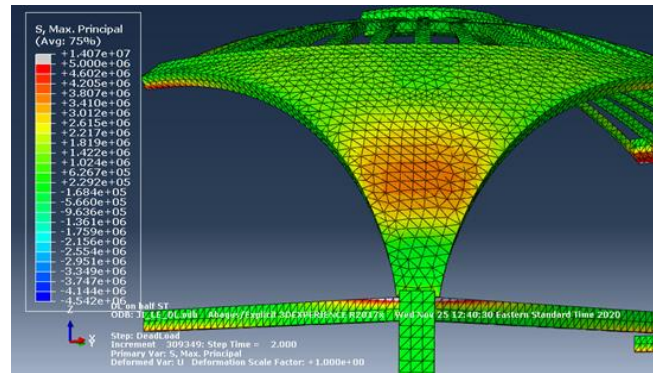
The plot of the dome principal stresses clearly indicates that the structure is not funicular. Rather, tensile stresses exist at the arch apexes and near the mid-height of the pendentives, as shown in Figure 9. The spherical dome cap functions under low-level bending stresses (not visible) primarily induced by the arched openings between the pendentives which the dome spans.

Figure 9. Maximum principal stress under self-weight (linear elastic model).

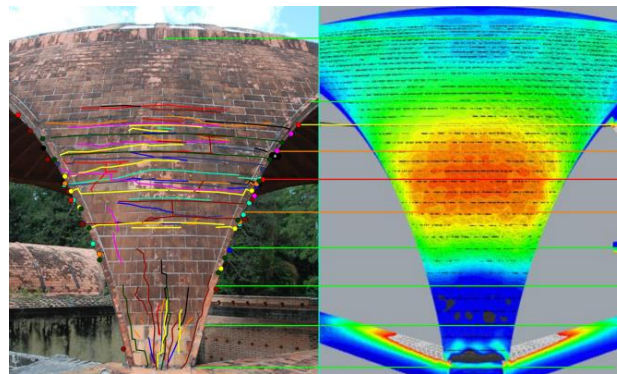
Crack maps were produced which detail the visible tile and concrete cracks on the extrados of the pendentives. The comprehensive crack map for all surveyed pendentives may be seen in Figure 10, left. This study led the hypothesis that these cracks, though apparently stabilized by the pendentive rebar, were a significant damage occurrence and might lead to a structural failure if allowed to develop.

To validate the stress results, the principal stress plot, which indicates the tensile stresses due to bending, was compared with the real domes' cracking. Figure 10 shows how the majority of the recorded cracks occur within the high to moderate stress region on the pendentive extrados.

Figure 10. Comparison of cracking behavior of classroom pendentives with model principal stress.

For the Practical Classrooms, the visual inspection and FE model both indicated that the pendentives are overloaded and under excessive bending stress that, whether due to instantaneous effects or concrete creep, has caused significant concrete cracking in the pendentive extrados. Other areas of concern are the cracking, section loss, and potential rebar corrosion at the arch apex and within the arch. The continued deterioration of the dome, merely from environmental exposure of the crack cross-sections but also from increased loads, could have catastrophic implications. Therefore, structural interventions that will alleviate the over-loaded condition of the pendentives are recommended.
