Structural validation of geothermal water basins constructed with durability enhanced ultra high performance fiber reinforced concrete (Ultra High Durability Concrete)

Salam Al-Obaidi ^{a,b,*}, Marco Davolio ^a, Francesco Lo Monte ^a, Ferdinando Costanzi ^c, Massimo Luchini ^c, Patrick Bamonte ^a, Liberato Ferrara ^a

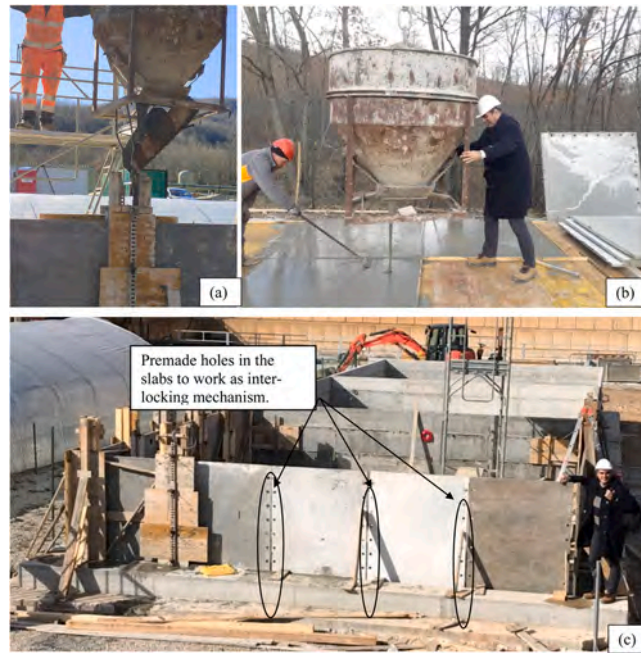
Fig. 4. Construction steps of the third basin – (a): pre-casting the slabs horizontally, (b) cast in place the columns, (c) arranging the precast slabs vertically in their positions before casting the stiffening column.

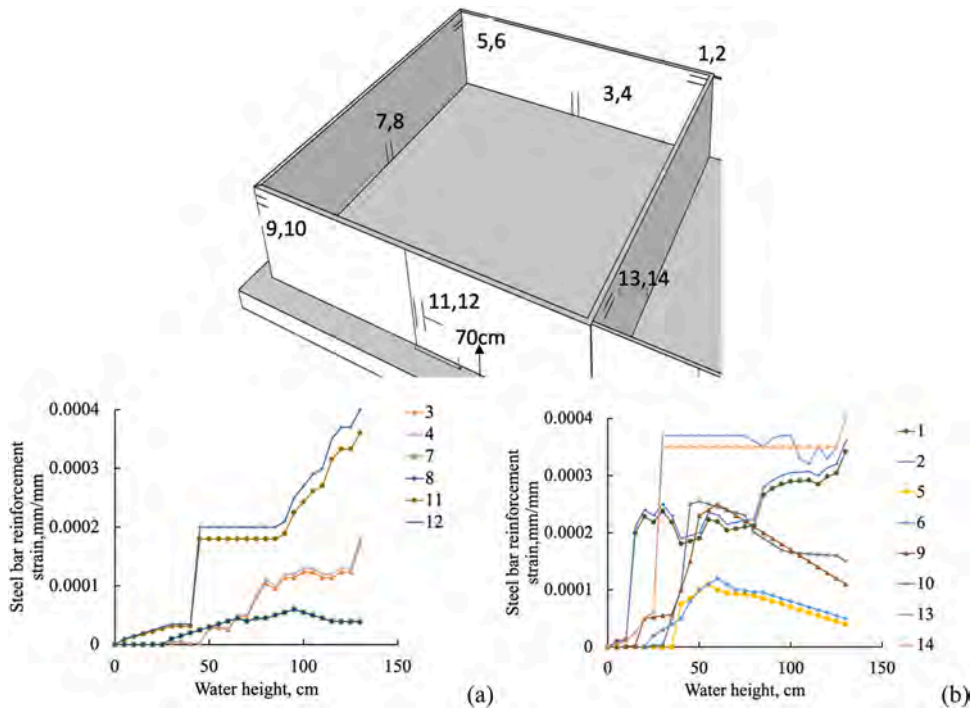
Fig. 13. Illustration of water level- steel bar strains for the first basin, a- strains from vertical bars, and b- strains from horizontal bars.

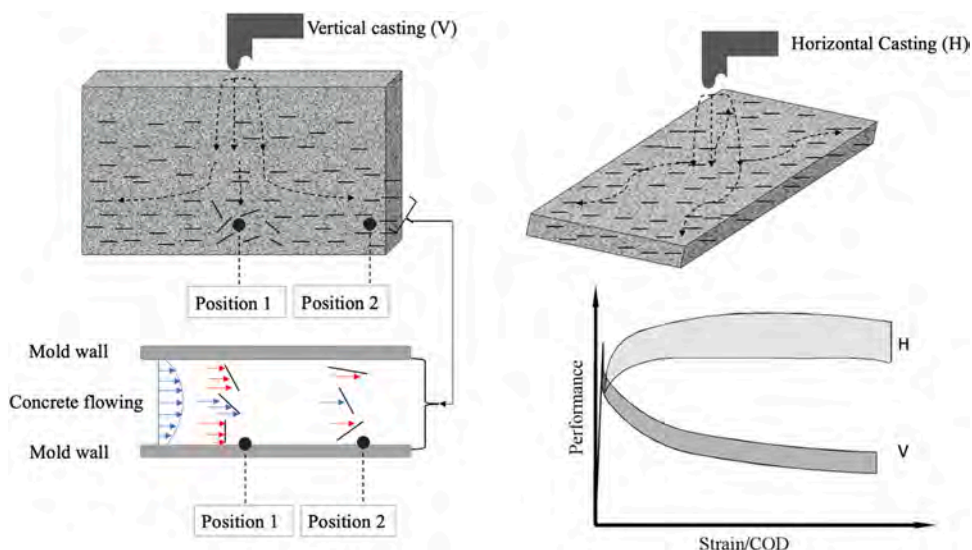
Fig. 20. Illustrating the mechanism and the effect of the vertical and horizontal UHPC casting.

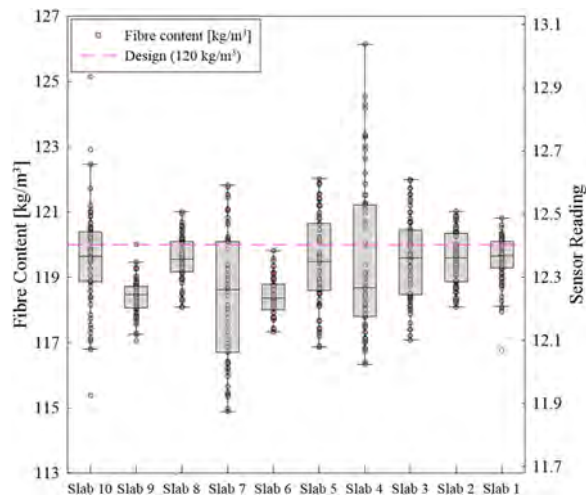
Fig. 22. Correlating the sensor reading with steel fiber content.

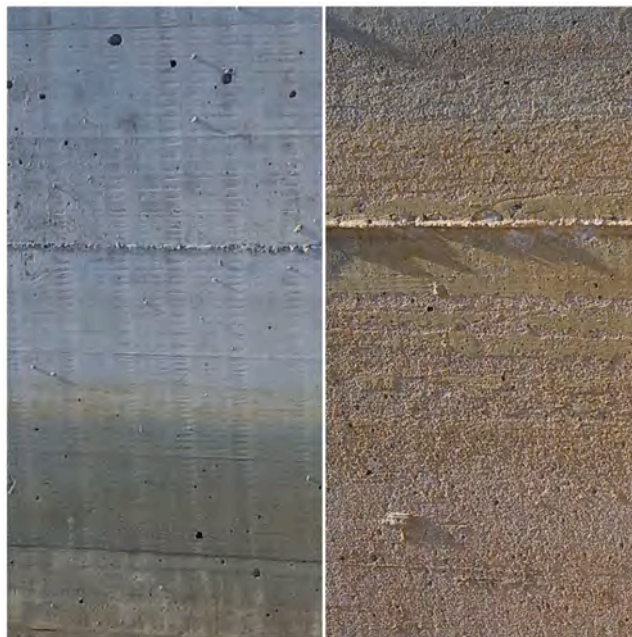
Fig. 29. Durability observations: geothermal water exposed surface condition from the second basin (left), and geothermal water exposed surface from the first basin (right).

The solution adopted for the third compartment, where the walls were made by precast UHDC slabs, revealed no shrinkage cracking problems as noticed for other basins. It is interesting to point out that after one year of being in service, some degradation has been noticed in the first basin, where leaching in immersed concrete layers was observed during filling the basin as shown in Fig. 29 right, where also some surfacing sand particles are shown which can be easily removed from the surface of the wall. On the other hand, this did not appear in the second nor the third basin, where the UHDC materials were used Fig. 29-left. The main reason for the leaching is the decrease of the pH value below the stability limits of cement hydrates, Table 1: as the acids attack concrete, calcium decomposes to

amorphous hydrogel that can be washed out by the water enclosed in the basin, which is clearly evident in Fig. 29-right. The progression of this mechanism can lead to scaling of the section and mechanical stresses which eventually make the basin as structurally deficient.
