From Survey to Action: AI-Driven Severe Damage Mapping

Keywords: AI, Segmentation, Heritage in Risk, Survey, Post-disaster, Damage Assessment.

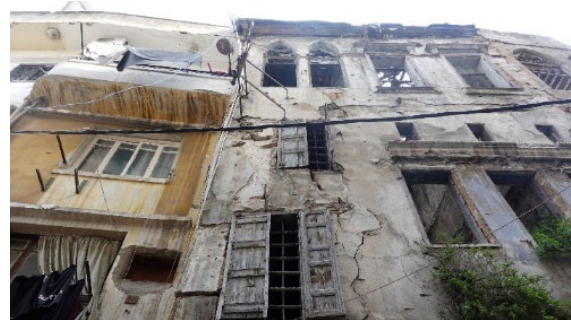
Figure 3. Image of the case study

First case study is a three-story traditional residential building constructed with masonry load-bearing walls and finished with lime-based plaster, Baghdadi timber ceilings, and a roof covered with red clay tiles. The building reflects construction techniques and material typologies characteristic of late Ottoman-period urban housing in Tripoli, both in its structural system and architectural expression, and represents a typical example of traditional residential architecture in the region (Figure 3).

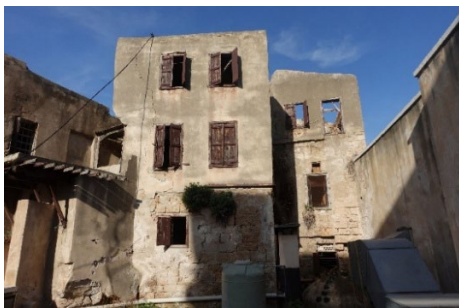
Figure 9. Image of the case study

The second case study is also a three-storey residential structure, situated within a highly compact urban fabric, where adjacent residential structures are directly connected or separated by minimal gaps (Figure 9). It was built primarily with masonry load-bearing walls, Baghdadi timber ceilings, and cement-based plaster finishes resulting from later interventions. While maintaining the traditional structural typology, the use of modern materials has introduced material incompatibilities that affect its structural behaviour and state of conservation.
