Structural characterization for the seismic protection of heritage churches

Maria Adelaide Parisi¹ and Claudio Chesi²

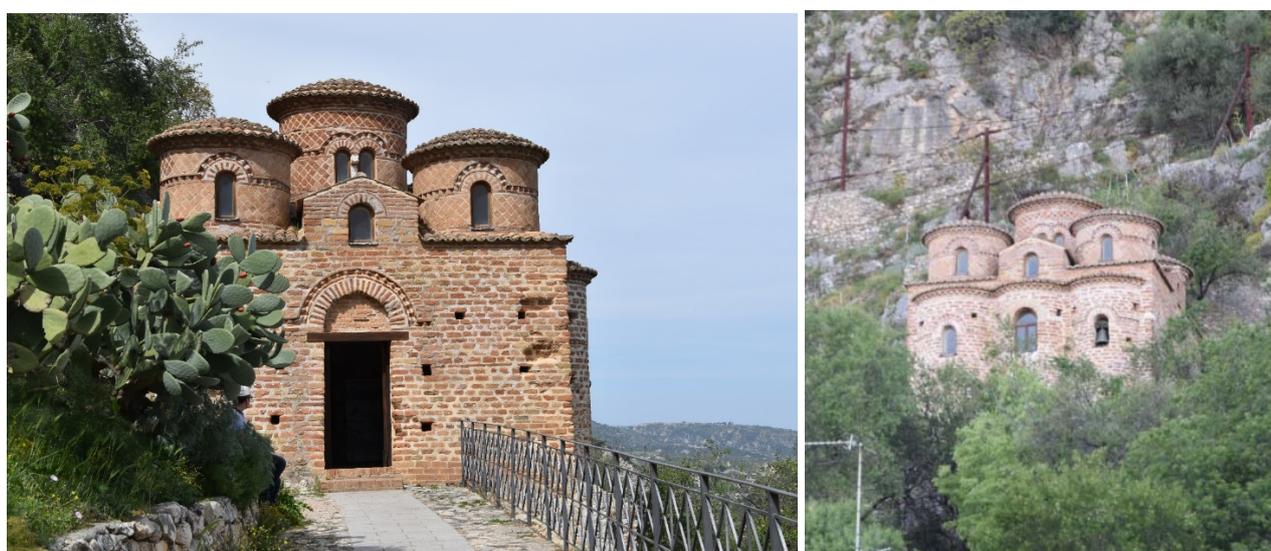
Figure 1. The “Cattolica” and its location on the mountain side

The church “Cattolica” of Stilo, Calabria, Southern Italy, is considered to date back to the 10th century and is one of the rare cases of byzantine churches in Italy. Located on a steep slope, fig. 1, it is partially supported by rock and partially by a landfill, but no sign of settlements are found, in spite of the long history of earthquakes in a highly seismic region. The dimensions are small, approximately 7.5 by 8 meters in plan. The four stone walls are covered by a system of 4 barrel vaults and 5 small cylindrical towers with semi-spherical vault (see fig. 2). The wall on the valley side includes three vaulted apses. In the interior, four stone columns support the vaults system. No substantial modifications of the structure appear to have occurred in its lifetime, beyond some remodeling of the entrance shape and similar interventions, until the beginning of the 20th century. At the time, the building was abandoned, having lost its original religious function, and had undergone decay. It

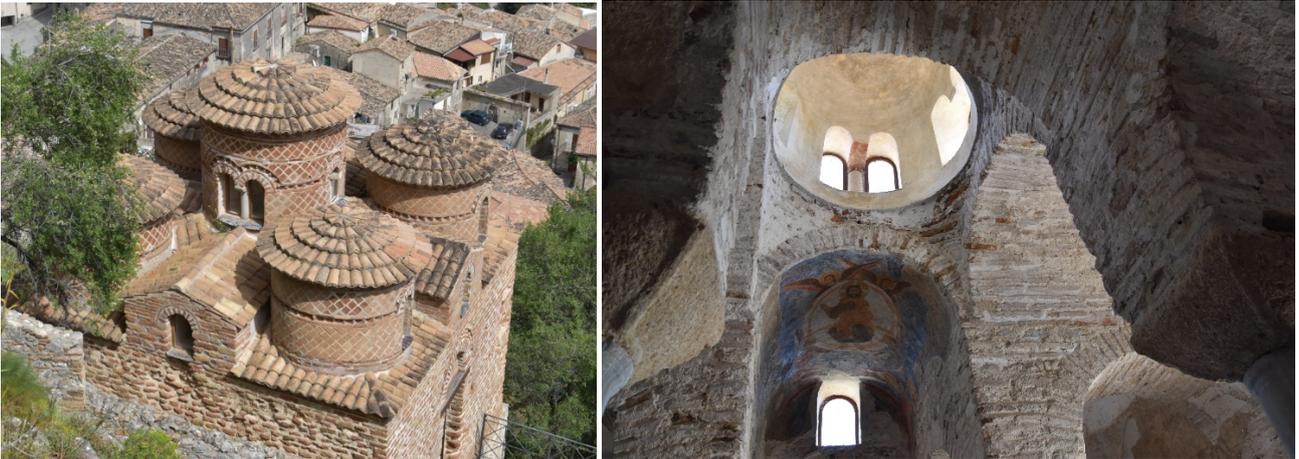
Figure 2. The system of towers and vaults

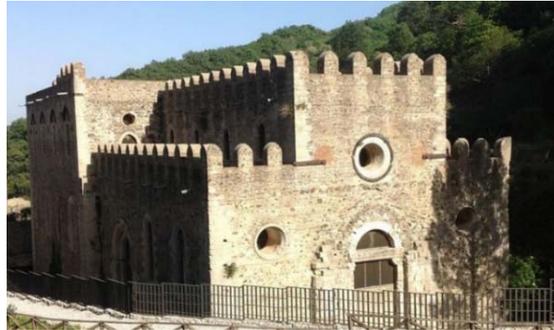
Figure 8. The Norman church

The church of S. Mary of the Valley in Messina, Sicily, in fig. 8, in spite of an apparent external simplicity, is a case of very complex geometry, partially due to layers of modifications and additions [9].

The church, already cited in a document of year 1168, is an example of Norman architecture. The area is characterized by high seismicity, although the very strong event of 1908 with epicenter only 17 km away did not produce but local damage to the church.

The history of this building, which had suffered periods of decay, has been restored, and is now closed to the public, may be reconstructed with fair precision in general and with very good detail for the last century. It comprises a series of interventions, for modification or reconstruction of parts, and most recently for strengthening of elements and foundations. The result is a situation where the original complex geometry has been further complicated by new or modified parts and by the presence of different materials. The walls alternate local stone with lines of bricks, columns and arches are in stone blocks, vaults in bricks.
