G. Janszen, G. Capezzer, A.M. Grande, L. Di Landro
Mitigation of Impact Damage with Self-Healing and Anti-Sloshing Materials in Aerospace Fuel Tanks
Aerospace, Vol. 6, N. 2, Article 14, 2019, p. 1-17
doi:10.3390/aerospace6020014

Article

Mitigation of Impact Damage with Self-Healing and Anti-Sloshing Materials in Aerospace Fuel Tanks

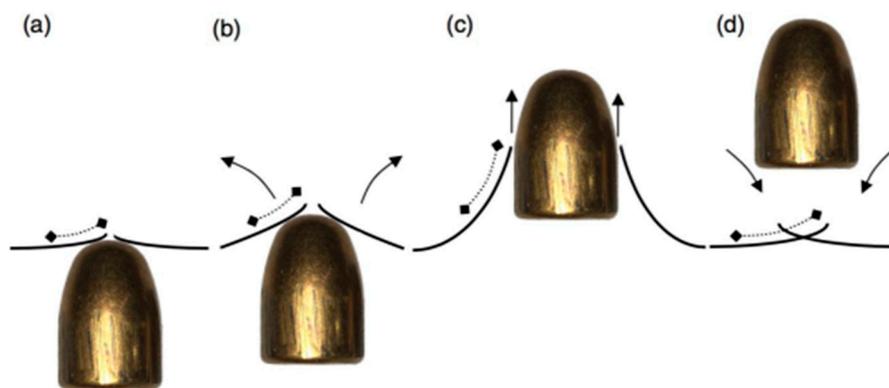
The material studied in this work is an ethylene-methylacrylate copolymer-based ionomer (Surlyn[®]8940 by Du Pont de Nemours), which has demonstrated its remarkable self-healing capabilities when punctured in firearms shootings; thanks to these capabilities, a number of prospected applications in safety and space components have been proposed [6–8]. This polymer is intrinsically self-healing, in that the autonomic repair is activated by the damage itself. The healing mechanism is based on the strain and friction energy dissipation, leading to rapid melting of the material during the

perforation phase, followed by the hole closure caused by the strain recovery and final material welding and solidification, which occur immediately after puncture, within a fraction of a second [1–3,9–12]. The perforation and healing process is visualized and summarized in Figure 1: A high-speed projectile hits the sample (a) that rapidly deforms (b). The very high deformation and strain rate accounts for a rapid and consistent increase of temperature in the punctured zone, so that the material melts and breaks (c). Since only a small zone melts, and thanks to the viscoelastic recovery, there is an important strain relief that closes the perforation immediately after the bullet passage, while the hole edges are still molten (d), bringing to the final welding. The ionomeric nature of the polymer possibly enhances the viscoelastic recovery and the retrieval of relevant mechanical performances. While the general mechanism is well recognized, a number of issues regarding the energy contributions involved in the heating and healing, in addition to the influence of the material conditions and bullet characteristics over the whole process remain to be fully interpreted.

Figure 1. Perforation and healing process.

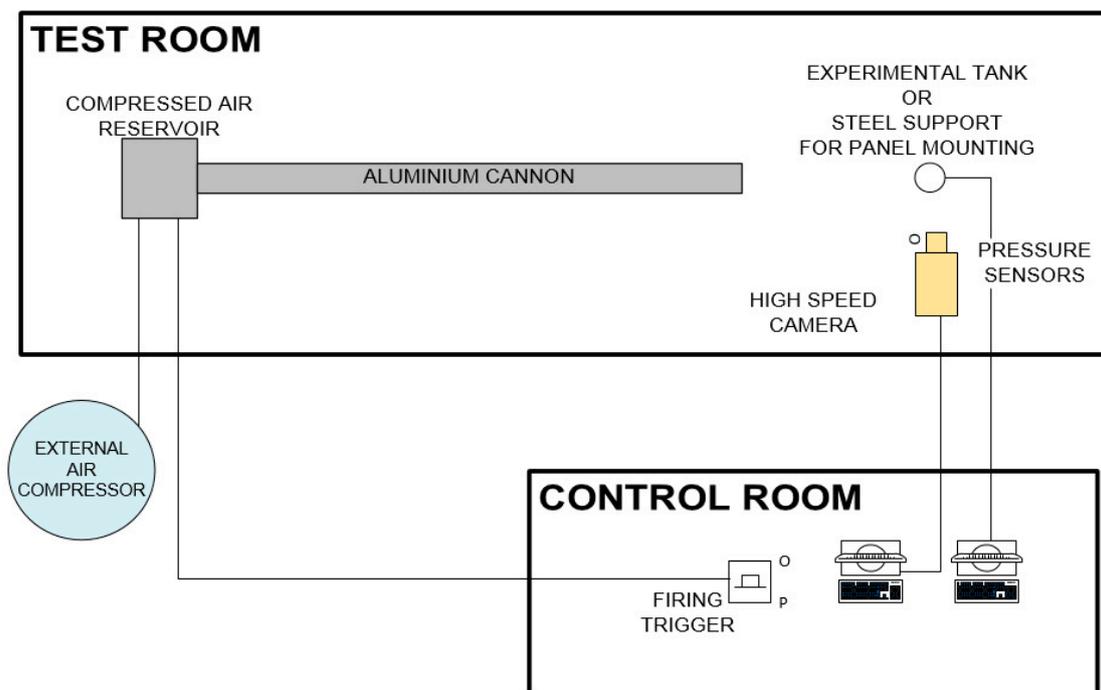
= 3.52 g). The speed was measured by means of a high-speed camera. The available shooting facility is composed of an air chamber pressurized at 6.5 bar by an external air compressor and separated from the outside ambient through a 0.075 mm thick metal foil. An electronic switch activates a solenoid which triggers a sharp point toward the metal foil. After the foil puncture, the differential pressure causes the sudden expansion and flow of the compressed air through a long aluminum tube (length 7 m, internal diameter 40 mm, external diameter 70 mm). The air flow launches a high-density polyethylene (HDPE) sabot, which carries the steel sphere inside the aluminum tube until it reaches the end of the barrel; a dissipative aluminum tube absorber and an aluminum stopper block the sabot at the end of the tube, while the steel sphere is projected against the target.

A high-speed Phantom v5.1 camera was employed to measure the projectile velocity prior to and after the impact by recording the time required to cover a short distance. Projectile speeds in the range 150 to 200 m/s are reached dependent on the air reservoir pressure [16]. In Figure 2, the schematic of the ballistic test set-up is shown.

Figure 2. Schematic of the ballistic test system.

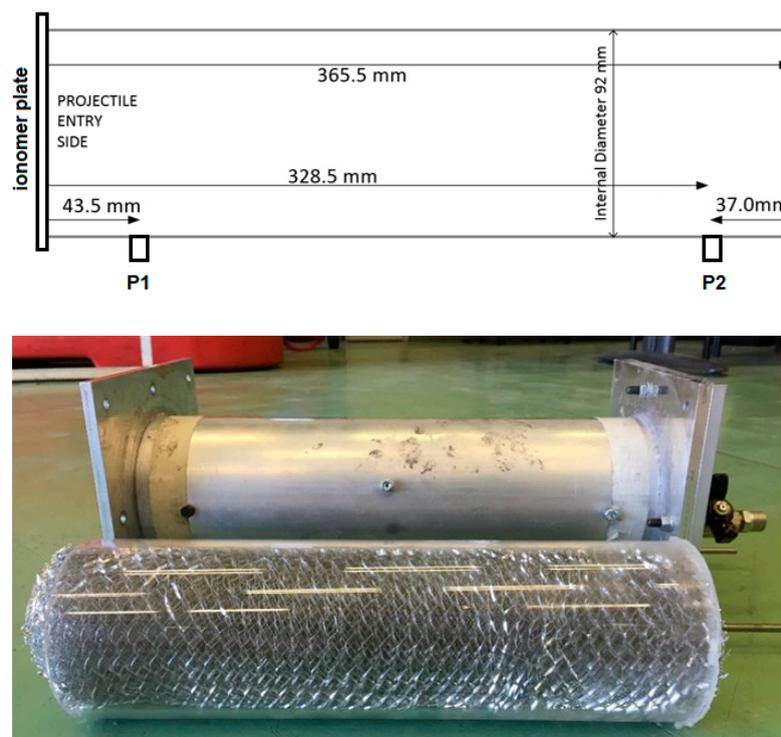
Ballistic tests of a simplified model tank were performed using steel balls as projectiles with sizes ranging between 2.35 mm and 16.6 mm (mass between 0.053 g and 18.74 g). Figure 3 shows the tank mock-up configurations employed.

Figure 3. Fuel tank sketch indicating the location of the pressure gauges (**top**) and an image of the aluminium and transparent tanks (with Explosafe[®] filler inside) (**below**).

Finally, ballistic tests on a mock-up of the new conceptual solution for fuel tanks were carried out. The tests were conducted using the same air gun as that used in the low-speed ballistic impacts on flat plates. The tank mock-up consisted of a 6064 T6 aluminum alloy tube (92 mm internal diameter, 366 mm length), with flanged ends to fit the ionomer Surlyn[®] 8940 plates. The tank could be pressurized with water inside and with the presence of the anti-sloshing filler. Pressure sensors were placed in different positions along the tube. A similar tank with a transparent PMMA tube was used for tests requiring internal observation; no pressure sensors and no pressurization option were adopted in this case.

Explosafe[®] was used as an anti-sloshing material in the tank; it is made of an aluminum sheet manufactured by slitting and expanding a foil to create hexagonal holes. The average density of Explosafe[®] is 30 kg/m³. It was used both as a single rolled block or as small cylindrical pellets fitting the tank space. Its presence in aircraft fuel tanks is expected to reduce liquid sloshing, to dampen pressure peaks in case of impacts and to slow down fuel spilling in case of perforation, thus providing explosion suppression effects [17–19].

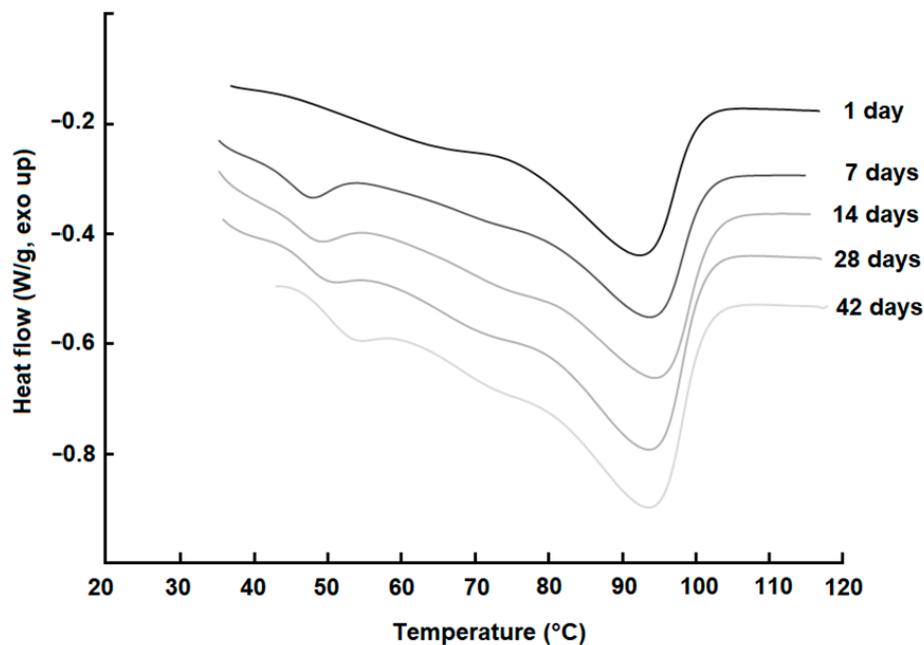
DSC tests show a clear change of the secondary transition temperature, T_i , between 40 °C and 60 °C and the corresponding heat transfer; the peak, which may be related to the ionic presence, becomes more defined and shifted to higher temperatures with the increasing aging time. According to the tests performed, the secondary transition cannot be detected for a sample aged 1 day which might be due to the low size of the ordered microstructure formations for this aging time, see Figure 4. The lower peak appears for samples aged for more than 1 day and gets bigger with the aging time, as reported in Table 1. These results show that aggregates grow so that molecular mobility and a re-organization of the polymer chains is possible during the aging of the material. At about 90 °C, full melting occurs as indicated by the large endothermic peaks; no relevant effect of aging is evidenced over the melting process.

Figure 4. DSC curves of the EMAA ionomer at different aging times (curves are vertically shifted for better readability).

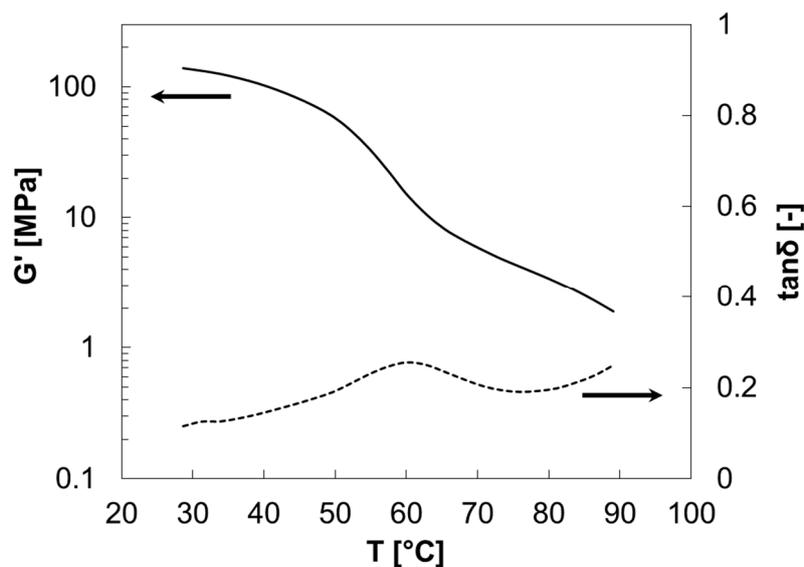
DMA tests confirm these results: A drop of storage modulus, due to the secondary transition, shows that some molecular motion is activated between 40 °C and 70 °C; in this case, evidence of a transition is also shown after the shortest aging time, see Figure 5.

Figure 5. Storage shear modulus, G' (–) and dissipation factor, $\tan\delta$ (–) measured by DMA after one day of aging.

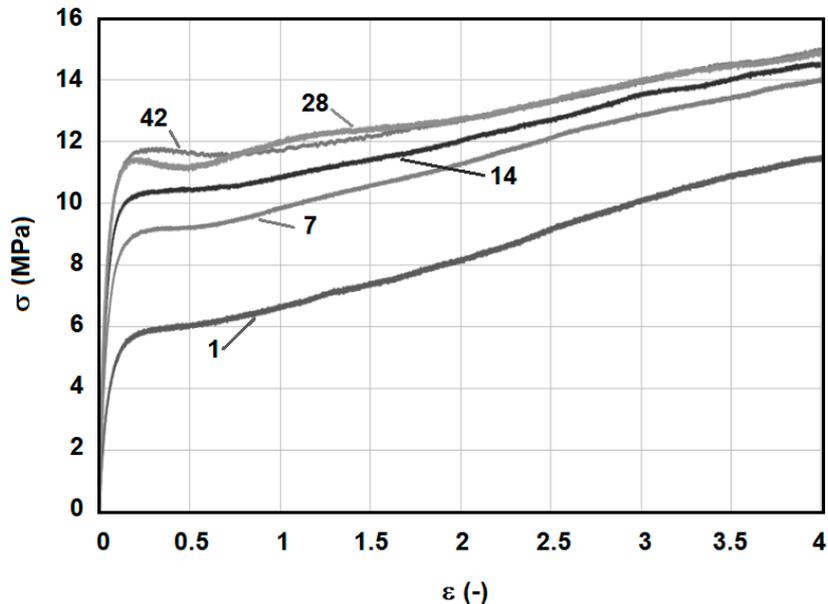
The main results of the tensile tests performed are shown in Figure 6. An increase of the stiffness and the yield stress with aging time can be noticed. Stabilization occurs after about 30 days. Failure of the specimens cannot be observed at the low strain rate applied due to the limited displacement capability of the testing system. At the crosshead speed of 5 mm/min, failure always occurs for strains exceeding 400%.

Figure 6. Stress–strain curves at different aging times (from 1 to 42 days).

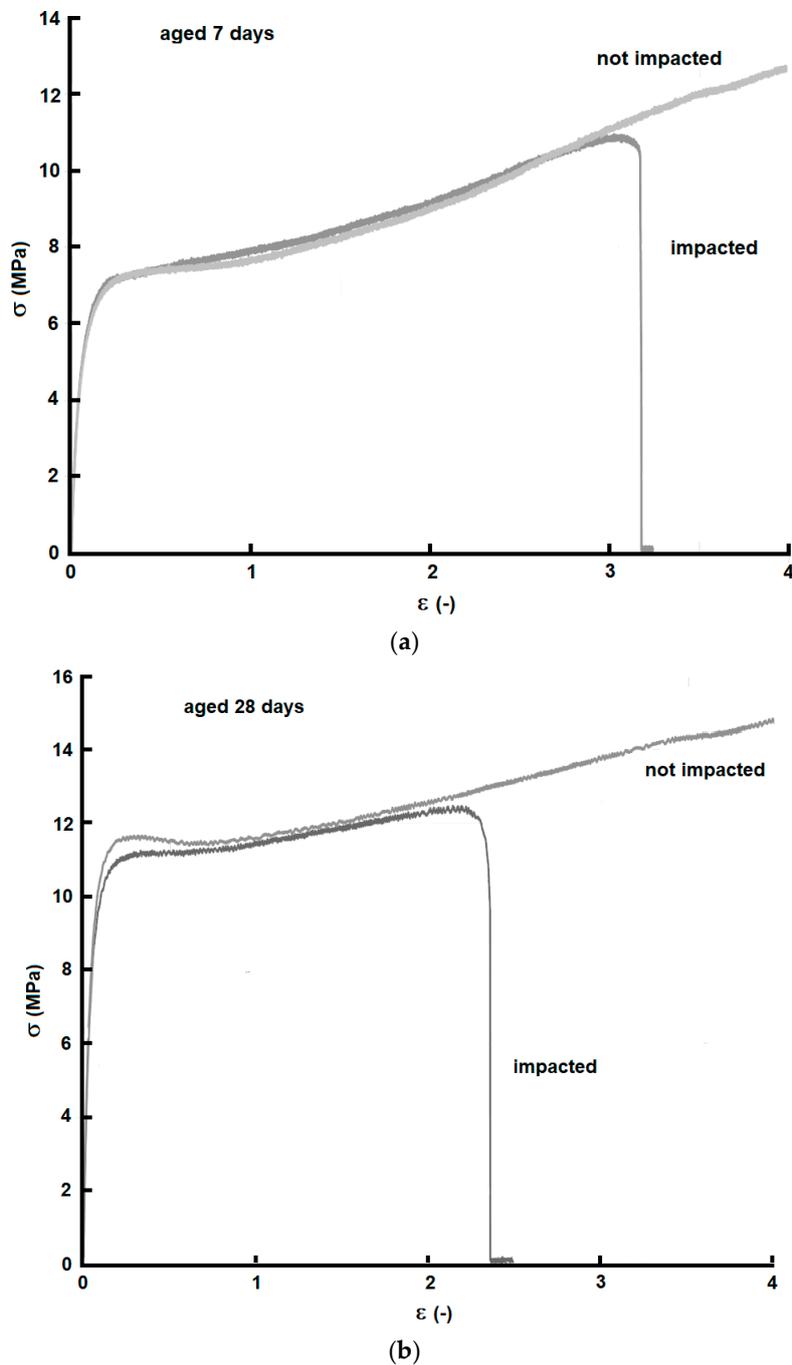
In order to understand how the healing process influences the mechanical behavior of the ionomer, completely healed impacted specimens were tensile tested after the same aging times as the not impacted specimens. It should be noted that the material volume interested by melting and re-welding is a small portion of the total volume of impacted specimens; most of the impacted region, although deformed during impact, is not subjected to an actual phase change. As a matter of fact, the results did indicate an appreciable variation in terms of the yield strength and stiffness. On the other hand, impacted and healed specimens showed a lower elongation and stress at break, which reduced with

increasing aging time, but remained quite large and always well above yield values. Figure 7 reports, as examples, the stress–strain curves recorded in impacted and not impacted specimens after 7 and 28 aging days.

Figure 7. Stress–strain curves collected from specimens aged 7 days (a) and 28 days (b) before the impact.

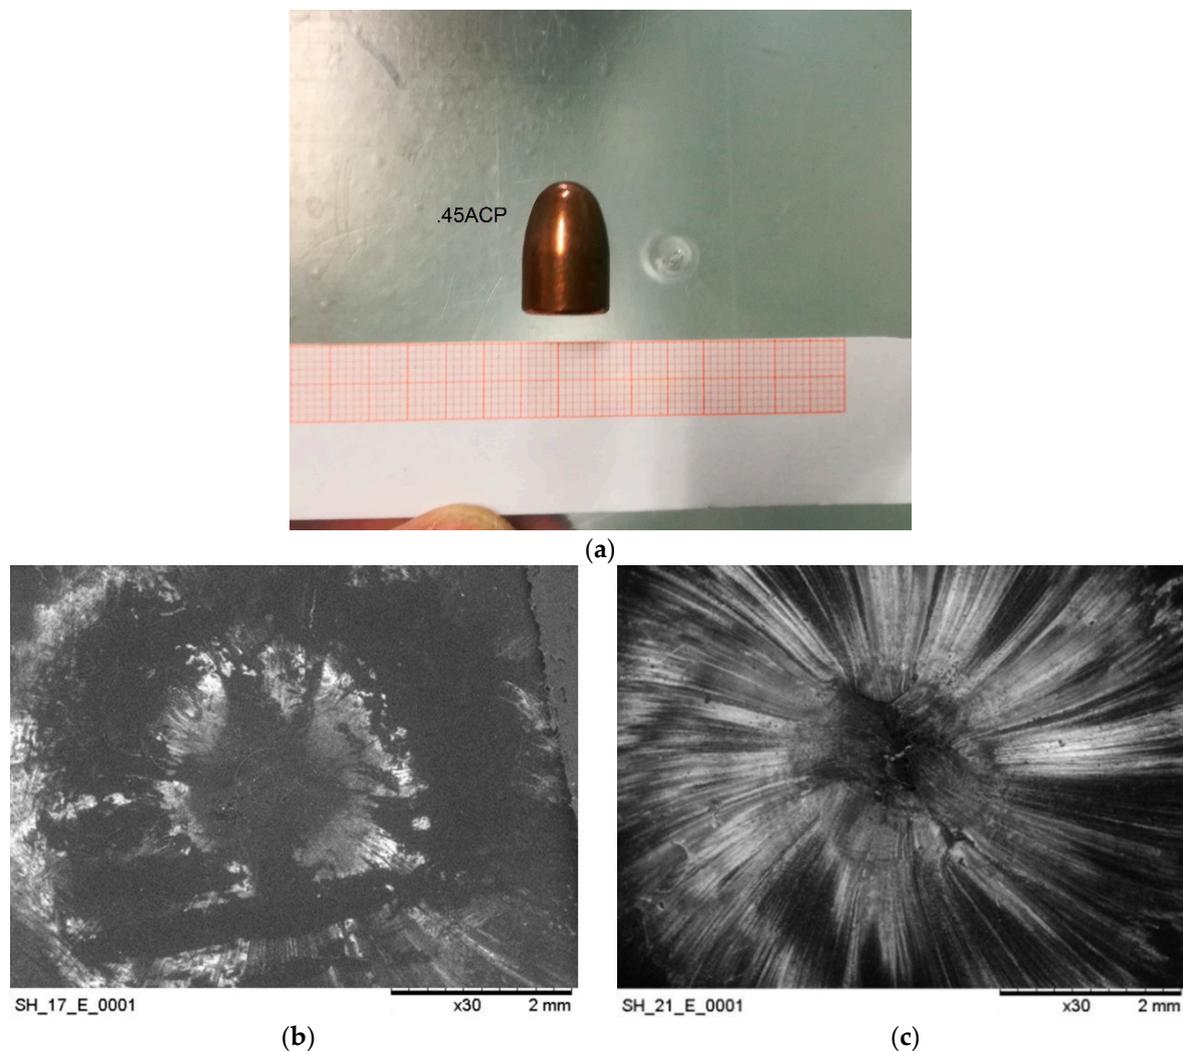
Ballistic tests were carried out using 9×21 bullets (diameter 9.03 mm) shot with the rifle. Full healing was obtained in all cases, as confirmed by leakage tests. In Figure 8a, an example of a healed panel after bullet puncture is shown; SEM images, see Figure 8b,c, show the difference of bullet passage through ionomer panels in the two situations, i.e., with and without lubricant. In both images, two different circular areas can be distinguished; an internal area, where the material melted, which is much smaller than the bullet diameter and an outer area where most of the viscoelastic deformation occurred with no phase change. It is in the outer area where the main differences can be noticed; the absence of the striations suggests that the lubricant, with its slippery effect, allows the bullet to pass through the ionomer with lower material stretching (low plastic deformation). This observation may be linked to a rapid viscoelastic return and a lower drop of the temperature in the melted area; the consequence of which seems to be improved healing. This was confirmed by the tensile tests carried out after the shot tests; the samples on which the lubricant was applied showed no failure in the perforated area, while in all the other cases the failure started from this area. On this basis, considering that melting occurs in any case, the friction energy seems to represent a significant but not critical contribution to the total melting energy, whose main origin is thus attributed to the strain energy.

Figure 8. Self-healed panel after bullet puncture (a). SEM images of punctured EMAA panels with (b) and without (c) the presence of lubricant.

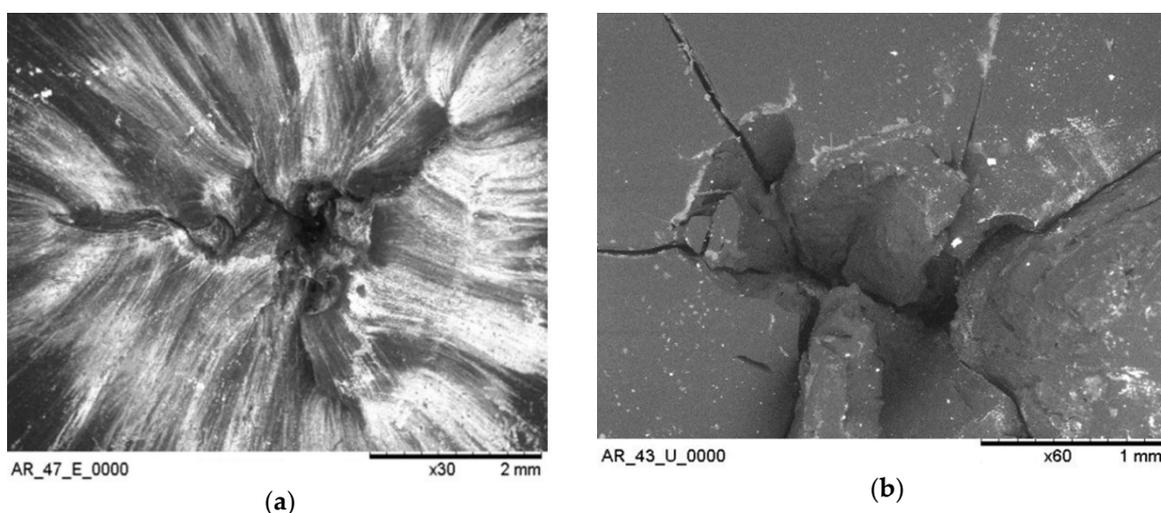
Ionomeric panels tested at different temperatures in the range $-40\text{ }^{\circ}\text{C}/70\text{ }^{\circ}\text{C}$ with firearm shots (.45ACP bullets) showed full healing after single impacts. Multiple-shot tests were carried out to investigate the ability to heal in the case of consecutive shots in the same location. The results obtained by these tests showed that at up to two perforations at the same point, leaving about 30 s between each other, the material healed properly. All the samples passed the leakage tests. On the other hand, SEM observations, see Figure 9, showed a somewhat worse re-welding with respect to a single healing.

Figure 9. SEM images projectile entrance side (a) exit side (b) after two shots in the same location.

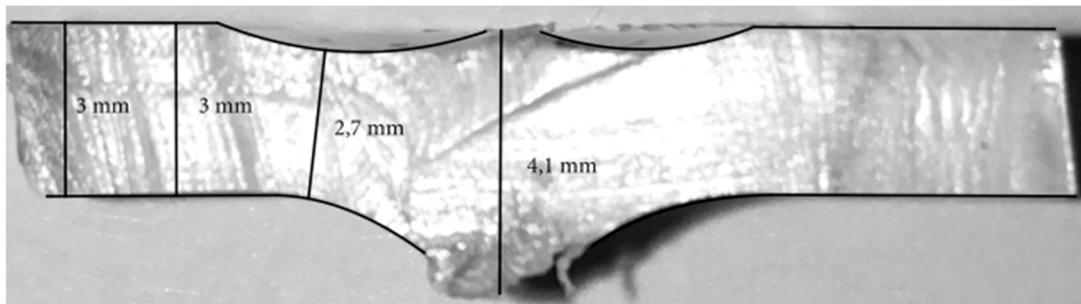
It was observed that, after the first shot, plastic deformation occurs that changes the thickness of the sample in the impacted area, as can be seen in Figure 10. In particular, material stretching in the outer part of impacted area leads to a somewhat reduction in the thickness.

Figure 10. Enlarged photograph of a specimen sectioned at the puncture location. Thickness profile after the first shot.

As long as the panel thickness/projectile diameter ratio is greater than the critical one ($(t/d)_{crit} \sim 0.2$ [20]) the healing still takes place, but the local mechanical characteristics are lowered by the phase changes and the permanent plastic deformation of the previous shot.

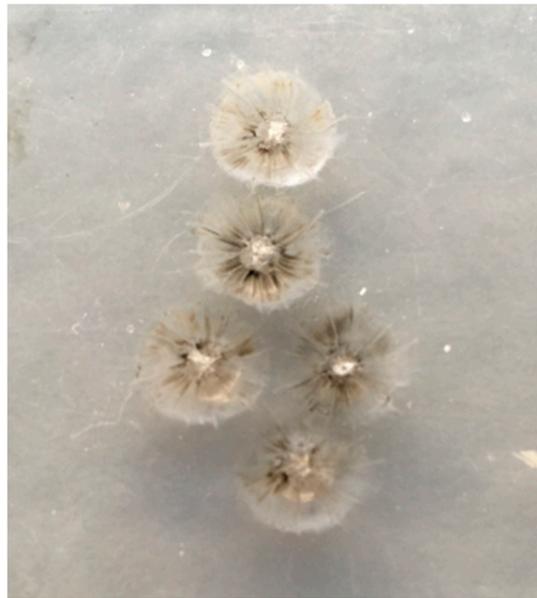
Additional multi-shot tests were conducted at different points within a range of 20 mm. Complete healing was observed in all tests, see Figure 11.

Figure 11. Multiple-shots at different locations.

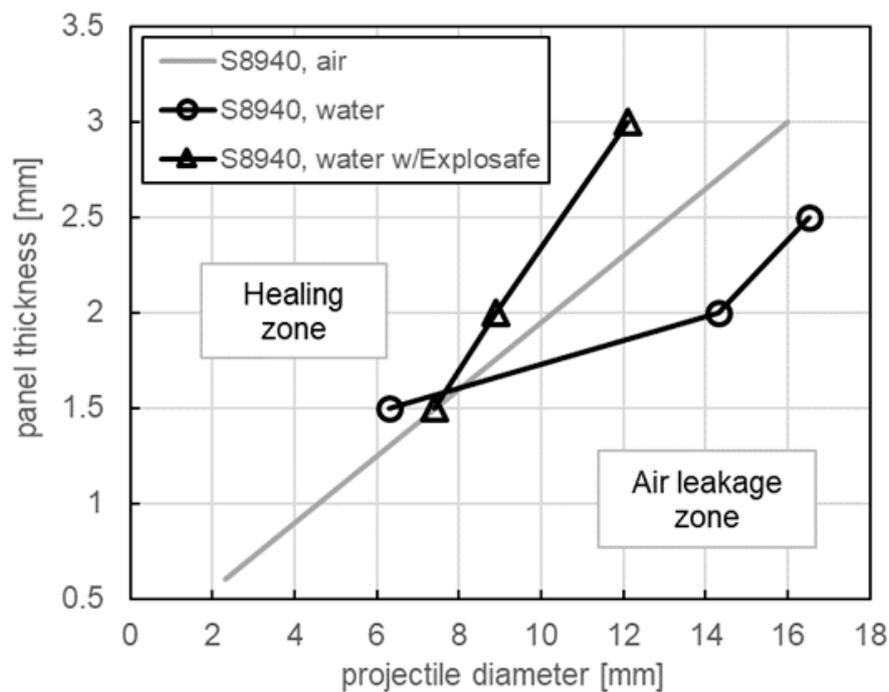
A somewhat lower healing efficiency was observed when both water and Explosafe® filler (single block or pellets) were inserted into the tank. Figure 12 compares the results of ballistic tests with and without water and Explosafe® in the tank; “air leakage” specifies conditions when only partial healing was indicated by leakage tests. A higher t/d threshold than in previous configurations was noted, indicating a lower healing efficiency. A possible explanation of this can be linked to a temporary pressure increase during impact due to a reflection wave, interfering with the healing process.

Figure 12. Comparison of self-healing results of ionomeric panels with and without water and Explosafe®.

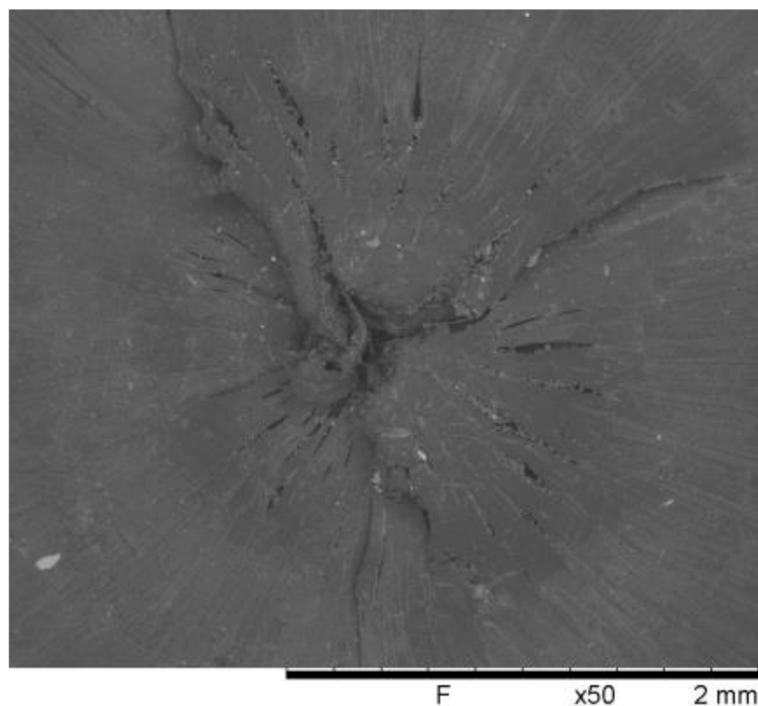
Leakage tests and SEM analysis gave additional information regarding the healing efficiency. Most of the tested panels did not show any evidence of water spilling after bullet perforation; however, air leakage tests resulted more critical and about half of the panels showed air passage. This confirms that self-mending is a general tendency in this material, although in some cases, it is not able to provide full hole sealing. A comparison of SEM images of the impact area observed after tests indicates that the presence of water leads to lower petalling, possible indication of minor local deformation in the hole area, compared to the configuration in air, see Figure 13.

Figure 13. SEM image of the projectile exit side of a healed ionomeric tank wall (water inside).

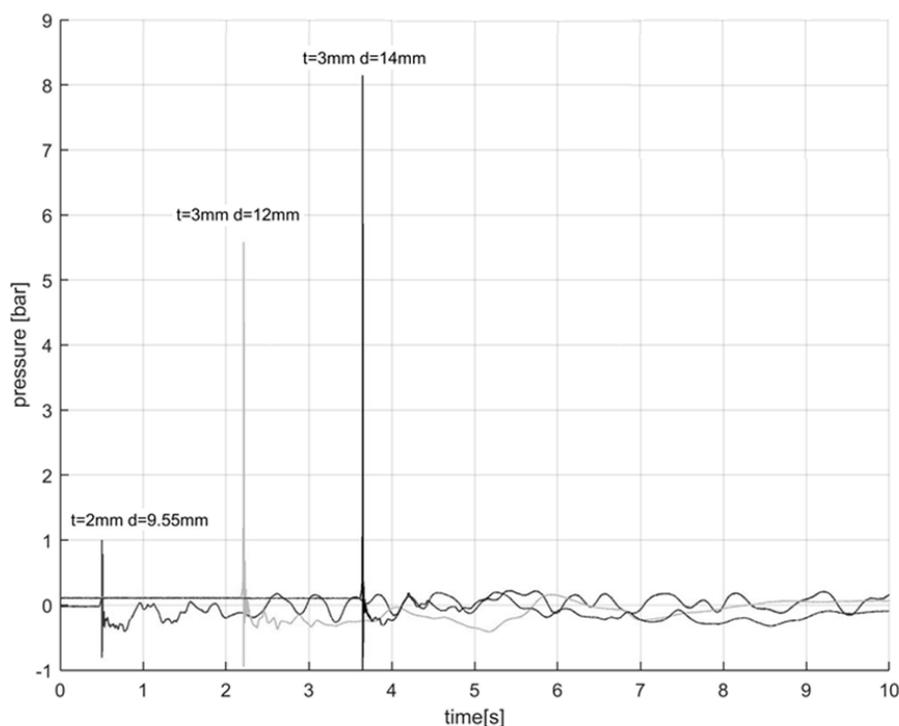
In all tests with a water-filled tank, pressure variations were recorded during the entire impact event by sensors placed near the impacted wall (P1) and near the opposite wall (P2); sensors placed in other locations did not provide clear results. As a general trend, it was observed that the bigger the impacting sphere, the higher the pressure peaks. This is expected both considering the larger volume of the projectile entering the tank and the higher deflection of the panel due to the impact energy. Figure 14 shows, for example, the pressure peaks recorded near the impacted wall of the non-pressurized tank in tests with spheres of different size. A comparison between different configurations shows that a remarkable reduction of pressure peaks is observed when Explosafe® anti-sloshing filler is present, see Figure 15, with pellets leading to a more efficient pressure peak reduction. In the case of a pressurized tank, a similar trend was observed, again with a more efficient peak reduction effect given by filler in pellets form. It was noticed that during impacts, the internal overpressure was maintained and, only when a small hole remained unsealed after impact, a slow reduction of pressure was recorded afterward.

Figure 14. Pressure peaks recorded next to the tank impacted wall (pressure sensor P1) during perforation with steel spheres of different size (between 9.55 and 14 mm diameter).

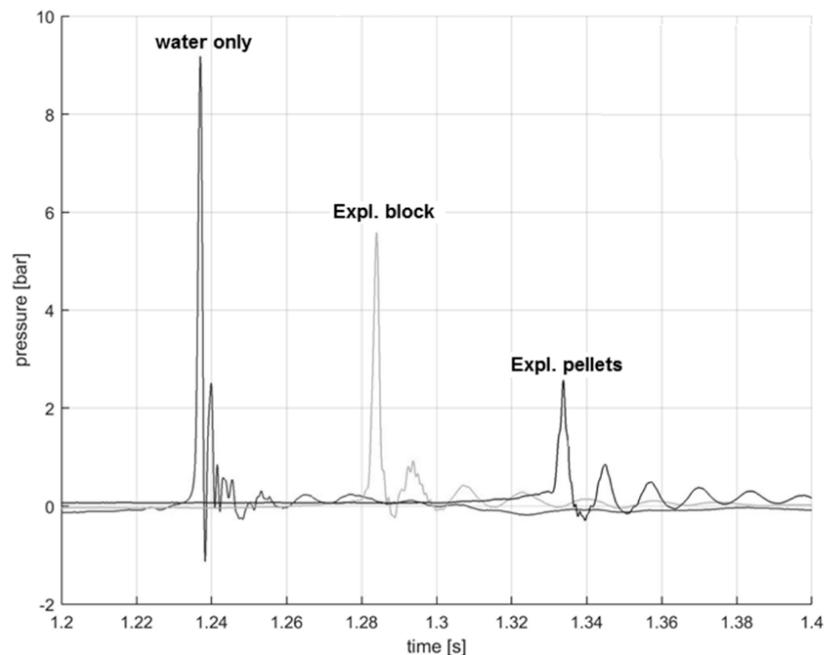
Figure 15. Pressure peaks recorded in the tank far from the impacted wall (pressure sensor P2) with different configurations ($t = 3$ mm, steel sphere 14 mm).
