ANALYSIS OF THE PERIODIC BREATHING OF A TRANSVERSE ANNULAR CRACK PROPAGATED IN A REAL ROTATING MACHINE

S. Chatterton, P. Pennacchi, A. Vania, P. Rubio*
Politecnico di Milano, Dept. of Mechanical Engineering
*Universidad Carlos III de Madrid

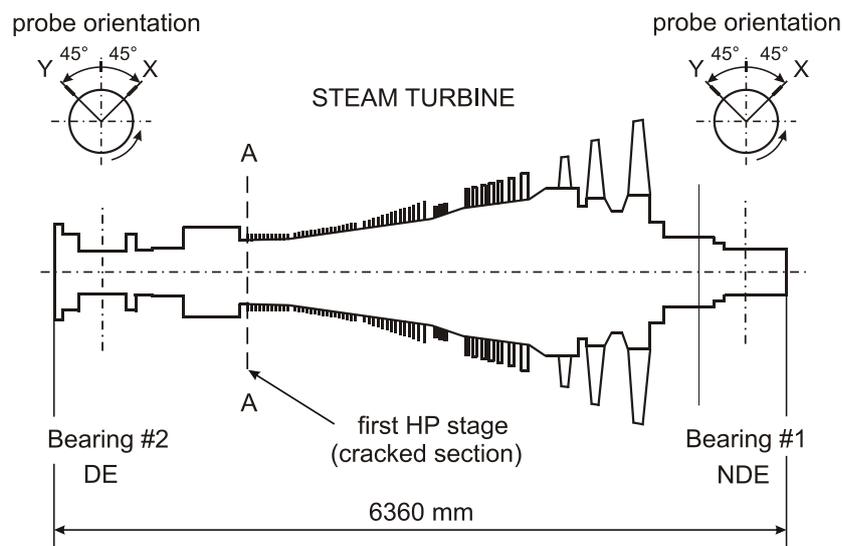
The rotor was supported by two five shoes tilting-pad journal bearings in load-on-pad configuration (LOP). The front-end pedestal of the HP casing contained the thrust bearing. Each journal bearing was equipped with a pair of XY proximity probes mounted 90 degrees apart. Figure 1 shows the steam turbine layout and the journal bearing numbering. Bearings #1 and #2 were located at the non-drive end (NDE) and at the drive end (DE), respectively.

Figure 1. Steam turbine configuration

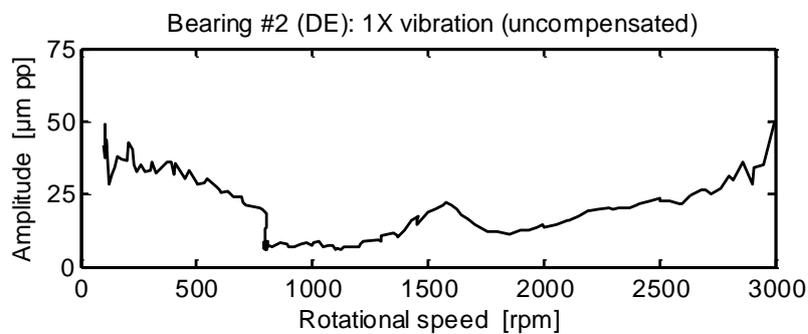
Figure 2 shows that during the remaining part of the runup the 1X vibration amplitude is rather low. Conversely, the amplitude of the 1X vibration measured at the inboard bearing #2 at the beginning of the speed ramp is not very low. This indicates that the turbine shaft, whose initial thermal state was cold, was affected by a not negligible eccentricity, although the machine had been operated in barring mode for many hours before the runup.

Figure 2. Amplitude of the 1X uncompensated vibration measured at the inboard bearing #2 during a cold runup

In the long-time period during which the rotational speed was kept constant the weak but hot steam flow caused a continuous heating of the turbine shaft. This gave rise to an important thermal gradient both in radial and axial direction. As a result, the shaft crack, which had not been detected yet, was affected by a partial closure that caused a decrease of the 1X vibration amplitude. This is the reason for the drop down of the vibration level shown in Figure 2, in the speed range close to 800 rpm.

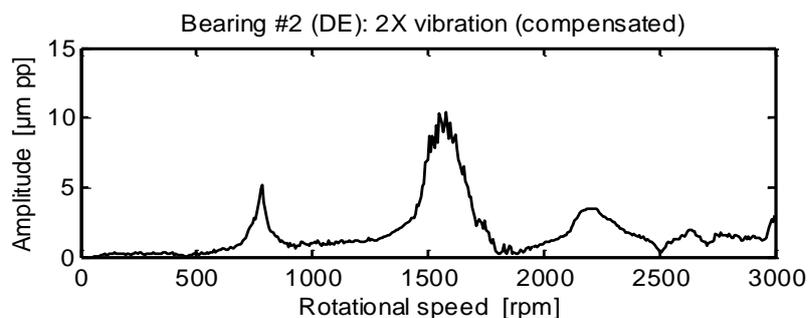
Figure 3. Amplitude of the 2X compensated vibration measured at the inboard bearing #2 during a cold runup

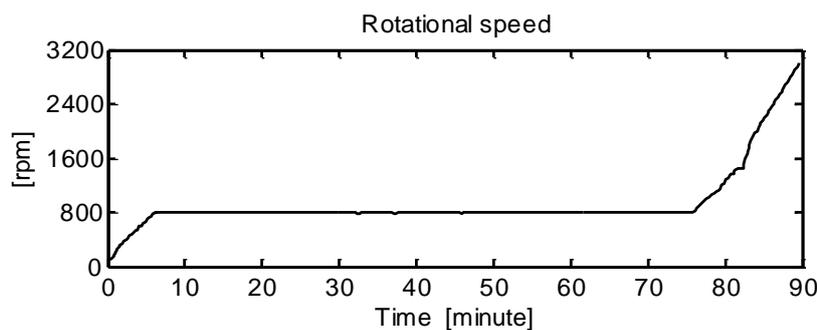
Figure 4. Trend of the turbine rotational speed measured during a cold runup

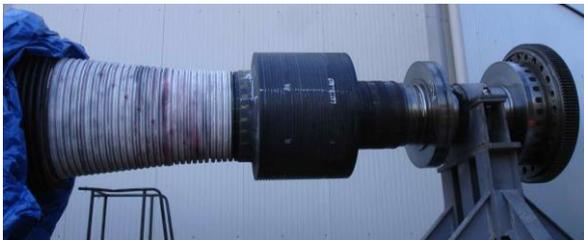
Figure 5 shows the turbine shaft after having removed the blades of these stages. An evident crack was found at the bottom of the slot of the first HP stage where the blade roots were mounted. The thickness of the crack was so large that a simple visual inspection was sufficient to detect it. Besides, the crack was extended all over the circumferential surface of the shaft, at the bottom of the slot. Figure 6 shows an enlargement of the circumferential view of the crack.

Figure 5. Turbine shaft after having removed the blades of the first 27 HP stages

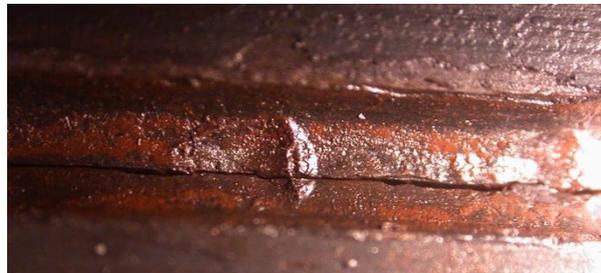
Figure 6. Enlargement of the circumferential view of the crack

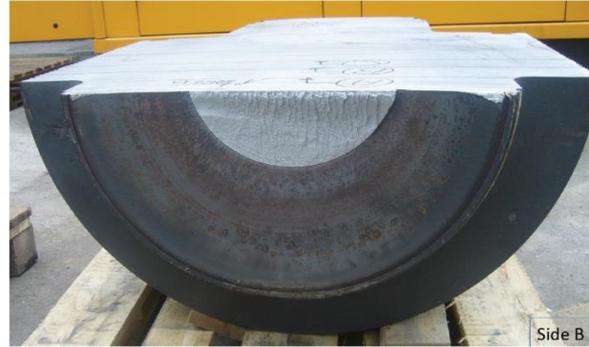
Figure 8. Front view of one of two halves of the cracked shaft

Figure 8 shows a front view of one of these parts of the shaft that contains the crack surface. The large depth of the crack is really evident. In the end, a thin slice of the shaft was cut from the two specimens, on the same side of the crack. Figure 9 shows a complete front view of the cracked section of the shaft. The specimens mentioned above were used to perform fractographic and metallographic investigations whose results are summarised in [2].

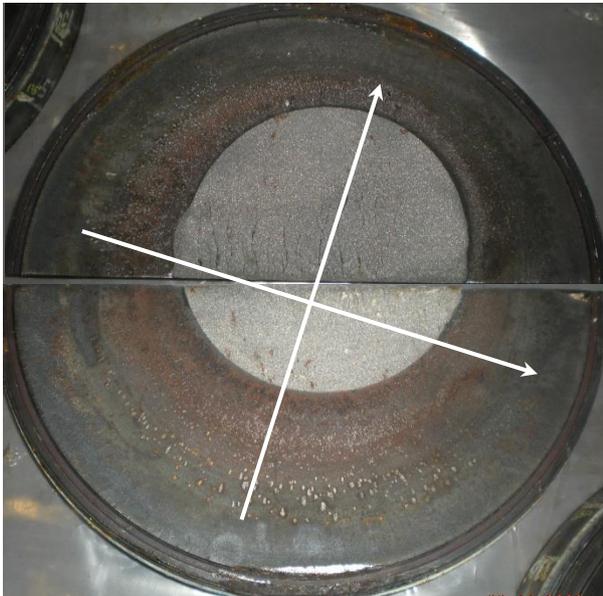
Figure 9. Front view of the complete cracked section of the shaft

Some authors call this kind of shaft cracks “circumferential cracks”, however most shaft transverse cracks are extended over a partial arc of the external surface. Conversely, the crack shown in Figure 9 is extended over the complete circumferential surface. Therefore, in order to avoid any misunderstanding, the authors of the present paper prefer to call it as “annular crack” (or “full circumferential crack”).

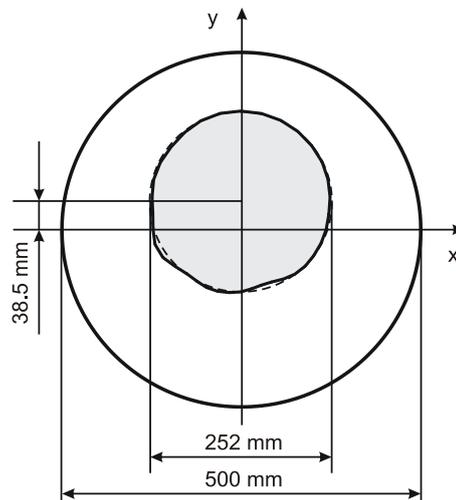
Figure 10. Geometrical parameters of the cracked section

The residual resistant section of the shaft is very small and nearly circular shaped. Besides, it is eccentric with respect to the centre of the original section of the shaft, whose diameter, measured at the bottom of the dovetail slots, is 500 mm. The radius of the circle that fits the crack front is 126 mm, while the eccentricity of the residual section of the rotor is about 38 mm (Figure 10). Therefore, the area of the residual section is about a quarter of the original section of the shaft.

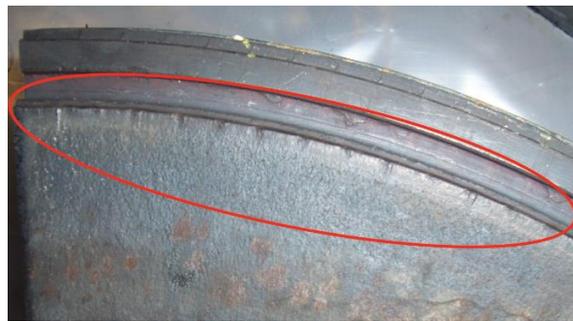
Figure 11 shows an enlarged view of the cracked section in the proximity of the external surface of the shaft. It is possible to note the presence of multiple initiation points of the crack. This confirmed the suspect that excessive mechanical stresses, likely generated by the recurrent thermal transients suffered by the steam turbine, caused the propagation of the crack, in the radial direction, starting from the root of most of the

Figure 11. Multiple initiation points of the crack

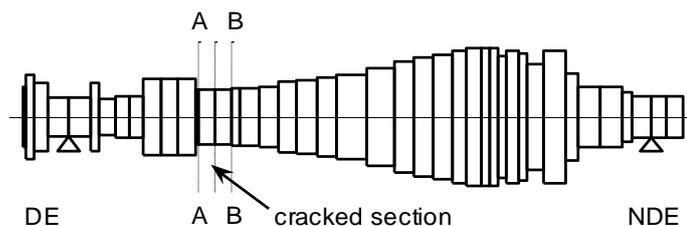
A preliminary finite element model (FE) of the turbine shaft has been generated (Figure 12). In accordance with common methods used to investigate the dynamic behaviour of rotating machines, this model is only composed of *beam* finite elements whose geometrical and mechanical characteristics allow the flexural and torsional stiffness of the shaft as well as its inertia properties to be simulated [19],[20]. Rigid journal bearings and pedestals have been included in the model.

Figure 12. Simplified finite element model of the turbine shaft

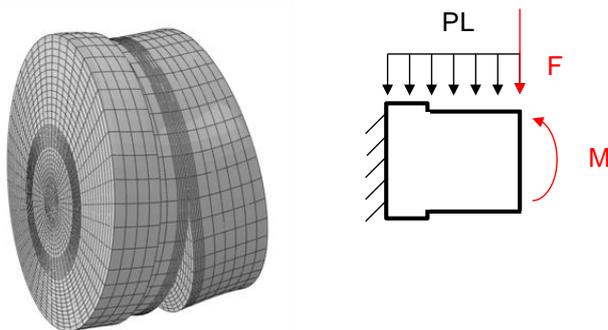
delimited by the cross-sections A and B has been generated using the commercial code ABAQUS (Figure 13 (a)). The length of this part of the rotor is $L = 282$ mm, whereas the diameter at the cracked section is $D = 520$ mm. This diameter is only a little larger than that evaluated at the bottom of the dovetail slot of the first HP stage.

The 3D finite element model is composed of a type of elements called C3D20, in accordance with the ABAQUS/Standard nomenclature (20 node quadratic brick). The final number of elements is 41664. The mesh density of this model has been considerably increased in the area close to the cracked section of the shaft (Figure 14) in order to obtain more accurate estimates of stresses and strains caused by the external loads that have been applied to the model. In order to simulate the effect of the weight, a vertical load, F , and a bending moment, M , have been located at the end of the shaft, and a distributed load, PL , has been applied across the length as can be seen in Figure 13 (b).

Figure 13. a) Detail of the 3D finite element model of a short part of the shaft that contains the cracked section (angular position 180°) b) Loads locations

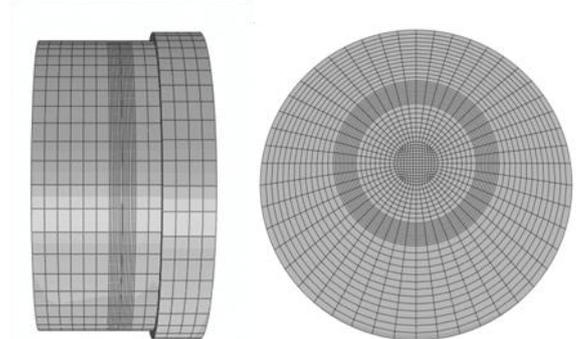
Figure 14. Lateral and front views of the model of the cracked section (reference angular position, 0°)

In the model configuration illustrated in Figure 14, the angular position of the shaft is such that the vertical axis is a symmetry axis of the crack, while the maximum depth of the annular crack is located in the bottom area of the cross-section. This angular position of both shaft and crack has been assumed as reference configuration (*rotation*) of the system.

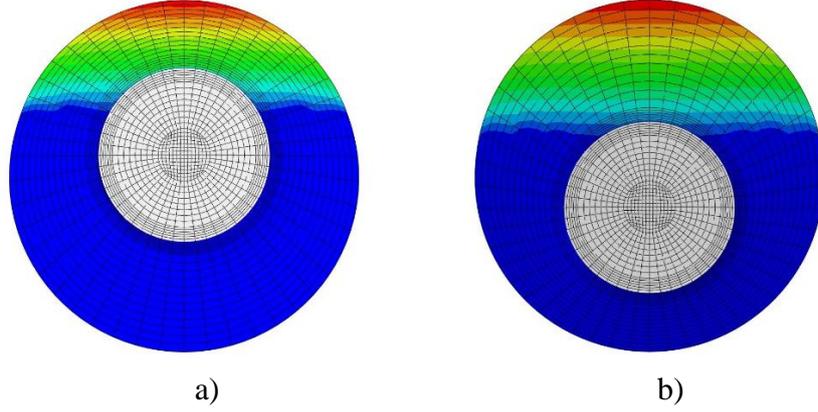
Figure 15. Crack closure evaluated for the angular position of 0° degree, a) and 180° degree, b)

Based on these results it is possible to evaluate the area and centroid of the actual resistant section, A_r , that is the part of the cracked section composed of both the residual resistant section and the part of the crack surface subjected to compressive stresses. Besides, it is possible to evaluate the angular position of the principal axes, x' and y' , of the actual resistant section, with respect to the horizontal reference axis, x , and the corresponding second moments of area. In the end, the inclination angle between the neutral axis and the horizontal reference axis can be obtained. Figure 15b shows the crack closure evaluated by rotating the shaft 180° degrees.

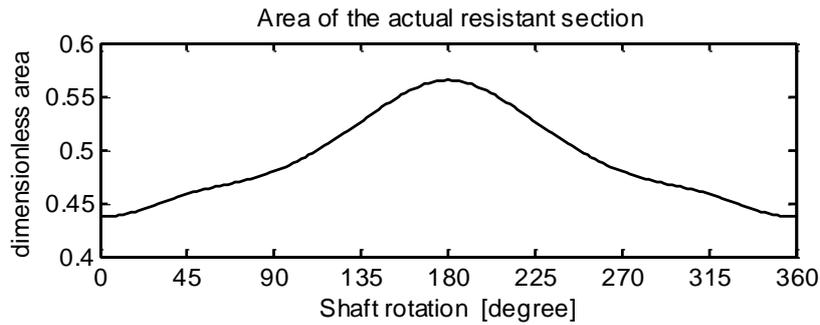
Figure 16 shows the parameter Λ as a function of the shaft rotation. The order analysis of the function $\Lambda(\theta)$ has been carried out. Table shows the mean value and the amplitude of the first five harmonic orders of the parameter Λ . The dimensionless area of the circular residual resistant section is 0.2349. Therefore, the closed part of the cracked section can give an average contribution to the area of the actual resistant section that is nearly the same of that of residual resistant section. Moreover, the amplitude of the first harmonic order of the parameter Λ gives the most important contribution to the changes in the area of the actual resistant section.

Figure 16. Effects of the shaft rotation on the area of the actual resistant section

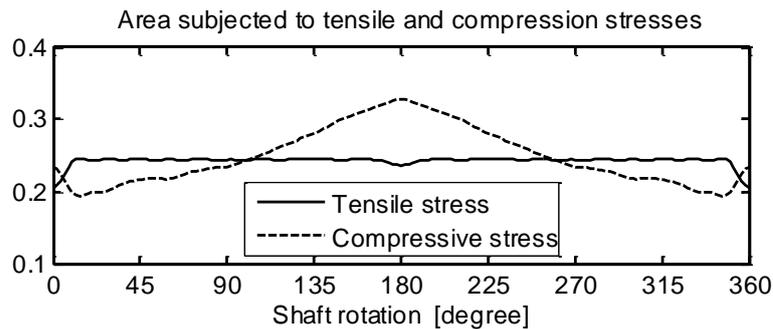
For a given rotation of the shaft, the dimensionless area of the actual resistant section can be subdivided into the area Λ_c , subjected to compressive stresses, and the area Λ_t , subjected to tensile stresses. Figure 17 shows the dimensionless parameters Λ_c and Λ_t as a function of the shaft rotation. Figure 16 and Figure 17 show that, as a result of the annular shape of the crack, the damaged cross-section of the rotor is able to transmit compressive stresses mainly through the closed part of the crack surface whose extension is affected by the breathing mechanism. Therefore, for any angular position of the shaft, the tensile axial stresses are mainly transmitted only by the residual resistant section of the cracked section. This breathing mechanism is quite different from that of common shaft transverse cracks having an elliptical front [1],[10],[11].

Figure 17. Effects of the shaft rotation on the area of the two parts of the actual resistant section subjected to tensile stresses and compressive stresses

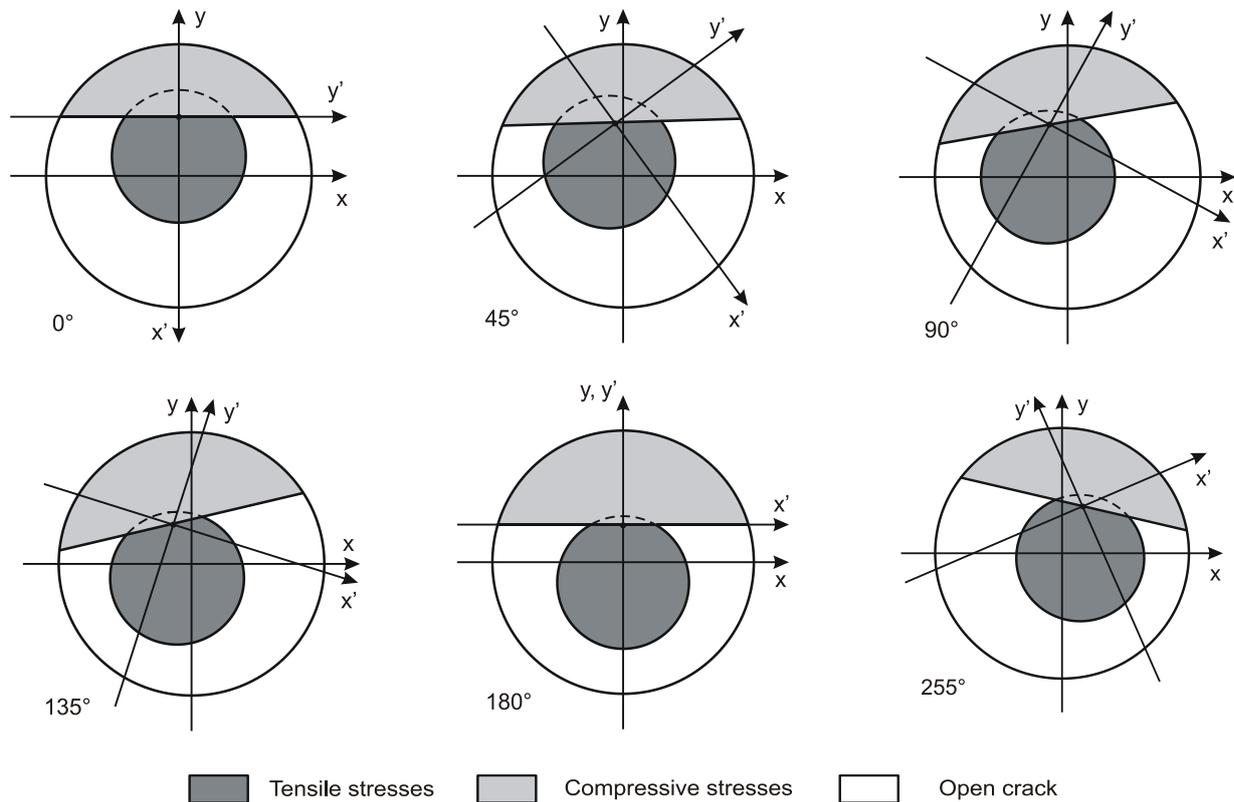
Figure 18 shows the parts of the cracked section that can transmit tensile and compressive axial stresses, as well as the open crack, evaluated for six different rotations of the shaft. In Figure 18 the open part of the crack is plotted with a white background while the parts of the cracked section that can transmit compressive and tensile axial stresses are plotted with different shades of grey. The principal axes, x' and y' , of the actual resistant section obtained for each angular position of the shaft are also shown.

Figure 18. Crack breathing evaluated for six angular positions of the shaft

Contrary to the crack breathing phenomenon that affects common shaft transverse cracks having an elliptical front, in the present case study the crack never closes completely over an entire revolution of the shaft. Conversely, because of the annular shape of the crack, the area of the crack surfaces that is subjected to compressive stresses is lightly influenced by the shaft rotation.

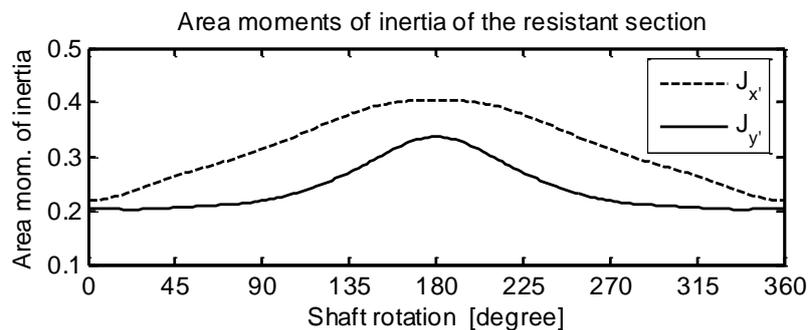
In order to obtain dimensionless parameters, the second moments of area of the actual resistant section, evaluated with respect to the corresponding principal axes, have been divided by the second moment of area of the original unbroken section of the shaft. These dimensionless second moments of area have been denoted $J_{x'}$ and $J_{y'}$. Figure 19 shows the periodic changes in the normalized second moments of area $J_{x'}$ and $J_{y'}$ evaluated over a full revolution of the shaft.

Figure 19. Effect of the shaft rotation on the second moments of area of the actual resistant section evaluated with respect to the principal axes (x' , y')

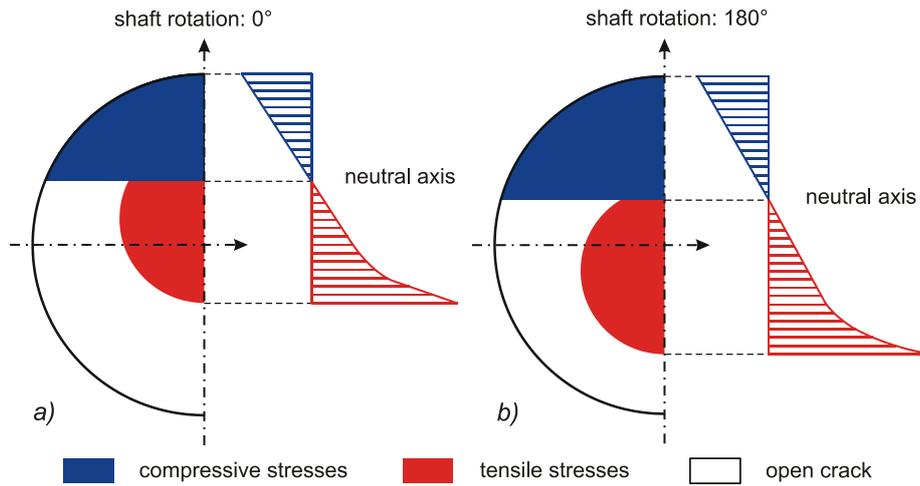
Figure 20 shows the distribution of the axial stresses evaluated along the diametrical vertical axis, at the cracked section, for the two angular positions of the shaft of 0° degrees and 180° degrees, respectively. The nonlinear effects mainly affect the tensile stresses evaluated in the lower part of the circular residual resistant section.

Figure 20. Distribution of the axial stresses evaluated along the diametrical vertical axis, at the cracked section, for the angular positions of the shaft of 0° degrees, a), and 180° degrees, b)

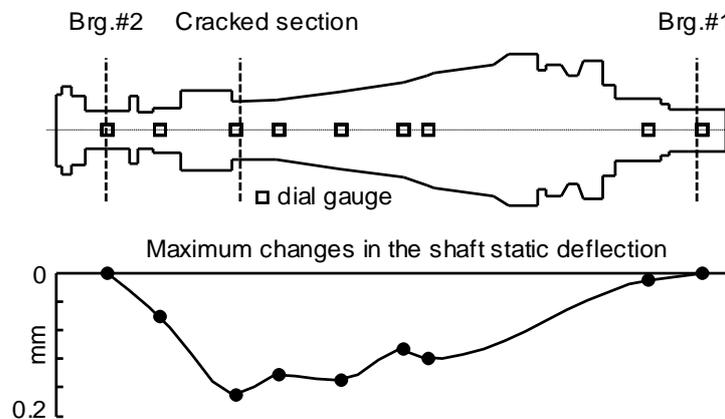
The results of this test, obtained for a given cross-section, have provided an estimate of the changes in the shaft static deflection caused by the crack breathing phenomenon that occurs over a full revolution of the rotor.

Figure 21. Maximum changes in the static deflection of the shaft, caused by the crack breathing, experienced over a full revolution of the turbine rotor

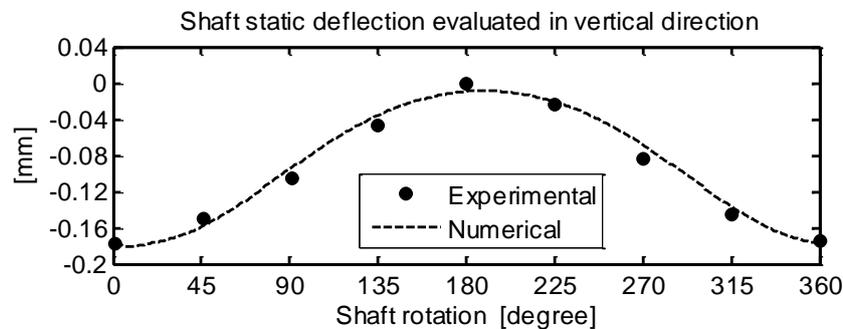
Then, the static deflection of the rotor has been evaluated for different angular positions, over a full revolution, with an angular step of 15° degrees. The shaft deflection evaluated in the cross-section A-A (Figure 12), which is very close to the axial position of the crack, has been considered for a comparison between experimental data and numerical results (Figure 22). The dots in Figure 22 represent the experimental readings (every 45° degrees) provided by dial gauges. The good accordance between experimental and numerical results, illustrated in Figure 22, confirms that the investigation method described in this paper for the study of the breathing mechanism of a shaft transverse annular crack can provide accurate results.

Figure 22. Effects of the shaft rotation on the turbine static deflection evaluated near the cracked section: comparison between experimental data and numerical results

Multiple readings of the dial gauges were collected changing the angular position of the shaft, with an angular step of 45° degrees, over a complete turbine revolution. In case of uncracked rotors and an ideal null geometrical runout, the dial gauges should give constant readings. Conversely, in the present case, the measures provided by the dial gauges depended on the shaft angular position. The maximum variation in the readings carried out at a given axial position is an estimate of the change in the local static deflection of the shaft caused by the crack breathing induced by the rotor weight. The maximum variations in the shaft deflection measured along the turbine are shown in Figure 21. The magnitude of these changes depends considerably on the axial position of the measurement point. The maximum change in the shaft static deflection has been detected in an area very close to the cracked section. The experimental readings collected for the cracked section, over a complete revolution of the shaft (every 45° degrees), are shown later on (Figure 22)
