MAXIMIZING THE VALUE OF PHOTOGRAMMETRIC SURVEYS IN THE CONSERVATION OF WALL PAINTINGS

L. Wong^{1*}, W. Rose², A. Dhanda³, A. Flavin¹, L. Barazzetti⁴, C. Ouimet³, M. Santana Quintero³

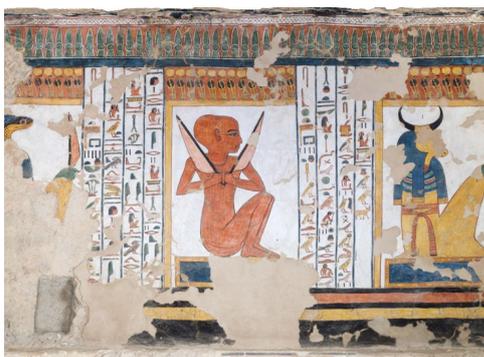
Figure 1. A detail of an orthophoto from the 2017 survey of the wall paintings in Chamber K of the Tomb of Nefertari (Credit: Carleton Immersive Media Studio; Carleton University. © J. Paul Getty Trust).

With 520 square meters of painting and a complex condition history (namely due to salts), the tomb presented a challenge in predetermining the desired level of detail in the images, and therefore in selecting an ideal spatial resolution for future monitoring. Based on the size of the tomb, the amount of painting, and constraints (narrow spaces, limited time on-site, and available equipment), the tomb was captured with an average spatial resolution of 0.35mm/pixel with a Nikon D800 (Figure 1).

A condition assessment of the wall paintings undertaken in 2020 found that the resolution of the captured images and orthophotos was not high enough to clearly distinguish small losses and cracks. This prompted a deeper exploration of the relationship between the spatial resolution of capture and the level of visible detail in the captured and processed images.

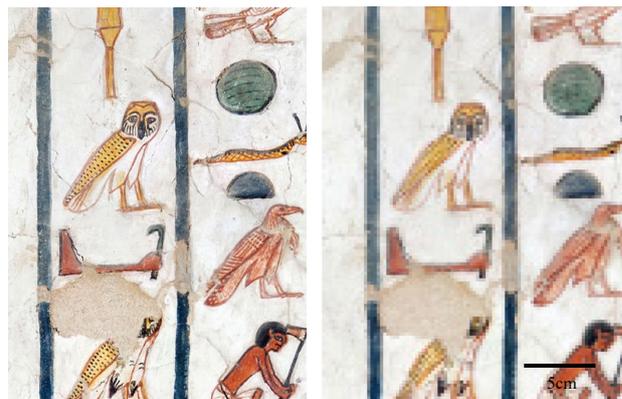
Figure 2. A detail of the orthophoto in Figure 1 captured with 0.35mm/pixel GSD (left) and the same image at 5.0mm/pixel GSD (right), demonstrating the effect of GSD on the level of visible detail (Credit: Carleton Immersive Media Studio; Carleton University. © J. Paul Getty Trust).

Spatial resolution for photogrammetry can be defined as the Ground Sample Distance (GSD), given as a real-world measurement of the distance between two pixel centers in an image, which is determined by a combination of the sensor size, pixel size, focal length, and the distance of the camera from the surface (Figure 2) (Stylianidis et al., 2016).

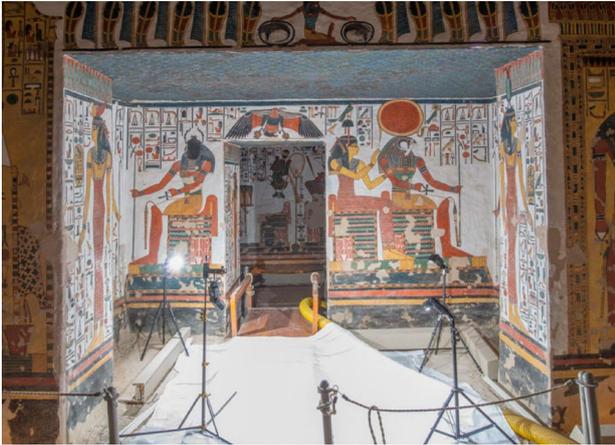
Figure 3. Speedlights and a white sheet were used to reflect light onto the paintings for even lighting during the 2017 survey of the Tomb of Nefertari (Credit: Carleton Immersive Media Studio; Carleton University. © J. Paul Getty Trust).

In the Tomb of Nefertari, speedlights were the best lighting option due to the limited space. The speedlights were set-up to limit repositioning during capture and their light was diffused with reflective sheets (Figure 3). However, areas of uneven lighting were present in some of the orthophotos (Figure 4). This was due to on-site obstacles: railings close to the paintings cast shadows, localized areas of painting were glossy and reflective, and fragile architectural features limited access to large areas of painting.

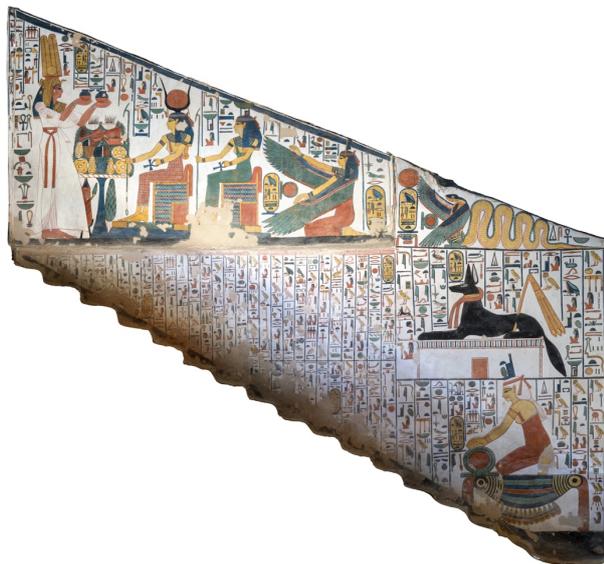
Figure 4. The lower half of the stairway wall paintings in this orthophoto are in shadow due to the position of a handrail in the Tomb of Nefertari (Credit: Carleton Immersive Media Studio; Carleton University. © J. Paul Getty Trust).

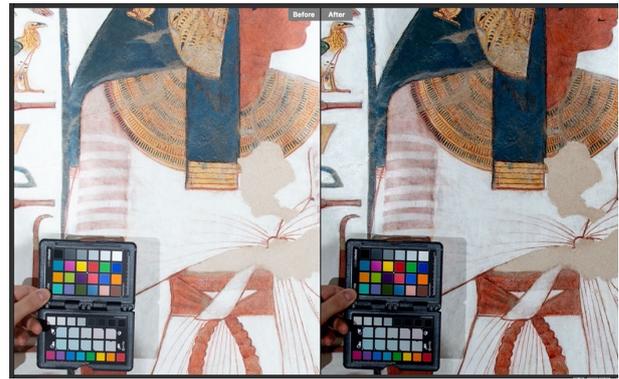
Figure 5. An example of post-processing white balance and exposure correction using an X-Rite ColorChecker® Passport in the Tomb of Nefertari survey before (left) and after (right) (Credit: Carleton Immersive Media Studio; Carleton University. © J. Paul Getty Trust).

Color is an important attribute of a wall painting and images need to be color corrected to serve as a useful record for future condition monitoring. Due to a wall painting's large scale, lighting conditions can change during the survey and color charts and gray cards designed for conservation imaging should be regularly included in the capture. In the Tomb of Nefertari, color charts and gray cards were used successfully to color correct the images (Figure 5).

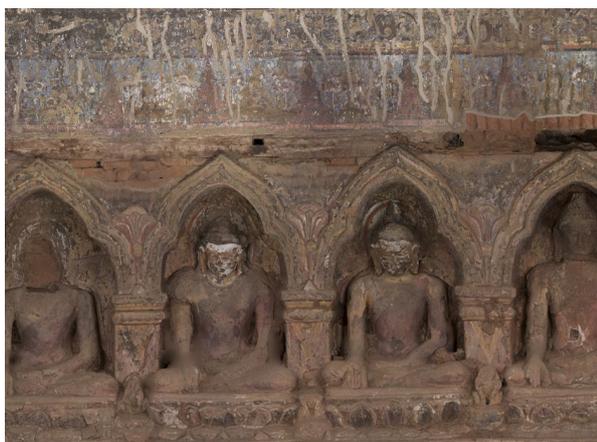
Figure 5. The 2018 orthophoto of the East inner wall in Myin-pya-gu. Areas of the image are out of focus and unevenly lit with shadows in the Buddha niches (Credit: © Carleton Immersive Media Studio; Carleton University).

Myin-pya-gu in Bagan, Myanmar is an 11th century Buddhist temple with a square circumambulatory corridor. Wall paintings and painted niches containing Buddha statues decorate the interior of the temple. Multiple photogrammetric surveys have been undertaken in Myin-pya-gu for different purposes and they demonstrate how variations in capture approach affect the visual fidelity achieved. In 2018, as part of professional training to the Department of Archaeology and National Museum of Myanmar, orthophotos were generated of the interior walls of the corridor using a Nikon D750 at a spatial resolution of 0.5mm/pixel and speedlights with diffusion directed towards the subject (Figure 5) (Reina Ortiz et al., 2019).

Another survey is required to record the decorated elements in Myin-pya-gu with higher visual fidelity. To plan the documentation strategy, the two previous sets of photogrammetric data were analyzed. The resolution of the 2018 orthophotos was not high enough to discern areas of conservation interest including cracks and details on the painting. The images were not completely in focus and intermittent bright and dark spots from speedlights without enough diffusion made legibility of the paintings difficult. The 2020 survey images had a high enough resolution to discern areas of interest, and the evenness of lighting was improved. However, in both sets of orthophotos, the niches and Buddha statues cast shadows onto the painted surfaces behind them, resulting in a loss of information in those areas.

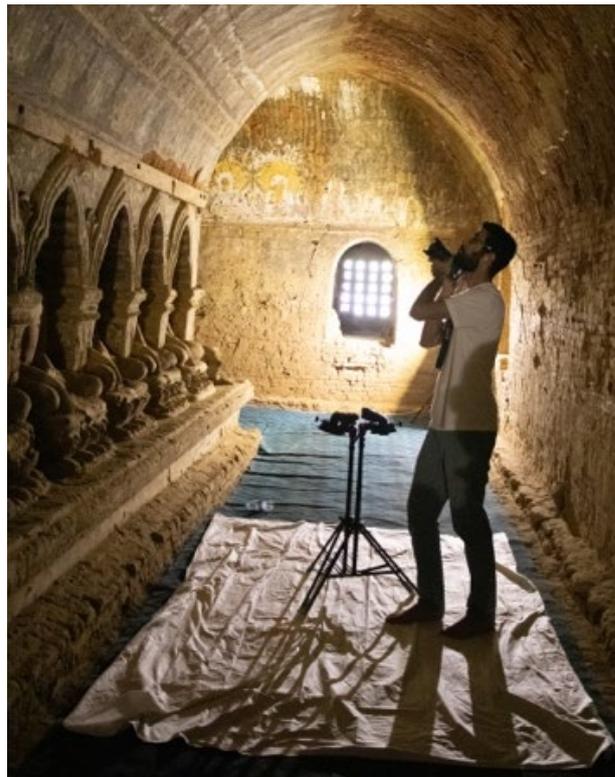
Figure 6. The 2020 capture of the interior of Myin-pya-gu by CIMS using speedlights reflected off a white sheet for even lighting in the orthophotos (Credit: Carleton Immersive Media Studio; Carleton University. © J. Paul Getty Trust).

In 2020, the temple was surveyed again using laser scanning and photogrammetry to create floor plans and elevations as part of the Getty Conservation Institute and Department of Archaeology and National Museum's Bagan Conservation Project. The entire circumambulatory corridor was documented at 0.2mm/pixel spatial resolution using a Sony a7R IV, capturing 6700 images with speedlights reflected off a white sheet (Figure 6, Figure 7).

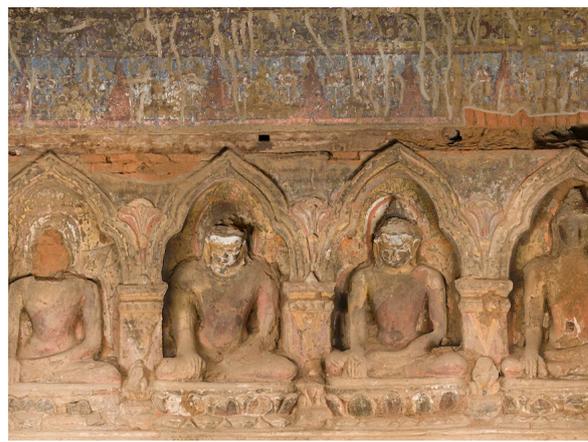
Figure 7. The 2020 orthophoto of the East inner wall in Myin-pya-gu, showing the same section as Figure 5. The image is mostly in focus and evenly lit but still has shadows cast in the niches (Credit: Carleton Immersive Media Studio; Carleton University. © J. Paul Getty Trust).
