Damage survey, simplified assessment and advanced seismic analyses of two masonry churches after the 2012 Emilia earthquake

by
Marco VALENTE⁽¹⁾, Gabriele MILANI^{*(1)}

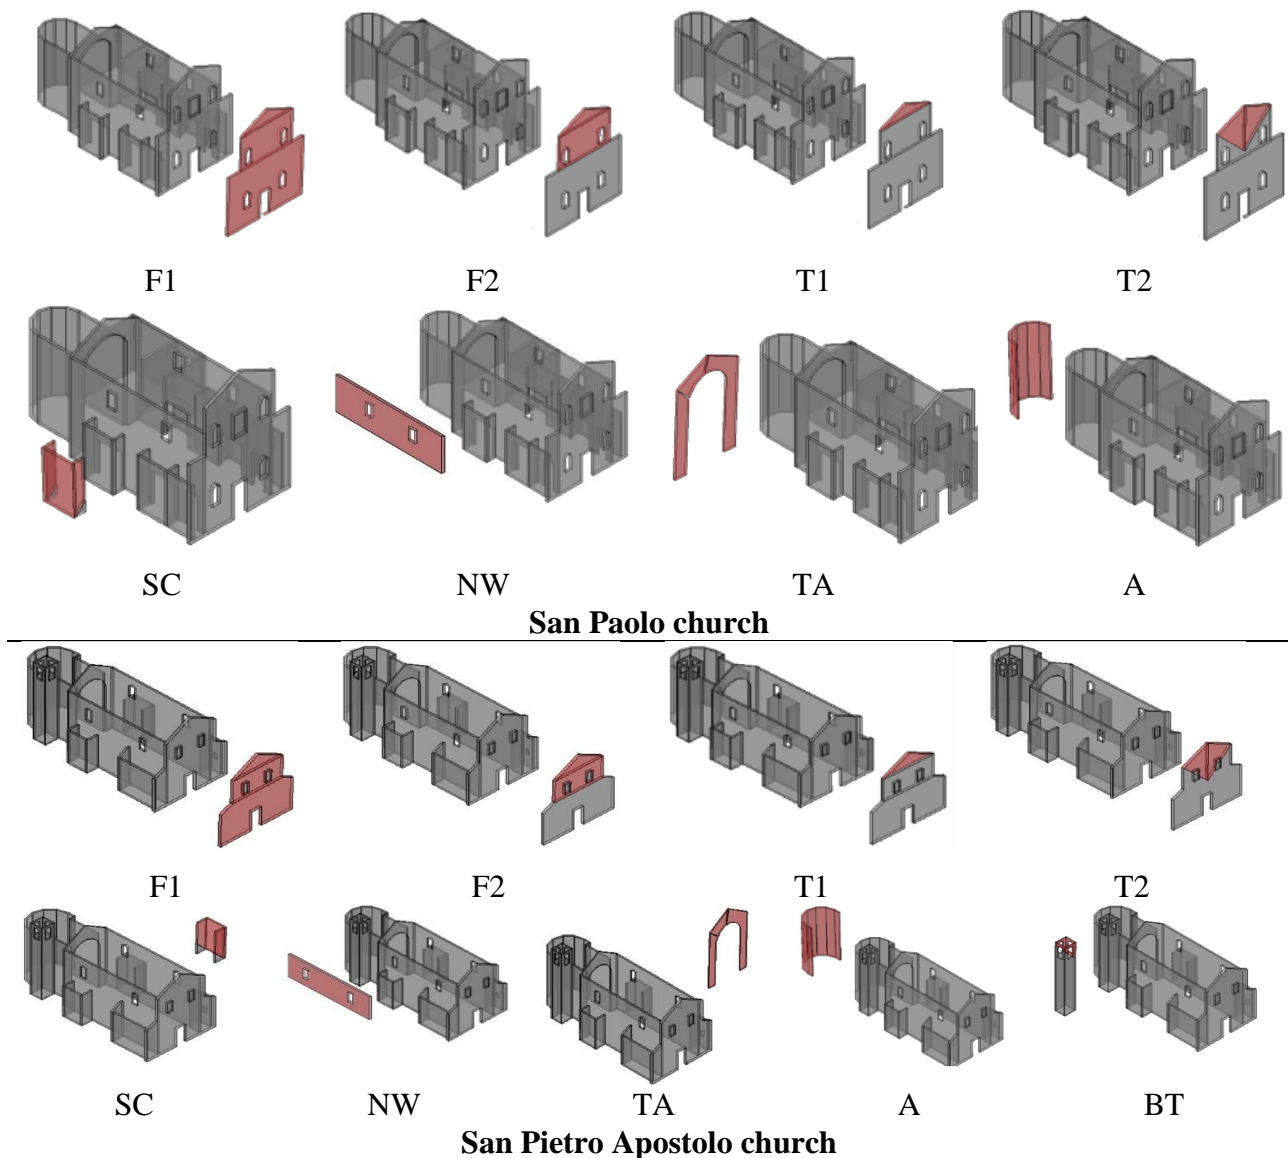
A preliminary assessment based on limit analysis with pre-assigned failure mechanisms is conducted on the two churches according to Italian Guidelines on the Built Heritage (DPCM 2011). The partial failure mechanisms of the two churches are evaluated by means of a manual approach assisted with a common 3D CAD software. Such a simplified approach is based on the following assumptions: (1) rigid bodies forming a failure mechanism; (2) masonry unable to withstand tensile stresses; (3) the application of the classic upper bound theorem of limit analysis. It is worth mentioning that some failure mechanisms taken into account by the code are not considered in this study due to the simplicity of the church under consideration and the absence of several architectural elements. The selected macro-elements of the two churches under study are shown in Figure 11. The meaning of the labels is the following:

Figure 11. Selected macro-elements investigated through the application of the limit analysis with pre-assigned failure mechanisms for the two churches under study. Notation: F1=Overturning of the façade, F2=Overturning of the upper part of the façade, T1= Overturning of the tympanum (horizontal hinge), T2= Overturning of the tympanum (inclined yield lines), SC=Overturning of the side chapel, NW=Overturning of the nave wall, TA=Triumphal arch, A=Overturning of the apse, BT= Belfry of the bell tower.

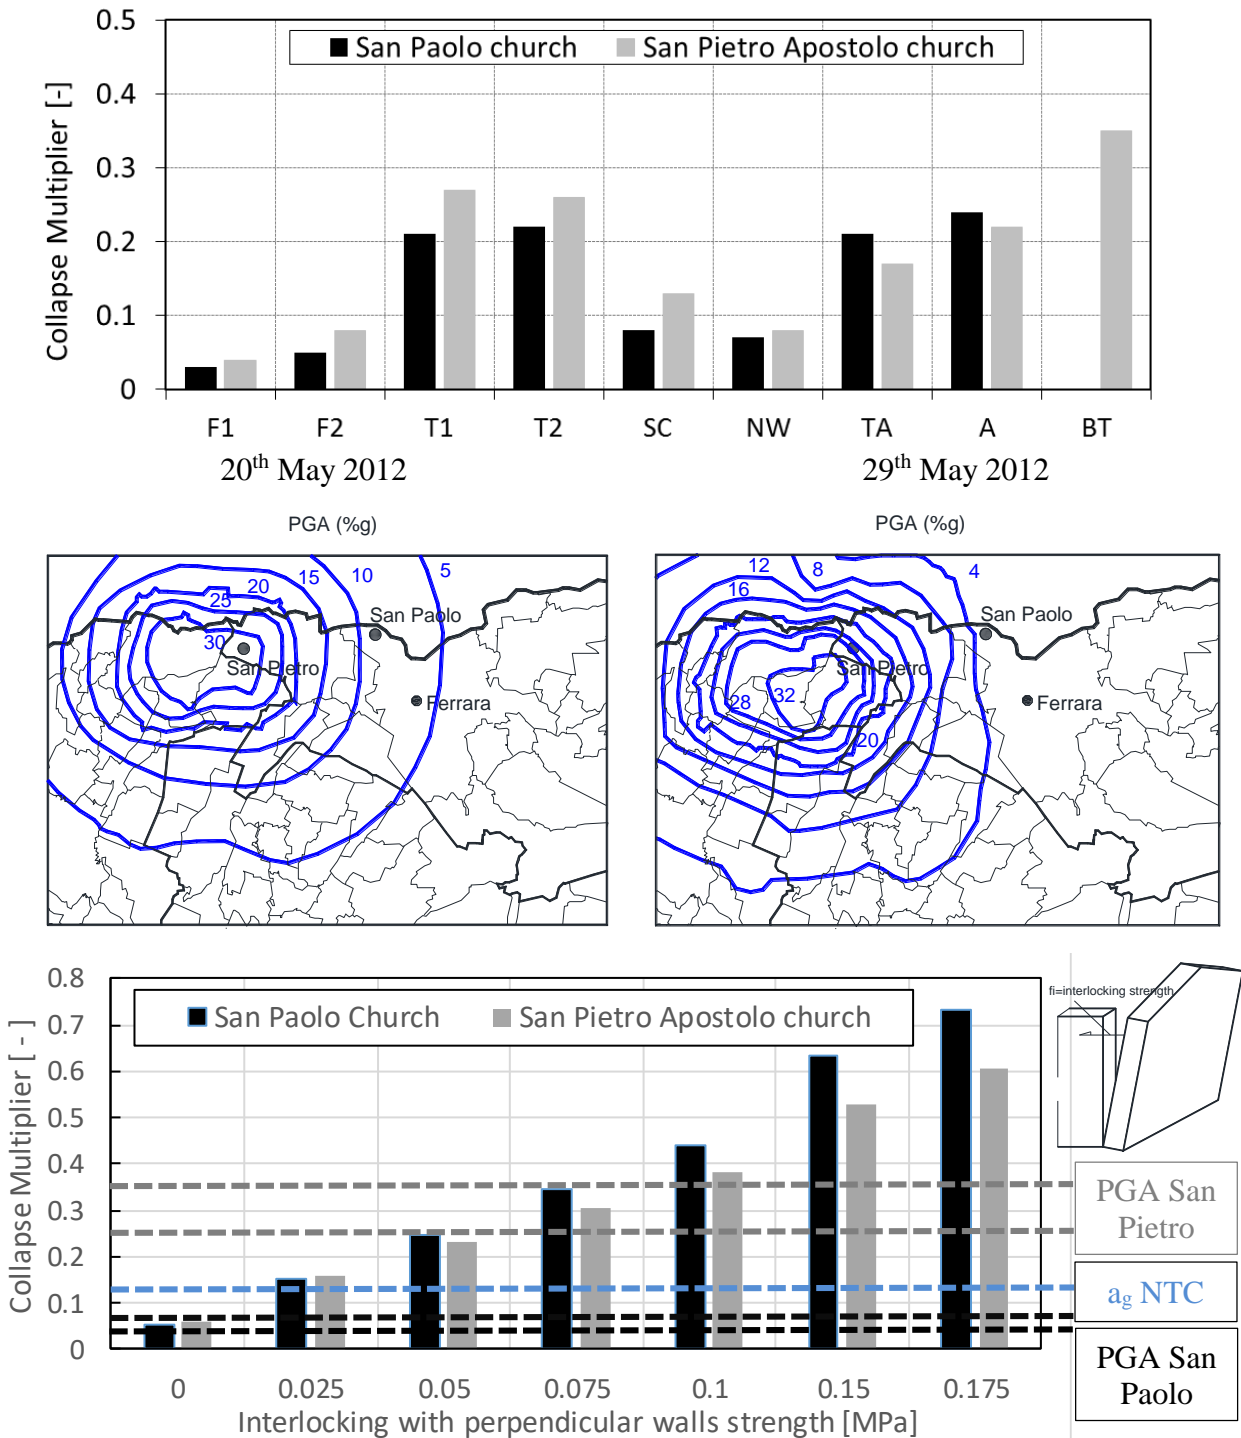
Figure 12. Top: Values of the collapse multiplier obtained through at-hand kinematic analysis for the different macro-elements of the two churches. Middle: PGAs registered during the 20th and 29th May seismic events. Bottom: Values of the collapse multipliers for the overturning of the two façades assuming a non zero interlocking strength with perpendicular walls.

From an analysis of Figure 12, it appears therefore clear that the most vulnerable macro-element is the façade for both the churches, a result consistent with the crack patterns observed after the seismic events. As can be seen again in Figure 12 (middle sub-figure), the PGAs registered during the 20th and 29th May seismic events in the region where the two churches are located were quite low for San Paolo church and moderately high for San Pietro church: the maximum horizontal acceleration a_g provided by the Italian code at the Life Safety Limit State (SLV) stands roughly in between. Without

taking into account any interlocking of the façade with perpendicular walls, a prompt collapse should be expected for San Pietro church and an almost full activation of the overturning for San Paolo church. Fortunately, such events did not occur, since both façades are still standing. A crucial issue to understand such extra-resistance is to properly evaluate, in the application of the partial failure mechanisms provided by the Italian Guidelines for the built heritage, a fictitious strength f_i at the interface between perpendicular walls representing interlocking between the façade and the nave walls, as sketched in Figure 12. Such strength is not easily identifiable in practice and would require detailed in-situ surveys with non-destructive tests, but it could give a preliminary indication of the effect of a partial interlocking existing on walls crossing on corners. Adding such extra-resistance to the overturning mechanisms at increased values of f_i , the results depicted in Figure 12 are found (bottom sub-figure), where it is clearly understandable that (i) a moderate increase of the interlocking turns out into a considerable increase of the load carrying capacity, (ii) the hypothesis of zero interlocking is over-conservative in the majority of the cases and hence not consistent with reality and (iii) the determination of the real interlocking between the walls is a crucial issue for any realistic evaluation of safety, which is the base of any planned seismic upgrading.

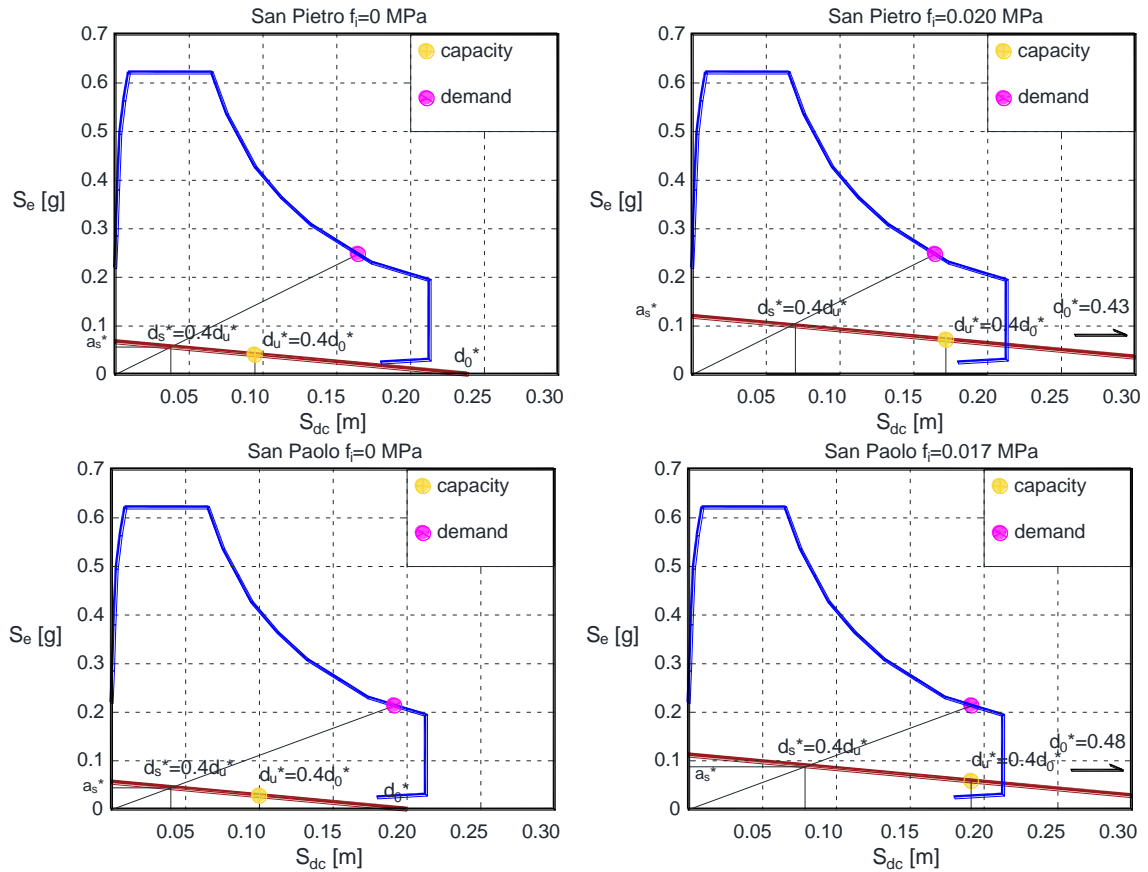
From Figure 13, it is clear that disregarding totally the interlocking strength between perpendicular walls leads to a largely unsuccessful safety assessment of the macro-block under the assigned seismic loads, whereas a small but non-zero interlocking is sufficient to increase enough the capacity.

The state of damage observed after the seismic events and the limit analysis calculations carried out (linear and non-linear) lead to conclude that the interconnection between the façade and the nave walls (for both the churches) is relatively effective, probably with a much higher quality of the masonry material for San Pietro church when compared to San Paolo church (subjected during the seismic events to PGA much lower than that predicted by the Italian Code).

Figure 13: Results of the non-linear kinematic analyses performed on both the façades of the churches for zero interlocking (left column) and non-null interlocking sufficiently high to make the analyses satisfied.

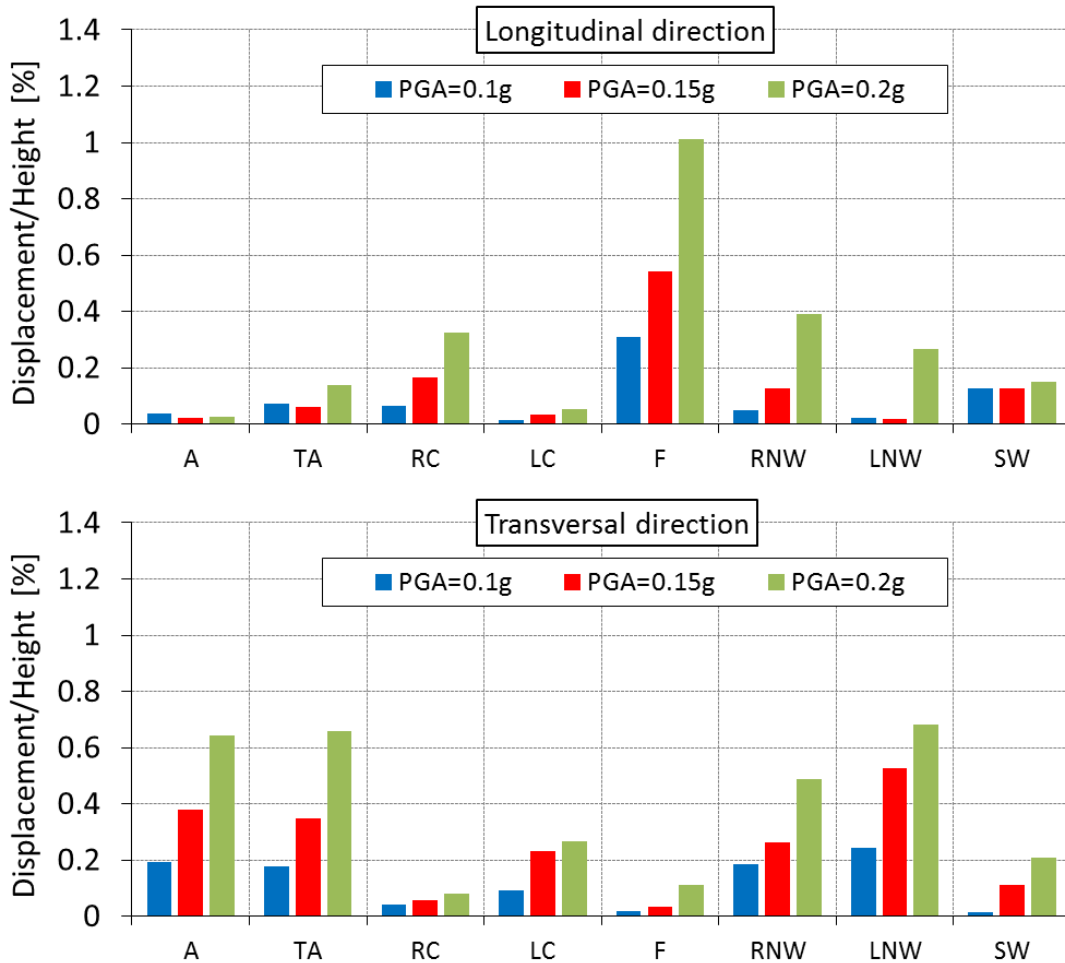
-Under PGA=0.2g, the façade presents very high normalized displacements (larger than 1%) in the longitudinal direction. In the transversal direction the highest normalized displacement (0.7%) is registered for the left nave wall, which is less restrained than the right one; slightly smaller normalized displacements (higher than 0.6%) are observed for the triumphal arch and the apse.

Figure 23. San Paolo church. Maximum normalized displacement registered for the main macro-elements in the longitudinal and transversal directions during the non-linear dynamic analyses with different PGA.

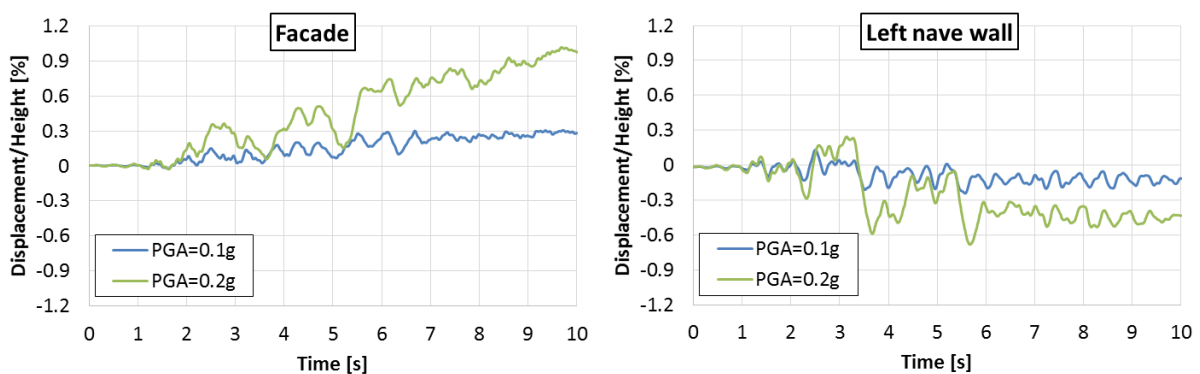
Figure 24 shows the displacement time-history registered for the façade and the left nave wall in the longitudinal and transversal directions, respectively, during the non-linear dynamic analyses with two different PGA values (PGA=0.1g and PGA=0.2g). It has to be noted that a large increase of residual displacements of the façade occurs in the case of PGA=0.2g, indicating an onset of collapse mechanism of the tympanum: a remarkable increase of the residual displacement can be observed also for the left nave wall. It is also important to remark that in the global FE model there is a non zero interlocking between perpendicular walls, because corners are modeled with elements perfectly bonded that behave exactly in the same manner as the selected masonry material (i.e. with small peak tensile strength and softening). Obviously, such hypothesis has the effect to slightly increase the load carrying capacity and hence decrease residual displacements. As far as the activation of a mechanism is concerned, the consequence is that macro-blocks are retained –at least partially- against overturning under pure mode I, especially when the results are compared with the failure mechanisms provided by the Italian Guidelines for the Built Heritage without accounting for interlocking.

Figure 24. San Paolo church. Displacement time-history registered for the façade and the left nave wall in the longitudinal and transversal directions, respectively, during the non-linear dynamic analyses with two different PGA.

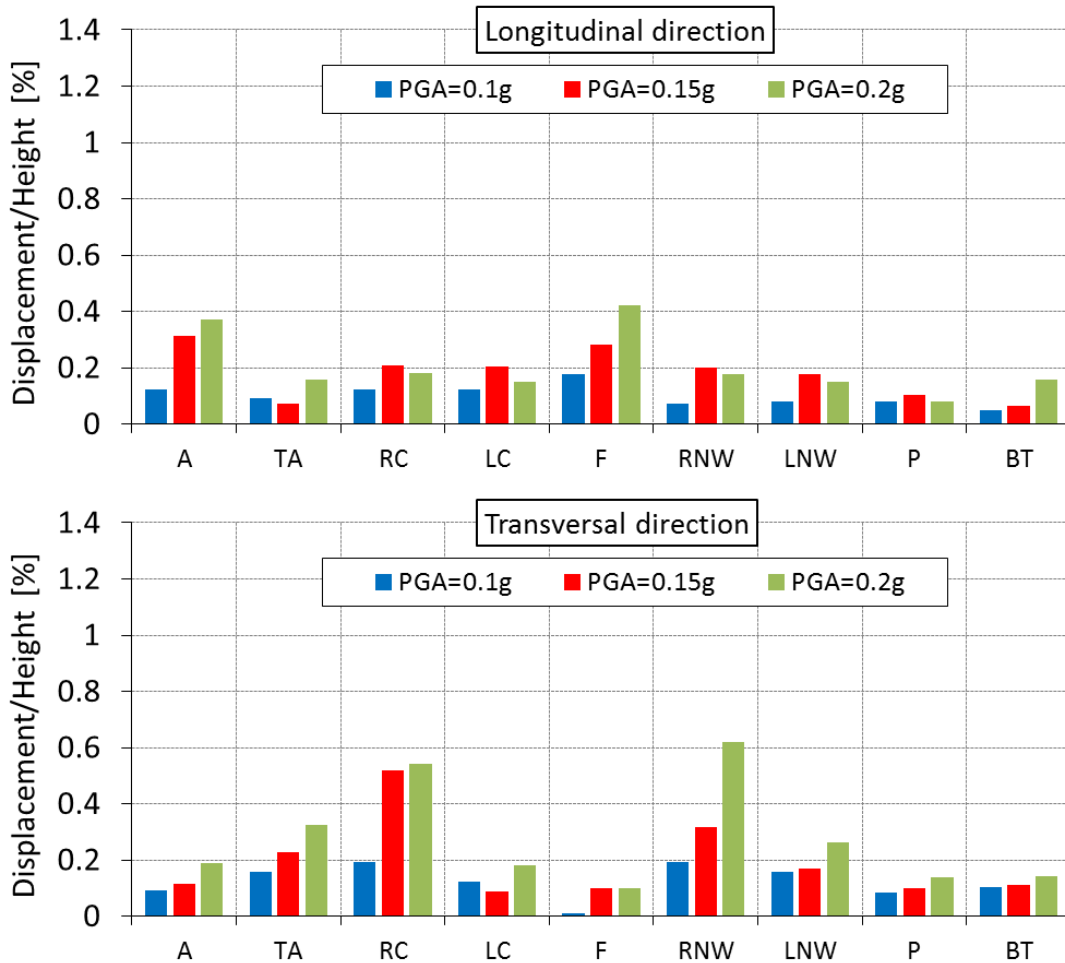
-Under $PGA=0.2g$, in the transversal direction the maximum normalized displacement is much larger (0.61%) for the right nave wall, which is less restrained by the side chapels when compared with the left nave wall. The normalized displacement of the bell tower is limited and smaller than 0.2% in both the directions. The façade presents normalized displacements larger than 0.4% in the longitudinal direction.

Figure 26. San Pietro Apostolo church. Maximum normalized displacement registered for the main macro-elements in the longitudinal and transversal directions during the non-linear dynamic analyses with different PGA.

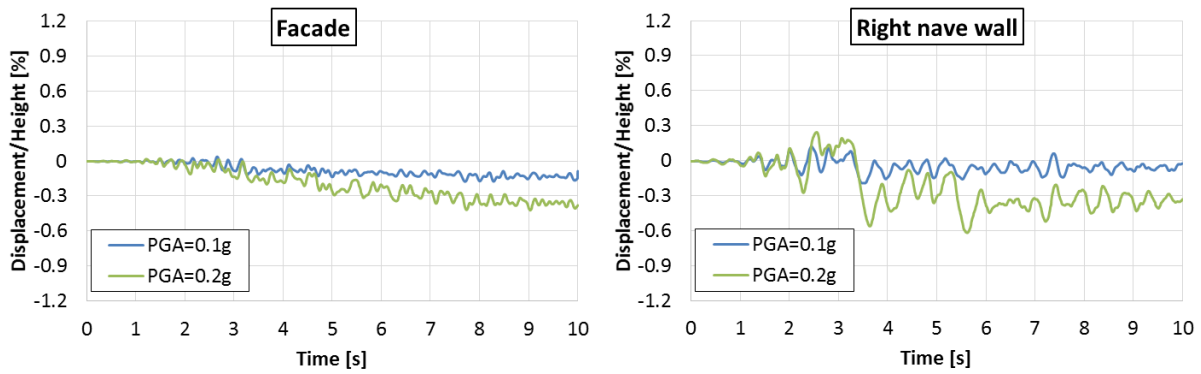
Figure 27 shows the displacement time-history registered for the façade and the right nave wall in the longitudinal and transversal directions, respectively, during the non-linear dynamic analyses with two different PGA values ($PGA=0.1g$ and $PGA=0.2g$). It has to be noted that the residual displacements are small for both the macro-elements in the case of $PGA=0.1g$; conversely, under $PGA=0.2g$ a clear increase of the residual displacements can be observed.

Figure 27. San Pietro Apostolo church. Displacement time-history registered for the façade and the right nave wall in the longitudinal and transversal directions, respectively, during the non-linear dynamic analyses with two different PGA.

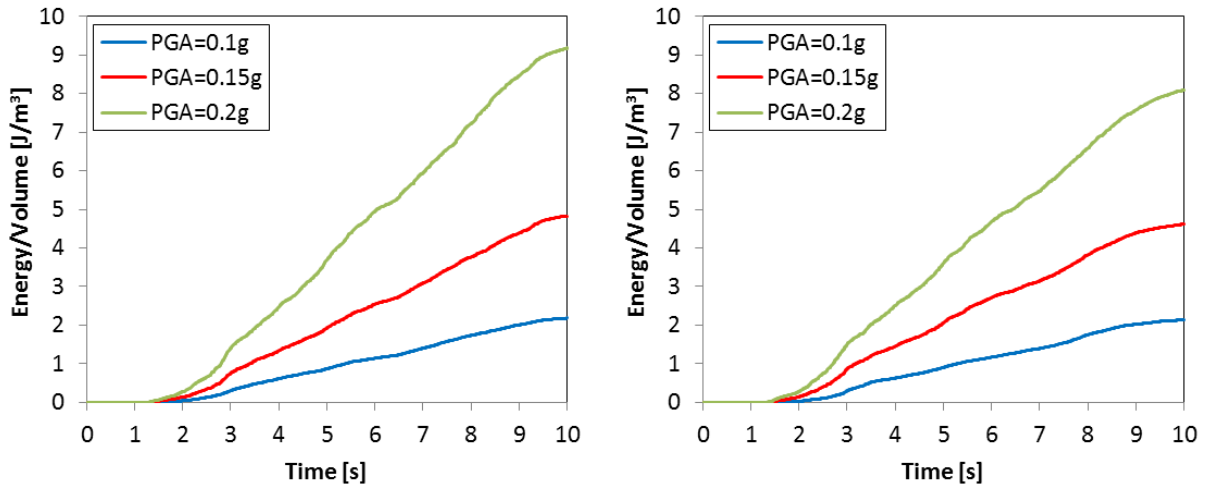
Figure 29 shows the evolution of the global energy density dissipated by tensile damage (EDDTD) for the two churches under different PGA. The values of the EDDTD are similar for both the churches, with slightly larger values for San Paolo church. A large increase of the EDDTD can be observed in the case of PGA=0.2g for both the churches.

Figure 29. Energy density dissipated by tensile damage for the two churches during the non-linear dynamic analyses with different PGA: San Paolo church (left) and San Pietro Apostolo church (right).

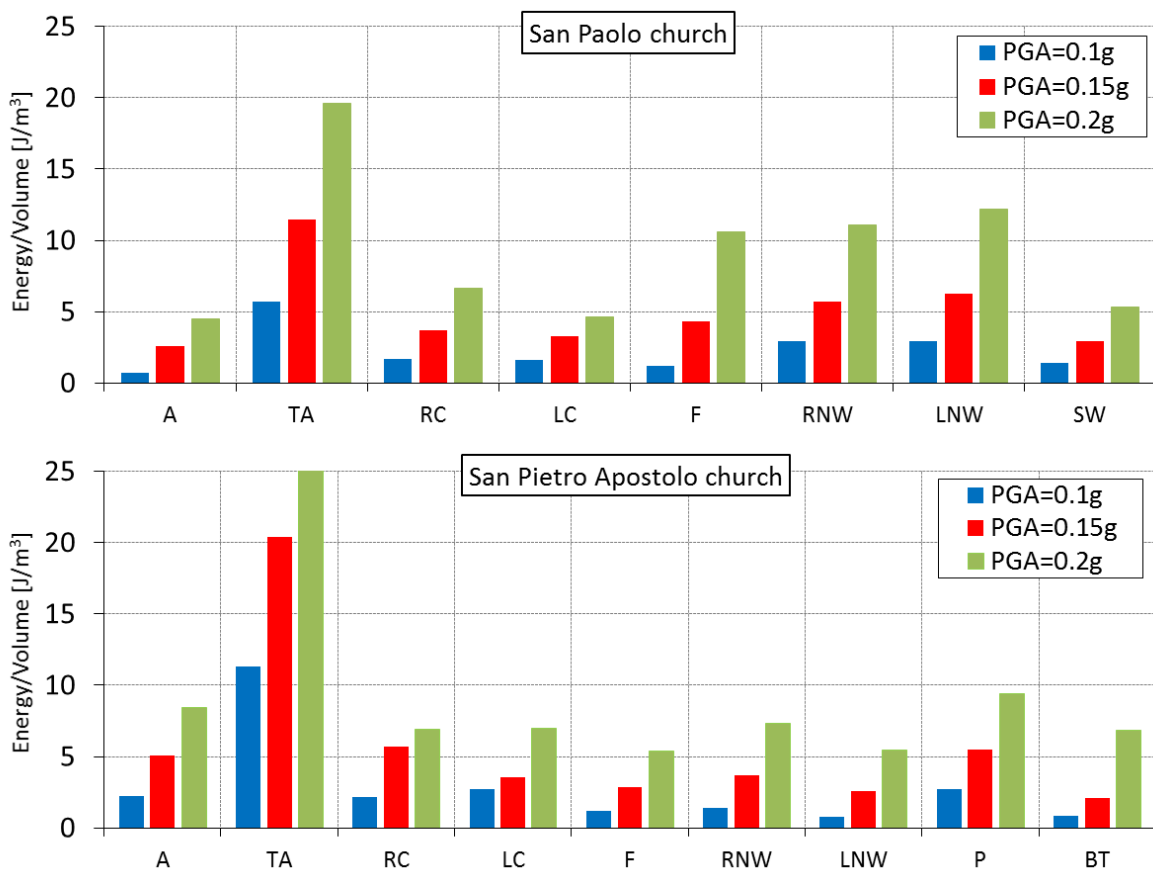
Figure 30 shows the energy density dissipated by tensile damage (EDDTD) for the main macro-elements of the two churches under different PGA. The highest value of the EDDTD is computed for the triumphal arch of both the churches, for all the PGA values. In the case of San Paolo church, high values of the EDDTD are also registered for the façade and the nave walls. As regards San Pietro Apostolo church, excluding the triumphal arch, a more uniform distribution of the EDDTD can be observed, with slightly larger values registered for the apse, the presbytery and the right nave wall.

Figure 30. Energy density dissipated by tensile damage for the main macro-elements of the two churches at the end of the non-linear dynamic analyses with different PGA.

-The maximum value of the energy density dissipated by tensile damage was registered for the triumphal arch of both the churches, as also confirmed by the considerable damage observed in the central part and at the edges of the triumphal arch in the contour plots. It is worth mentioning that the triumphal arch of San Paolo church exhibited high normalized displacements in the transversal direction. It can be noted that the field survey showed significant cracks in the triumphal arch of both the churches.
