**A MULTIDISCIPLINARY STRATEGY FOR THE
INSPECTION OF HISTORICAL METALLIC TIE-RODS:
THE MILAN CATHEDRAL CASE STUDY**

Bellanova Mariagrazia¹

Felicetti Roberto¹

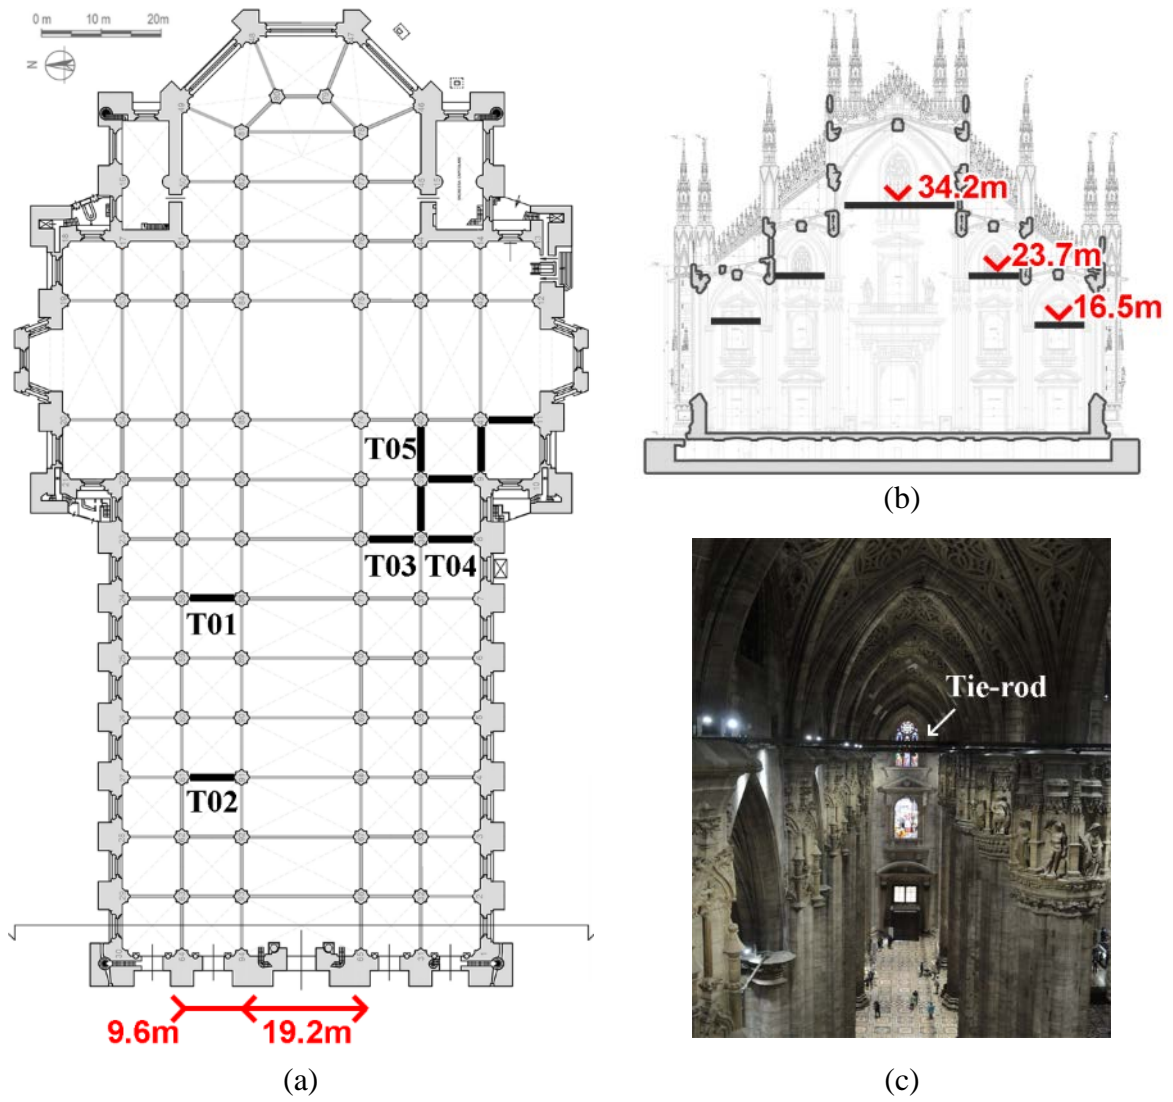
The first steps of the procedure were validated on site on seven tie-rods placed in the southern naves, close to tiburio, as highlighted in Figure 1. Historically this was one of the most suffering areas of the cathedral (Ferrari da Passano 1980) and nowadays it shows quite an interesting crack pattern on the vaults (Cardani, Coronelli, and Angjeliu 2016). The examined elements were chosen by comparing the results of the dynamic inspection (Vasic 2015), the displacement monitoring data recorded from the May 1988 to the November 2014 (Giussani 2015) and the corresponding trends of the mean strain. The tomograph MIRA A1040 was used to perform guided waves testing by collecting data on the larger vertical sides of the tie-rod. The recorded signals were processed by implementing the focusing procedure discussed before. Concerning eddy current testing, the probe prototype purposely built for this application was used. More emphasis was given to correlated indications characterized by two local strong variations of impedance, shifted by 100-200 mm on the opposite sides. Indeed these evidences are most likely due to the presence of an incipient crack along the forged weld. On the areas corresponding to eddy currents indications, a detailed visual inspection was performed as well. Pictures of 20 Mpixel resolution were taken by using Canon EOS 600 D high performance camera with an EF50mm f/2.5 compact macro lens, allowing close-up shooting up to 60 pixel/mm. Before taking pictures, the tie-rod surface was cleaned carefully.

Figure 1. Milan Cathedral, (a) plan, (b) section, (c) internal view

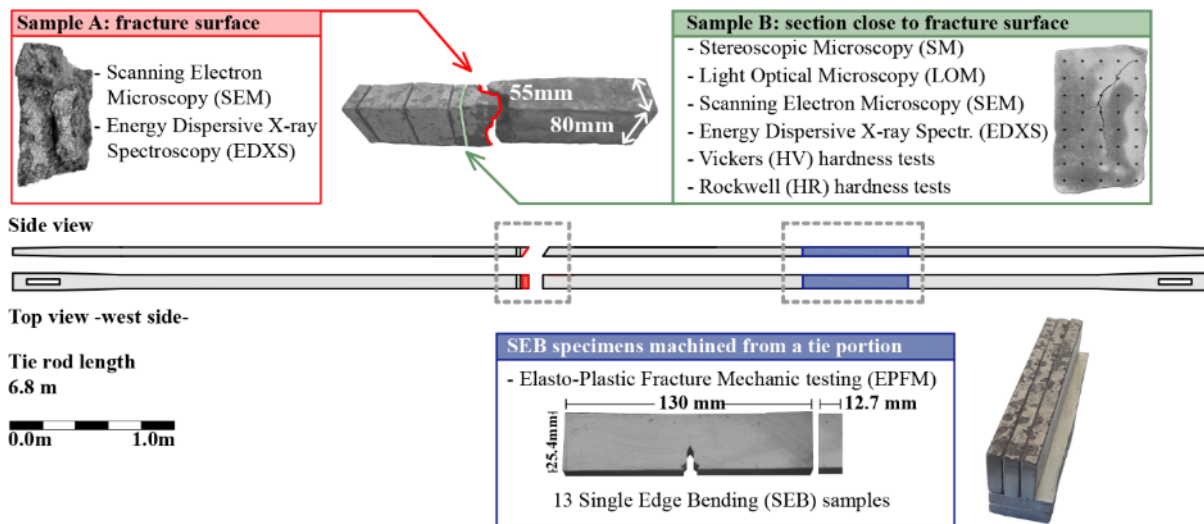
An overview on the localization of samples used for material characterization is summarized in Figure 2.

Figure 2: T01, location of samples used for material characterization

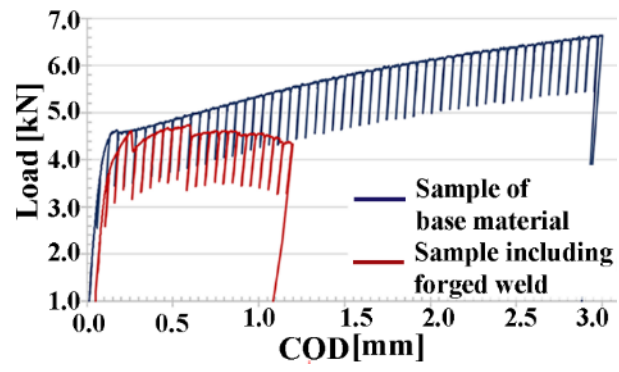
Figure 8. Load-displacement curves in Single Edge-Notched Bend (SEB) tests

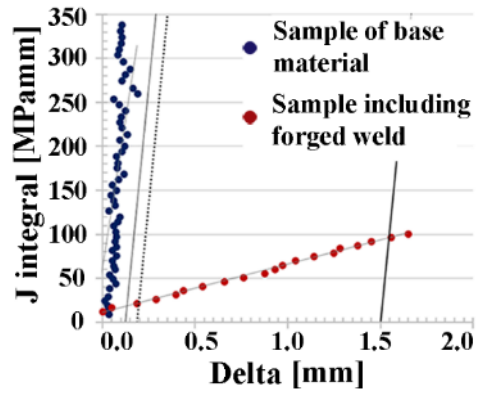
Figure 9. J intergral - resistance curves in Single Edge-Notched Bend (SEB) tests

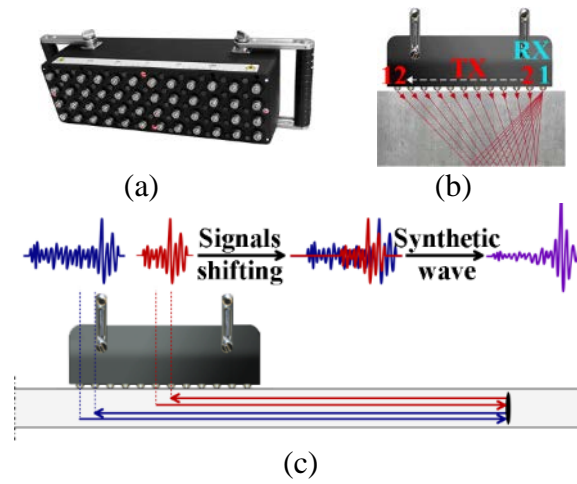
Figure 11. Guided wave testing (a) MIRA A1040 tomograph, (b) data acquisition procedure, (c) processing procedure representation

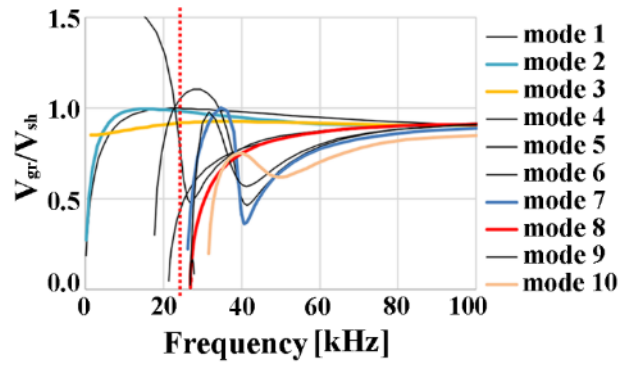
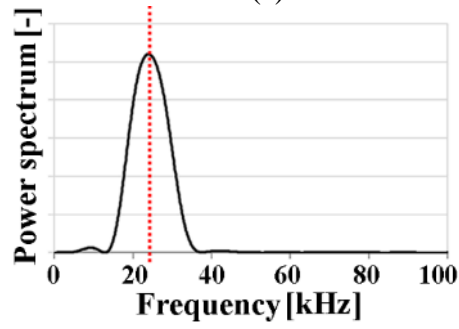
Figure 12. (a) Dispersion curves computed by the analytical polynomial approach, (b) power spectrum of the diagnostic wave

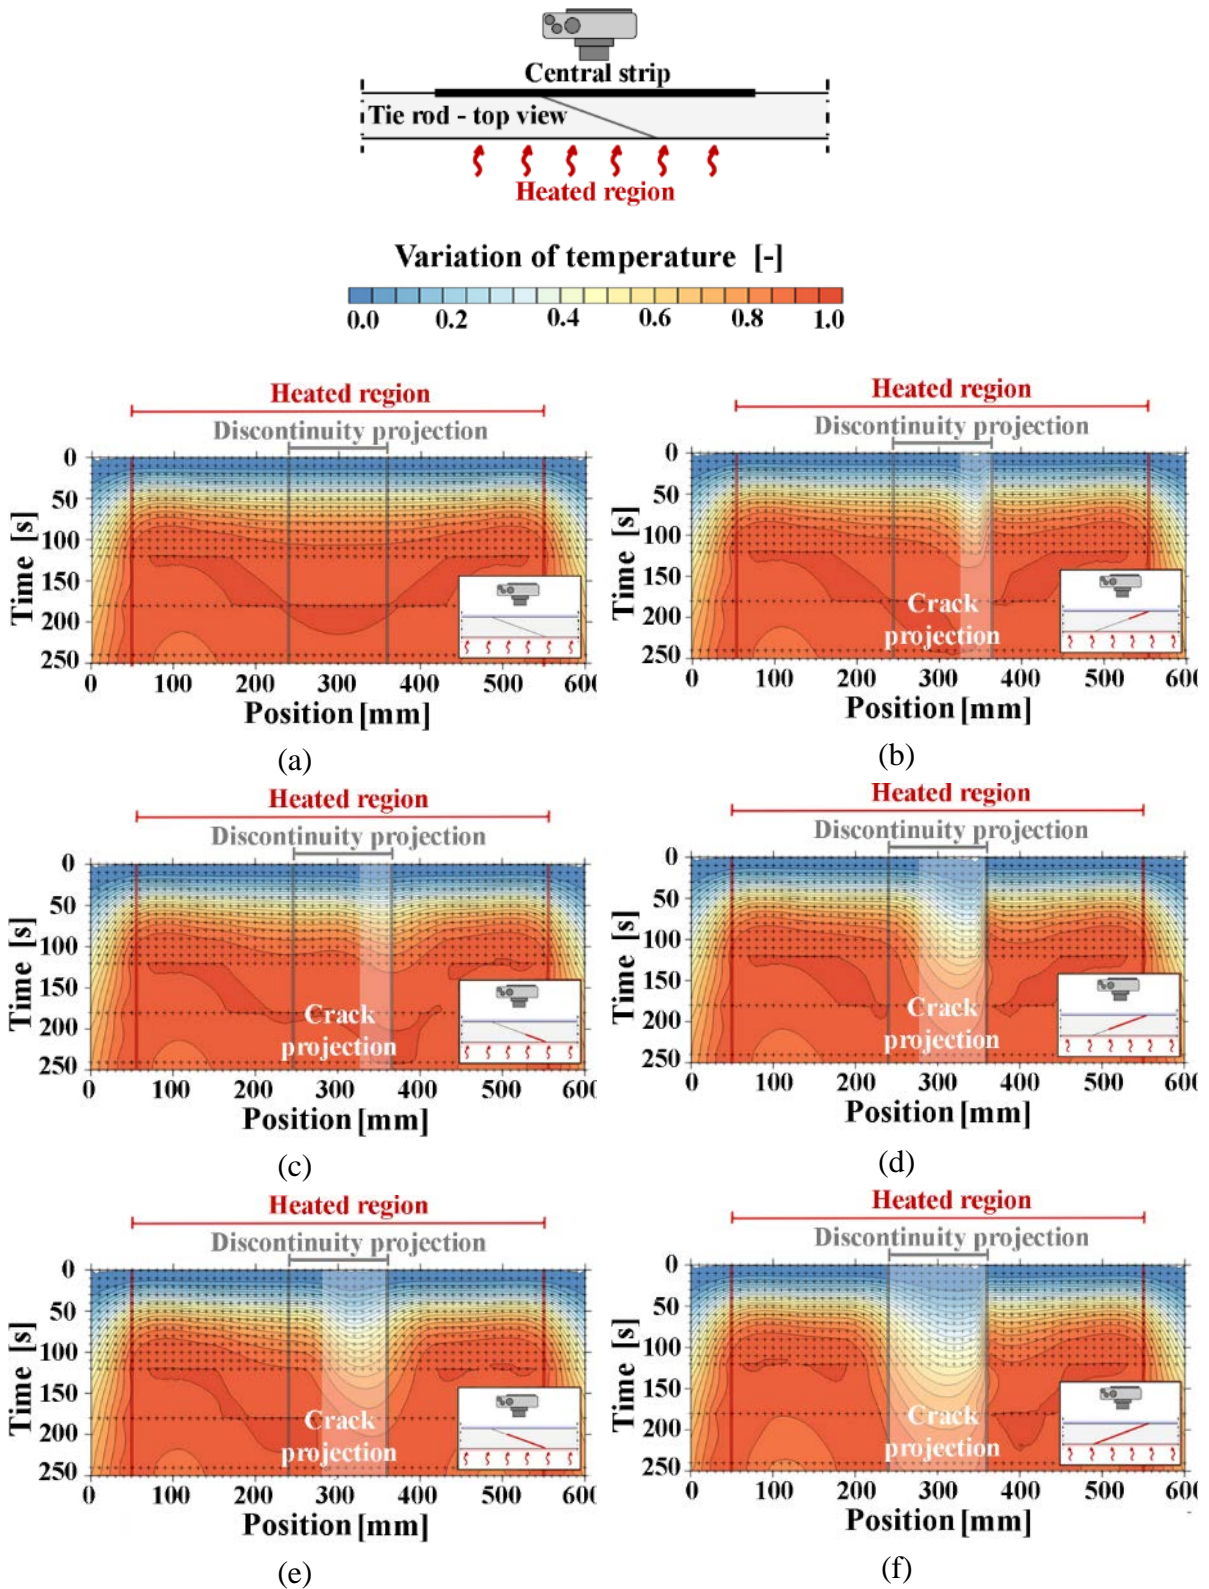
Bi-dimensional numerical simulations were performed to evaluate the effects of crack geometry, length, and position as well as the incidence of diffusion toward unheated regions. A step heating of $+10^{\circ}\text{C}$ lasting 20 seconds was used to simulate the thermal pulse. Different crack lengths were modelled. Emerging and non-emerging conditions were considered as well. Figure 16 shows the numerical simulation results in terms of the evolution of the temperature variation along a central strip. Every configurations showed the maximum contrast between defective and no-defective region after about 60 seconds. In the plots pertaining to the emerging crack (Figure 16 b, d and f) the sharp discontinuity indicates the crack tip. Defective regions can be distinguished unambiguously from the non-defective ones. One region characterized by high thermal gradients can be recognized. Its length is proportional to the crack size and it is approximately one-and half times the crack length. In the plots representing the non-emerging crack conditions (Figure 16 c and f) the variation of temperature is smoother. In the first stages

Figure 16. Numerical results of pulsed thermography, variation of temperature along a central strip, (a) discontinuity without defect (b) discontinuity with emerging crack involving one-third of the cross-section, (c) discontinuity with no-emerging crack involving one-third of the cross-section, (d) discontinuity with emerging crack involving two-third of the cross-section, (e) discontinuity with no-emerging crack involving two-third of the cross-section, (f) discontinuity with through-thickness crack

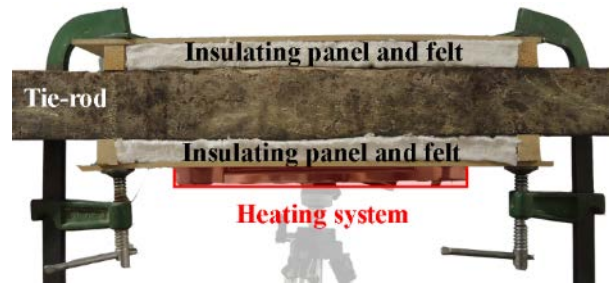
Figure 17. View from the observation side of the IR thermography showing the location of the thermal insulation to promote a planar thermal diffusion

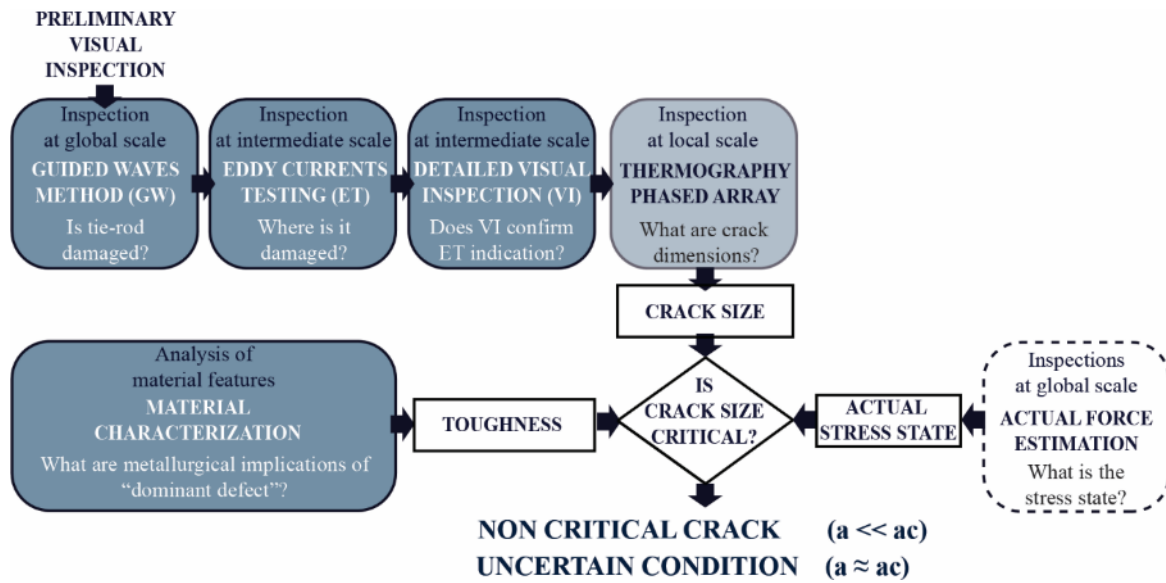
In any historic metallic component, the presence of defects is unavoidable. Therefore, it is important to understand the significance of the detected flaws in connection with the actual loading conditions. The performed research, combined with other established methods, allowed to define guidelines to perform a complete assessment of the structural safety of the historical metallic tie-rods, accounting for the presence of dominant defects. The flow chart of the proposed procedure is shown in Figure 21.

Figure 21. Flowchart of the proposed procedure
