# The San Carlo Colossus: An Insight into the Mild Galvanic Coupling between Wrought Iron and Copper

**Abstract:** The San Carlo Colossus, known as *San Carlone*, is a monument constituted by an internal stone pillar support to which a wrought iron structure is attached. Embossed copper sheets are fixed to the iron structure to give the final shape to the monument. After more than 300 years of outdoor exposure, this statue represents an opportunity for an in-depth investigation of long-term galvanic coupling between wrought iron and copper. Most iron elements of the *San Carlone* appeared in good conservation conditions with scarce evidence of galvanic corrosion. In some cases, the same iron bars presented some portions in good conservation conditions and other nearby portions with active corrosion. The aim of the present study was to investigate the possible factors correlated with such mild galvanic corrosion of wrought iron elements despite the widespread direct contact with copper for more than 300 years. Optical and electronic microscopy and compositional analyses were carried out on representative samples. Furthermore, polarisation resistance measurements were performed both

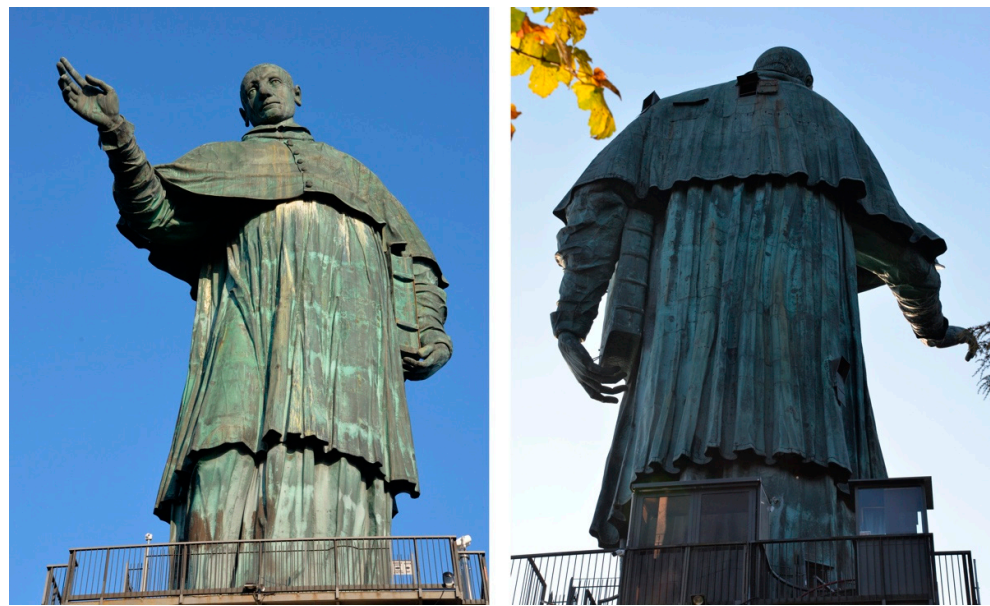
The Colossus of San Carlo Borromeo (1538–1584), called *San Carlone*, i.e., *Big Saint Charles* (Figure 1) due to its large size, located in Arona on the Lago Maggiore (Piedmont, Italy), was built between 1614 and 1698. The 22 m high statue (which is positioned on an 11 m high granite pedestal) was manufactured by a peculiar construction technique: An internal stone pillar supports a wrought iron structure, embossed with fixed copper sheets. The iron structure, in direct contact with the copper sheets, provides structural support and shapes the statue. Due to its construction technique and more than 300 years of outdoor exposure, the statue represents an opportunity for an in-depth investigation of the long-term galvanic coupling between the wrought iron and copper. Despite the frequent direct contact between the two metals, wrought iron presents only a limited number of areas heavily affected by corrosion, while the rest looks in quite good conservation condition.

**Figure 1.** The Colossus of San Carlo Borromeo (1538–1584), Arona (Italy), called *San Carlone*.

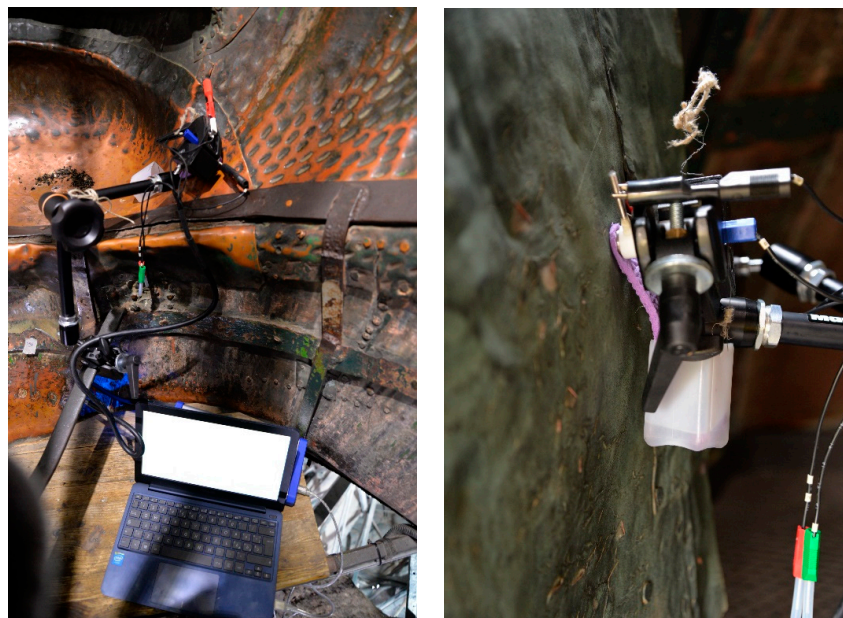
LPR and EIS measurements have been carried out on-site (Figure 3) by employing the Contact Probe proposed by Letardi [35]. The Contact Probe is constituted by an AISI316L stainless steel counter (CE) and pseudoreference (RE) electrodes embedded in a PTFE case. On polished cross-section of microsamples collected from the same monument, LPR and EIS measurements have been carried out with the Minicell by Amel s.r.l. The Minicell is constituted by a platinum counter electrode and an Ag/AgCl reference electrode hosted in a cylindrical plastic case where the electrolyte flows continuously with a minipump. All LPR, EIS, and  $E_{\text{corr}}$  measurements were performed with a portable potentiostat Ivium Technologies with CompactStat Ivium® software using oligomineral water (pH around 8 and conductivity around 200  $\mu\text{S}/\text{cm}$ ) as an electrolyte.

**Figure 3.** In situ electrochemical measurements with the contact probe.

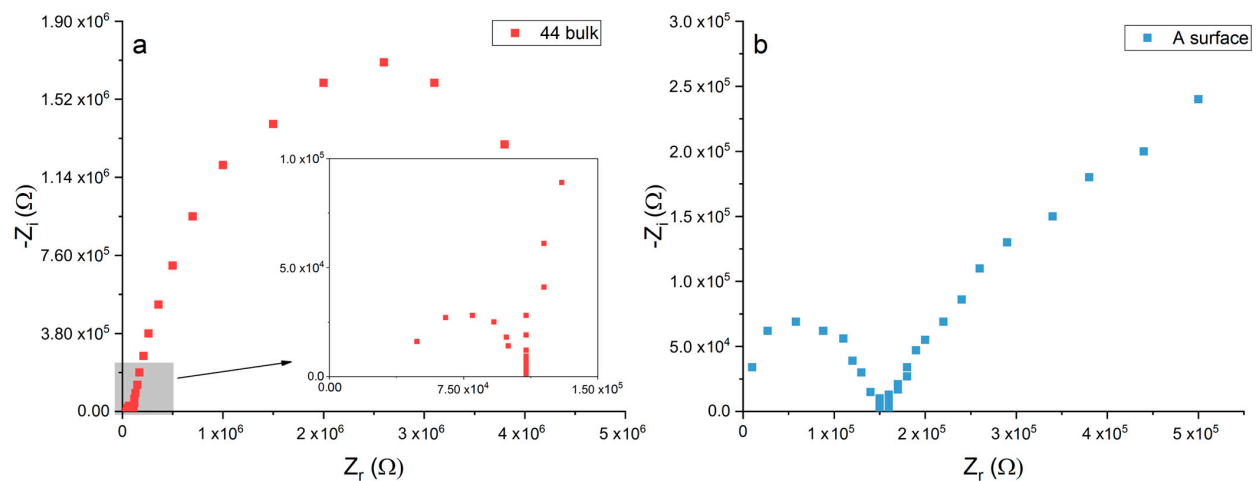
**Figure 11.** Nyquist plots of Sample 44 (a) and Sample A (b).
