XIX ANIDIS Conference, Seismic Engineering in Italy

Seismic Assessment of Typical Historical Masonry Churches in Banat region, Romania - Part I

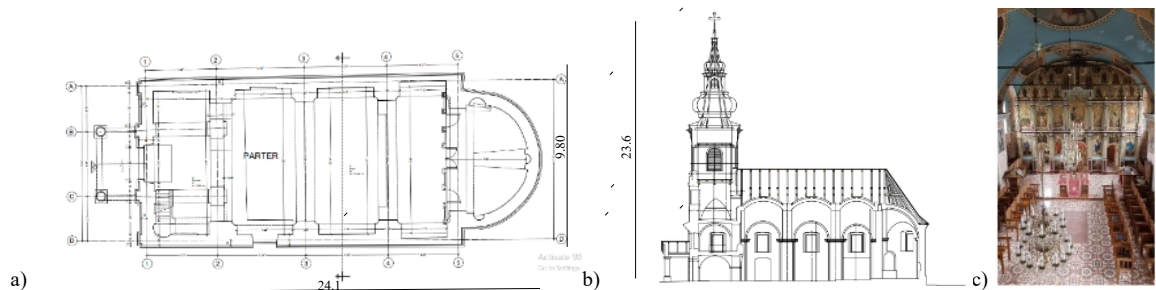
Fig. 1. Plan, section and interior paintings of the „Sf. Mare Mucenic Gheorghe” church in Beregsau Mare village, Romania

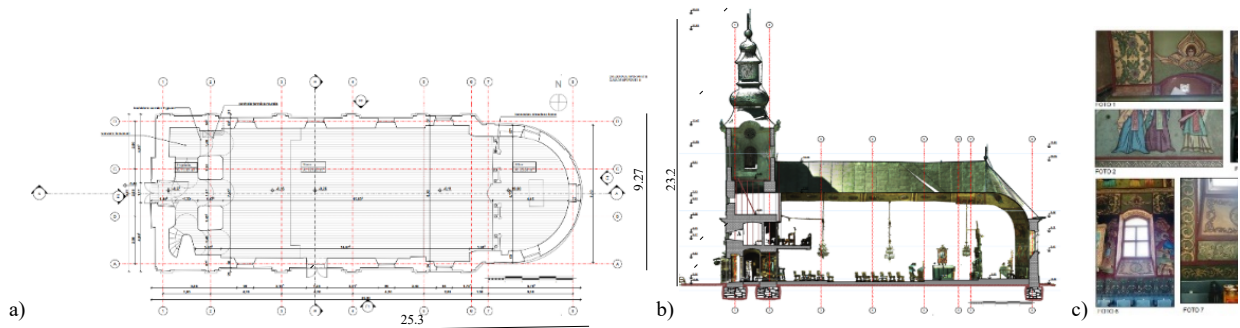
Fig. 2. Plan, section and interior paintings of the „Nasterea Maicii Domnului” church in Chizatau village, Romania

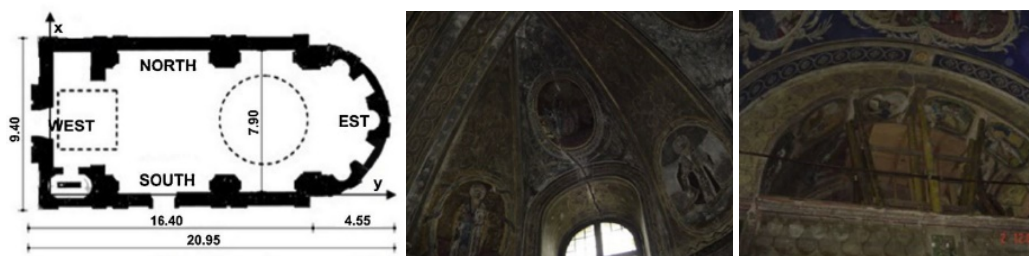
Fig. 3. Plan of the „Sf. Gheorghe” church in Birda village, Romania and interior paintings

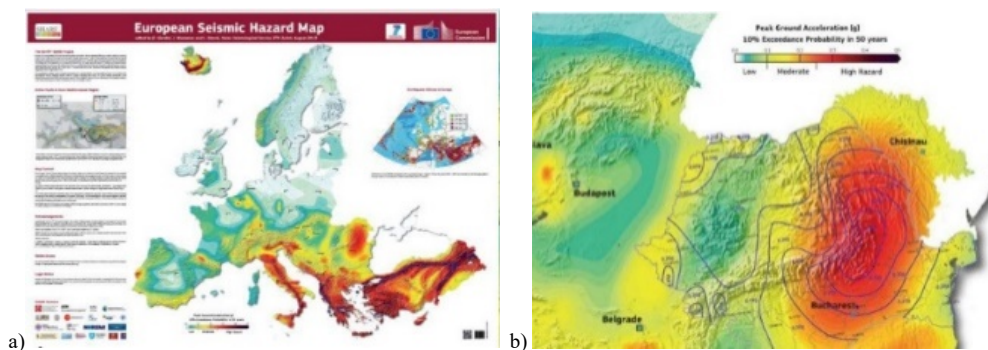
Although the churches are not far from each other in terms of distance, due to the specific seismic map of Romania they are in seismically active areas having different peak ground acceleration of 0,20g for Beregsau Mare and Birda and 0,15g for Chizatau, as presented in Fig. 4b.

Fig. 4. a) SHARE European Seismic Hazard Map 2013; b) SHARE map and P100-1 2013, peak ground accelerations for Romania overlay

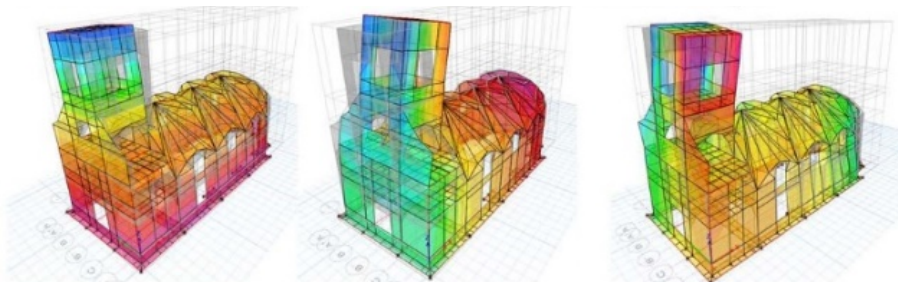
Fig. 7. Main vibration periods.

The main vibration periods are presented in Fig. 7 for translation in transversal and longitudinal direction and for torsion. The effective pressure on the ground, at the base of the foundations in the tower area, exceeds the corrected conventional pressure of the foundation ground. Therefore, it was proposed to consolidate the foundations by widening the foundations by 40 cm and making a perimeter beam of reinforced concrete. For the degree of seismic assurance R3 table 3 presents the ration for both directions.

Mode 1: Oy transversal translation T=0.246s Mode 2: Ox longitudinal translation T=0.175s Mode 1: Torsion T=0.128s

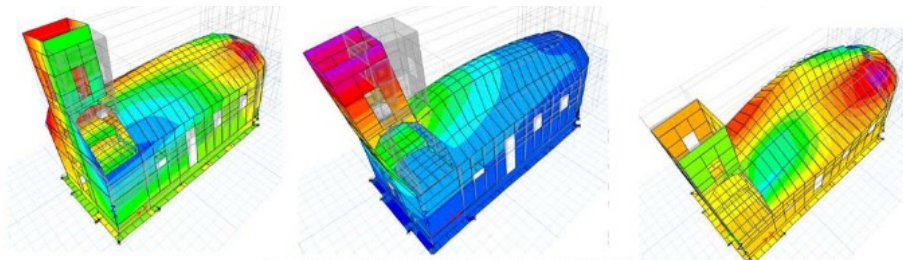
Fig. 8. Main vibration periods

Mode 1: Oy transversal translation T=0.44s Mode 2: Ox longitudinal translation T=0.33s Mode 1: Torsion T=0.23s

The main vibration periods are presented in Fig. 8 for translation in transversal and longitudinal direction and for torsion. For the degree of seismic assurance R3 table 3 presents the ration for both directions for the strengthen and unstrengthen building.
