MODELLING AND EFFECTS OF SEISMIC IMPROVEMENT INTERVENTIONS ON CHURCH ROOFS

3. The Centro-Italia earthquake of 2016 and the church of S. Martino dei Gualdesi

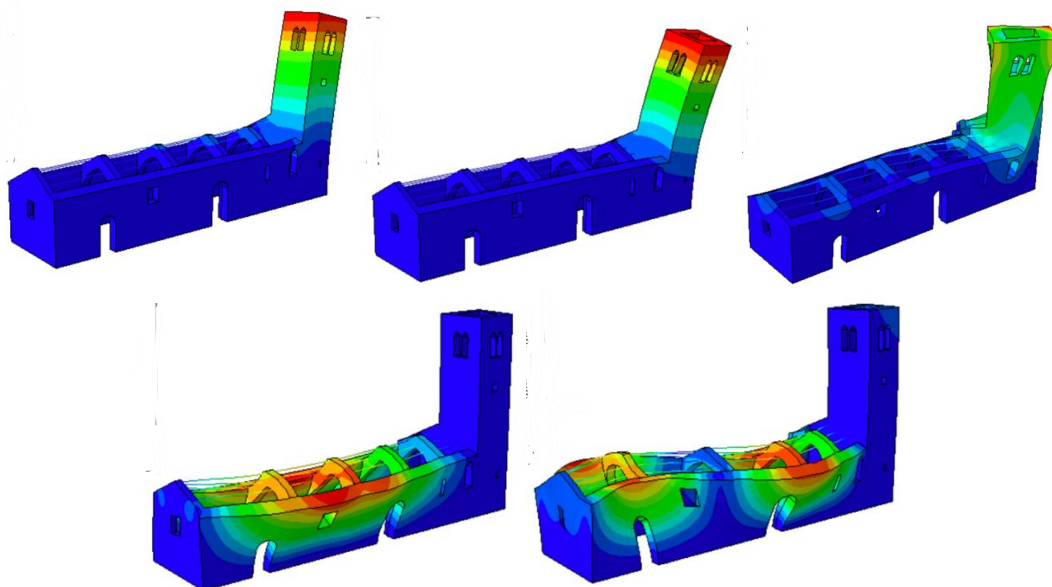
Figure 8. First five modal shapes for the case of timber roof structure; top line, from left: modes 1,2 and 5; bottom line from left, modes 3 and 4.

Figure 8 reports the first five modes for the roof structure in the current situation. The bell tower and the main body of the church have very distinct modes. The first two modes are translational for the bell tower, in the nave direction and across it respectively, while the first torsional mode is the 5th to appear. The 3rd and 4th mode concern the lateral deformation of the nave walls, which recalls a typical failure mechanism occurred in many churches. The participating masses are accordingly distributed in the main directions, and periods are those typically found in this church typology, as in Table 1.

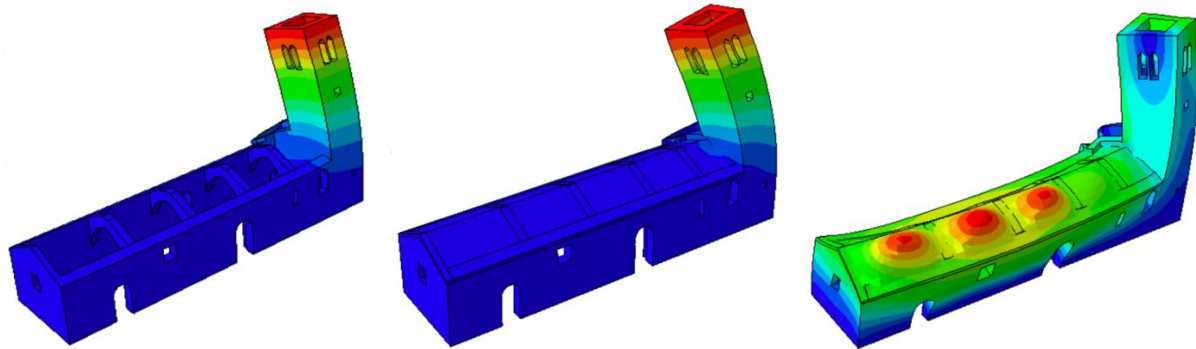
When the massive roof cover is present, the same basic sequence of modes appears (fig. 9). The first two modes are still bell tower modes, but with a significant rotation; in the 3rd mode the stronger top link restrains the lateral deformation and involves the bell tower in the deformation. Periods are lower (Table 2).

Figure 9. First three modal shapes for the case of massive roof structure; from left: modes 1,2 and 3.

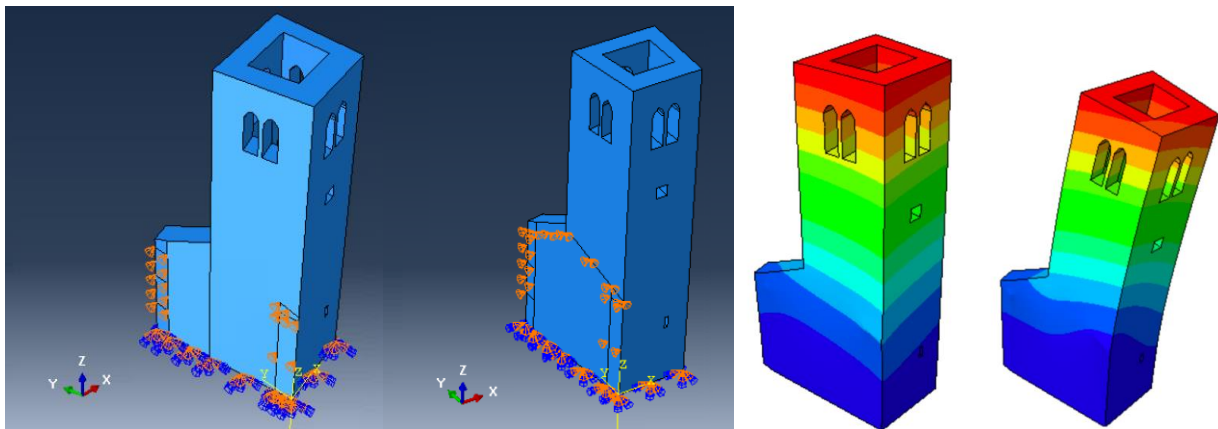
The figure shows also the two first modes of the bell tower model. An initial modal analysis has shown periods of 0,39 and 0,31 seconds for the lighter roof and of 0.31 and 0.29 seconds for the concrete cover case. Comparing such values with those from the full model, the concrete roof case matches values more precisely, with a 6.5 % approximation. Yet, all values appear reasonable for an indicative analysis.

Figure 10. (left) Restraints simulating connection with the church: case of timber roof (left) and concrete cover (right); (right): first two modes of the bell tower model.

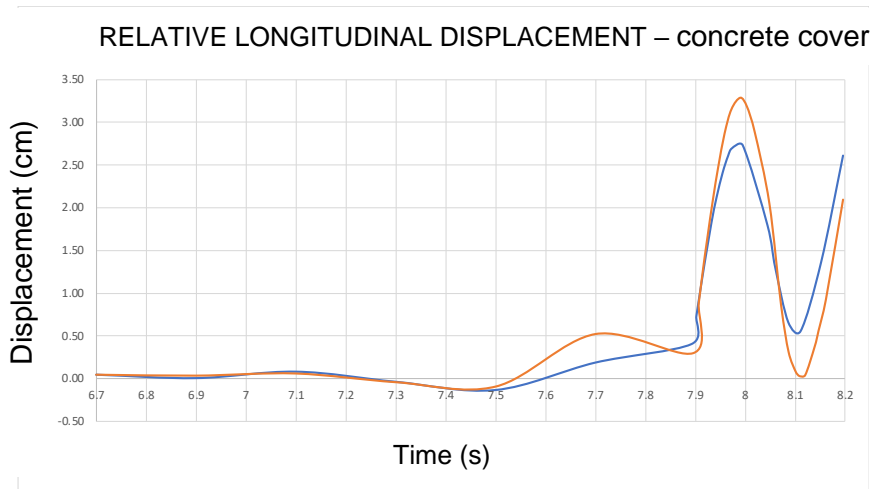
For further verifying the validity of results based on the partial model, a nonlinear dynamic analysis has been performed with the same recordings for a short extension of time, 8 seconds, also on the full structure. Figure 12 shows a favorable comparison of displacements in the two cases.

Figure 12. Displacements of the bell tower top relative to the ground in the longitudinal direction in the first 8.2 seconds of motion (partial model in red; full model in blue).

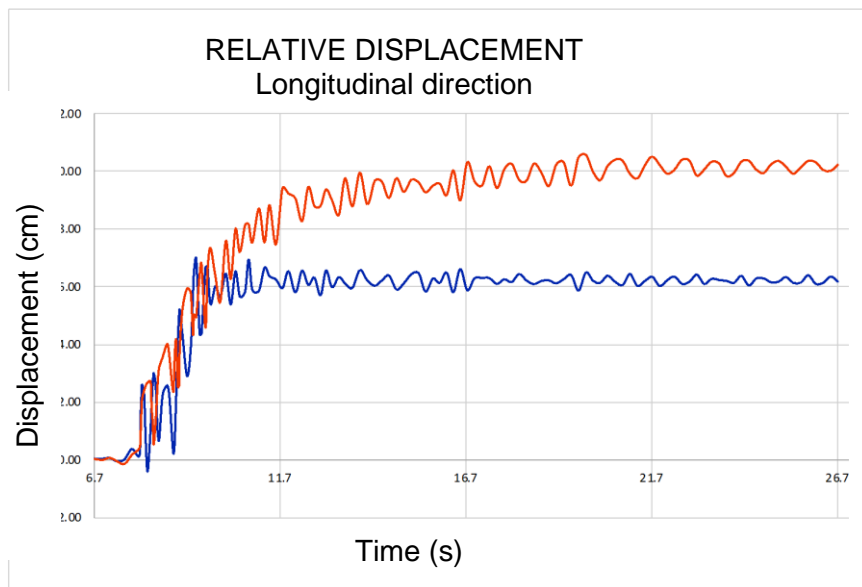
The crack pattern obtained numerically and that observed for the present roof case are compatible. Yet, for a more precise assessment of effects, a quantitative measure of damage has been developed making reference to the displacement of the tower top relative to the base during motion and to the residual displacement after motion. The amount of residual displacement may be assumed as a measure of plasticization. Figures 13 and 14 report the development of displacements for model 1 (lighter roof), and model 2 (heavier roof), in the longitudinal and transversal direction. The pictures show an important difference in the two results: the lighter roof develops a milder plasticization in the bell tower, with a particularly low residual displacement in the transversal direction. The heavier roof clearly corresponds to a greater permanent damage of the structure. The result confirms the negative influence of heavy roof solutions observed in several damage situations. A similar analysis performed on the previously mentioned church of S. Salvatore, which had undergone the same history of earthquakes and a comparable series of interventions, yielded corresponding results.

Figure 13. Longitudinal relative displacement of the bell tower top for models 1 (blue) and 2 (red)

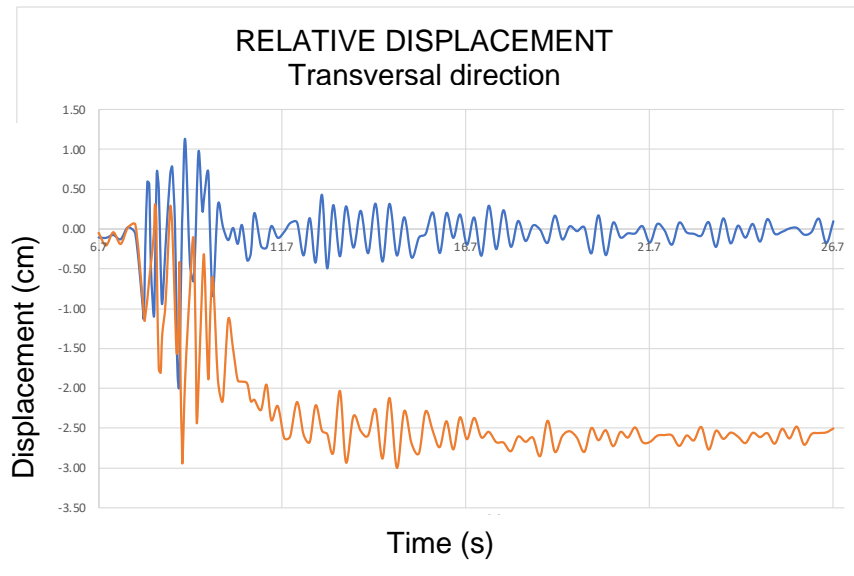
Figure 14. Transversal relative displacement of the bell tower top for models 1 (blue) and 2 (red)
