Article

Between Safety and Conservation—Procedure for the Assessment of Heritage Buildings Based on Historic Research

The procedure is implemented on the Arengario (Figures 1 and 2), the 13th-century Town Hall of Monza, representing the main symbol of the Commune Age of the city. Over the centuries, the building has been transformed several times due to the changes in its

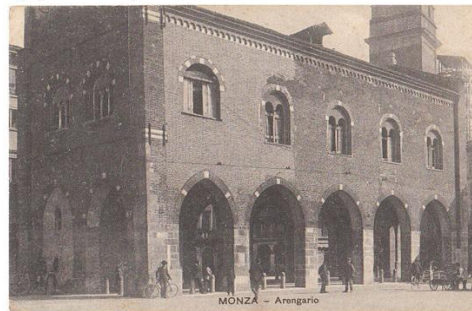
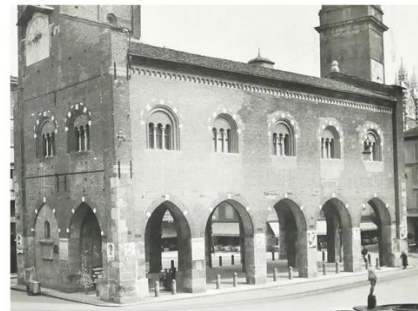
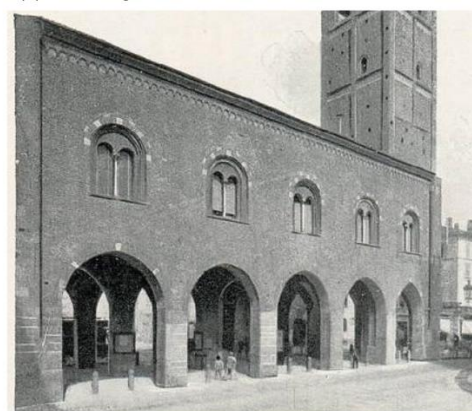
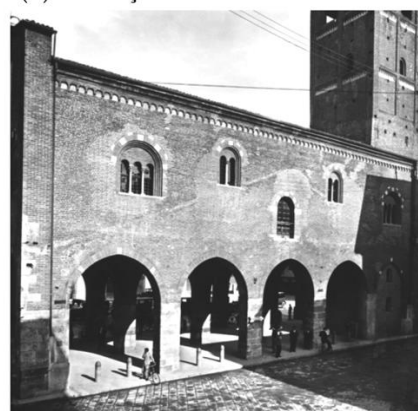
Figure 8. Historical pictures and postcards of the east (a,b) and west (c,d) fronts, before (a,c) and after (b,d) the restoration works of 1912–1915. The size, shape, and position of the several openings were modified.

The brick masonry shows several irregularities due to the past repairs and window redistribution (Figures 8 and 11). The stratigraphic survey of all the fronts enhanced the complex sequence of interventions that were partially confirmed by the historical research (Figure 11).

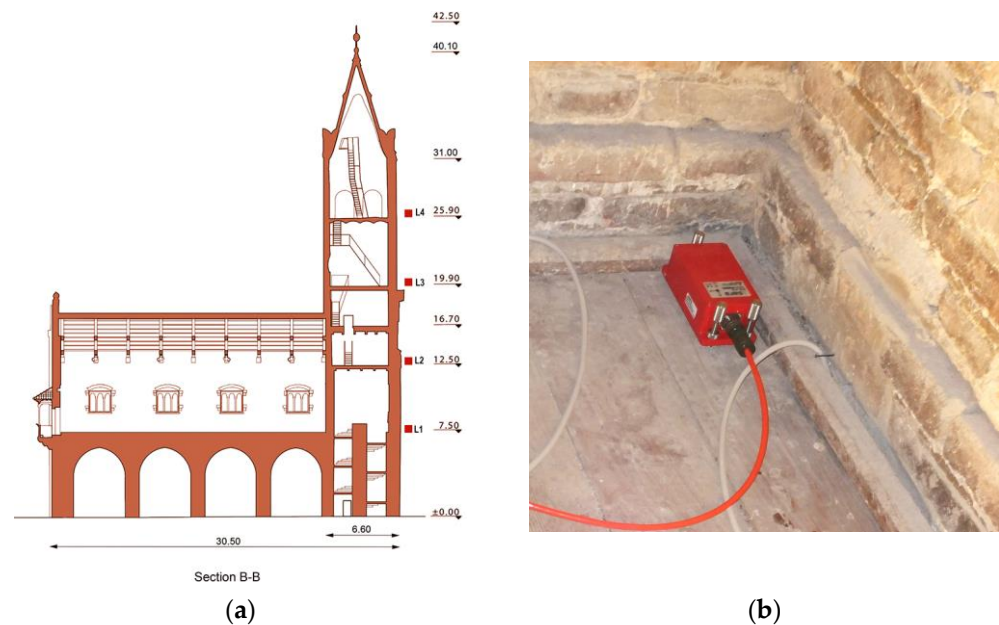
The vibration tests were carried out on 21 October 2021 with eight seismometers (electro-dynamic velocity transducers, SARA SS45), placed on four different levels (Figure 13), in order to better estimate the mode shapes of the tower [17].

Figure 13. Instrumented cross-sections (a) and sensors (b) used during the tests.

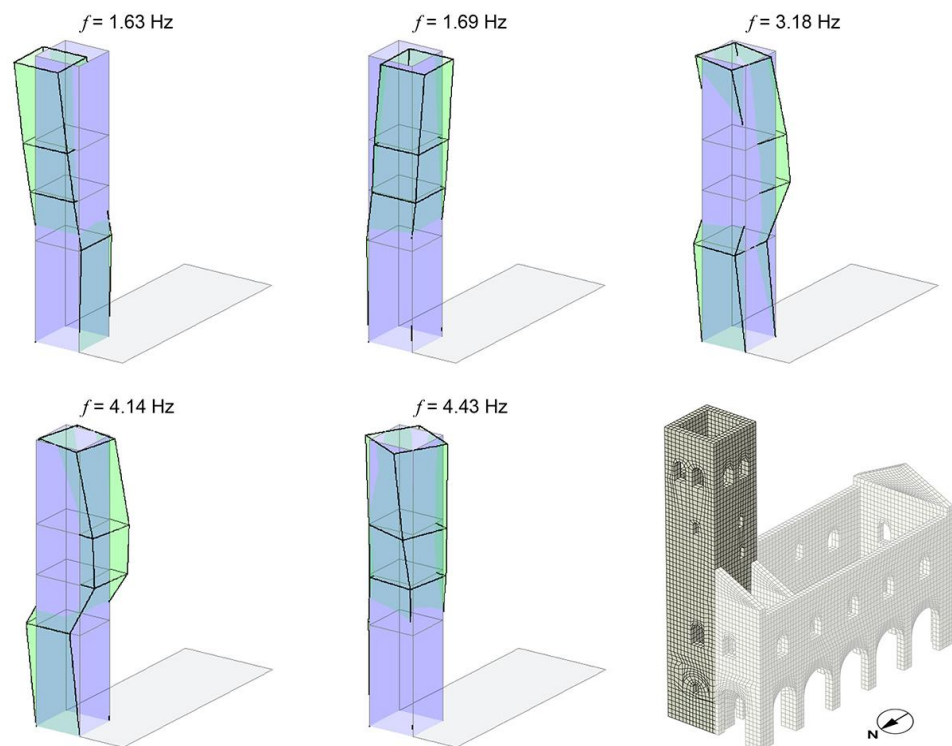
The data processing allowed us to identify five modes in the frequency range of 0–5 Hz. The mode shapes of the tower, shown in Figure 14 (under the assumption of rigid floors), include:

- Two modes involving dominant bending in the N-E/S-W plane (1.63 and 1.69 Hz), along the diagonal of the building. The presence of the hall and of the side walls in the north and east fronts can affect the behavior;
- Two modes involving dominant bending (3.18 Hz and 4.14 Hz) in the E/W plane (without a diagonal contribution);
- One torsion mode (4.43 Hz).

Figure 14. Identified vibration modes. (Modes at 1.63 and 1.69 Hz involve bending in the N-E/S-W plane along the diagonal of the Tower; modes at 3.18 Hz and 4.14 Hz are dominant bending in the E/W plane; torsion mode at 4.43 Hz).
