ANIDIS 2007

On site and laboratory investigation to assess material and structural damage on some churches hit by an earthquake

Anna Anzani, Luigia Binda, Lorenzo Cantini, Giuliana Cardani, Antonella Saisi, Cristina Tedeschi
Dipartimento di Ingegneria Strutturale, Politecnico di Milano, P.za Leonardo da Vinci, 32 – 20133 Milano, Italia

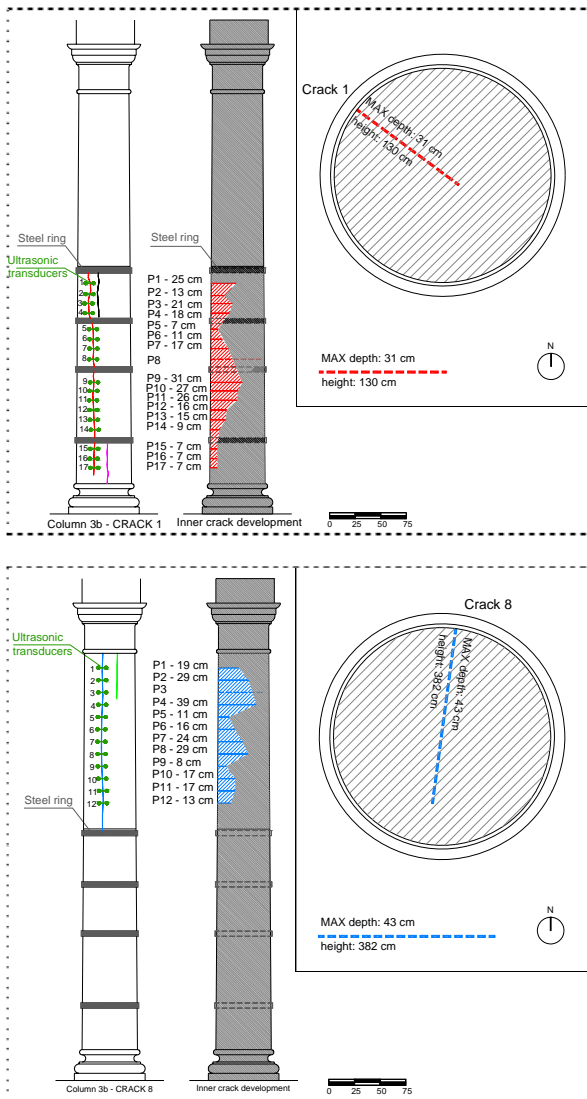
According to the low budget allocated by the single churches, only a few flat-jack and sonic tests were carried out after a very accurate choice of the test positions and some ultrasonic tests for detecting the columns integrity (Figure 14). Systematically, the testing points were chosen in the most representative parts of the bearing walls: taking into account that the façade is usually made of better masonry, the lateral bearing walls were chosen.

Figure 14. Ultrasonic tests to characterize the inner crack development into a column.

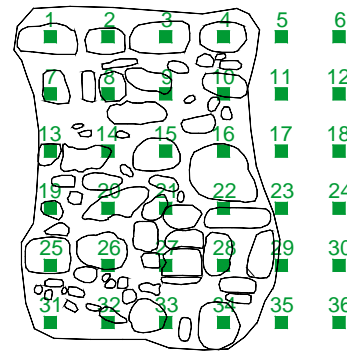
The calculated values of the modulus of elasticity allows to recognize three intervals corresponding to different categories of buildings: 1) from 189 to 803 N/mm² corresponding to a very weak masonry with internal voids and no connection between the masonry leaves, 2) from 1063 to 1732 N/mm², corresponding to a better masonry but with poor connections between the leaves, 3) from 2860 to 5260 N/mm² a definitely compact masonry well connected transversally. Figures 16 - 23 show some typical diagrams obtained with the double flat-jack tests compared with the results of sonic tests where the previous categories can be recognised. In particular, Figure 17 shows a bilinear response with low stiffness, according to a distribution of sonic velocities around very low values (Figure 16). The results have been obtained on the Rectory, which was built with a lower quality masonry than the church, described below. As appears from Figure 15, the masonry is

constituted by roundish stones, many of which of small dimensions, with big amounts of mortar.

Figure 15. S. Antonio in Morgnaga, rectory: redraw of the masonry in the testing area.

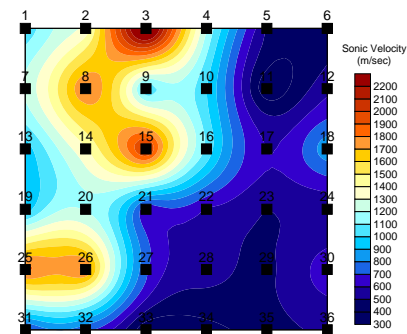
Figure 16. S. Antonio in Morgnaga, rectory:sonic tests.

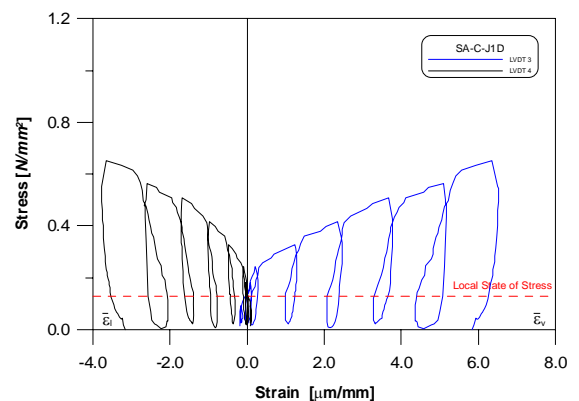
Figure 17. S. Antonio in Morgnaga, rectory: results of flat jack tests.

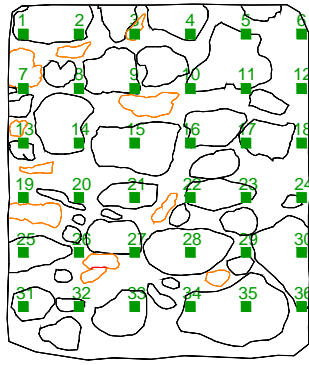
Figure 20 obtained on the church is typical of medium stiffness masonry, confirmed by an intermediate distribution of sonic values (Figure 19). The masonry aspect, as appears from Figure 18, is characterized by the presence of stones of bigger and more uniform dimensions, though the mortar joints are still rather thick and not precisely horizontal.

Figure 18. S. Antonio in Morgnaga, church: redraw of the masonry in the testing area.

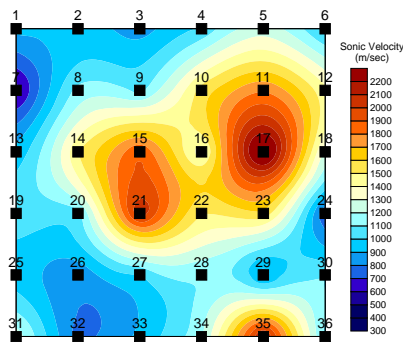
Figure 19. S. Antonio in Morgnaga, church: results of sonic tests.

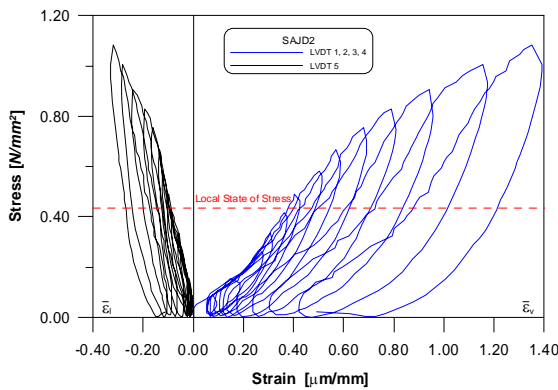
Figure 20. S. Antonio in Morgnaga, church: results of flat jack tests.

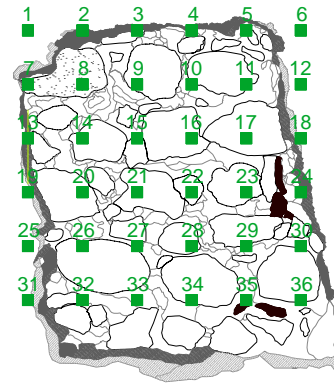
Figure 23 obtained on an other church shows higher stiffness of the masonry, also very high values of sonic velocity (Figure 22) and a masonry aspect (Figure 21) characterized by the presence of big stones, with voids filled with stone pebbles and thinner mortar joints. Figure 24 shows the relationship between the sonic velocity and the modulus of elas-

Figure 21. S. Michele in Sabbio Chiese, church: redraw of the masonry in the testing area.

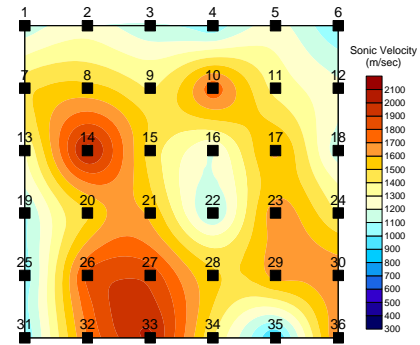
Figure 22. S. Michele in Sabbio Chiese, church: results of sonic tests.

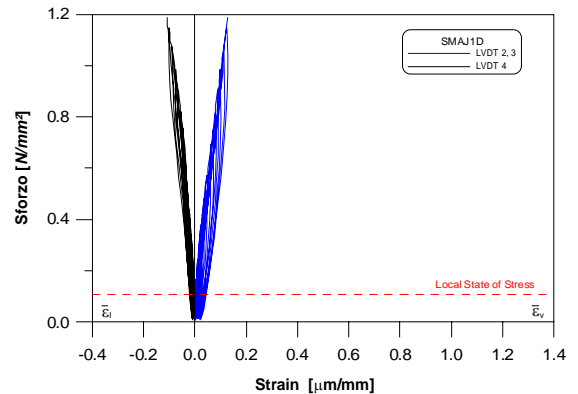
Figure 23. S. Michele in Sabbio Chiese, church: results of flat jack tests.

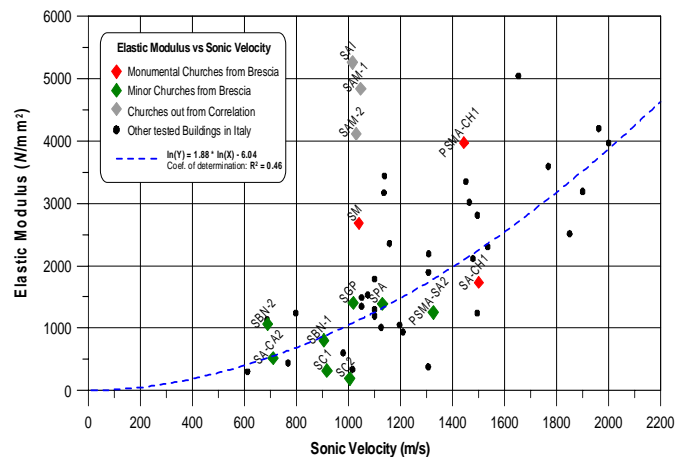
ticity measured by double flat jack tests, compared to other values previously obtained from tests on different stone-masonry walls in historic centers.

Despite some scatter in the results, obviously due to the non-homogeneity of the masonry studied, nevertheless an interesting direct relationship can be observed.

Figure 24. E vs. sonic velocity.

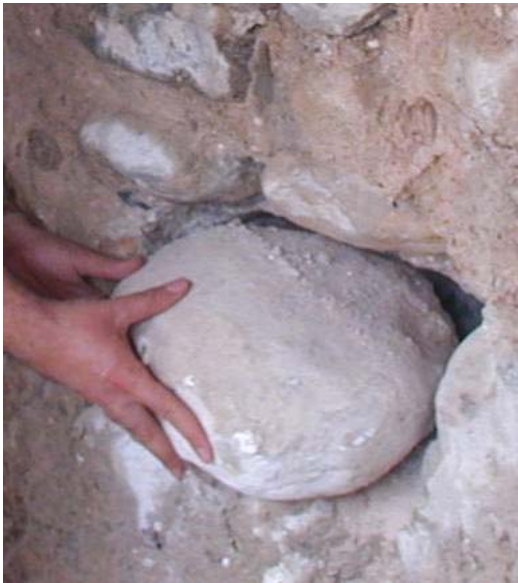
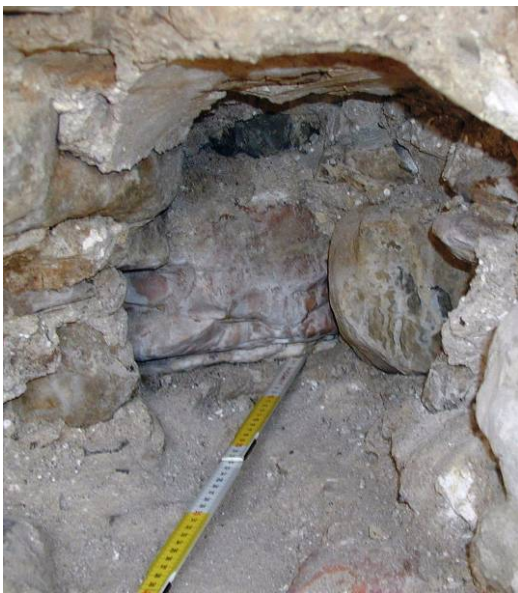
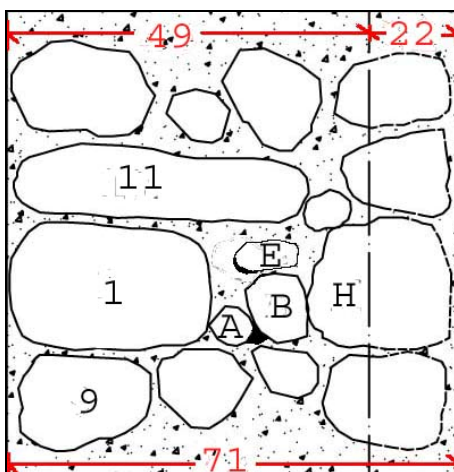
It was carried out by drilling and taking off some stones in order to visually investigate the wall texture, sketch the inner aspect of the wall (Figure 25), and sample stones and mortars for laboratory testing.

Figure 25. Study of the masonry morphology.

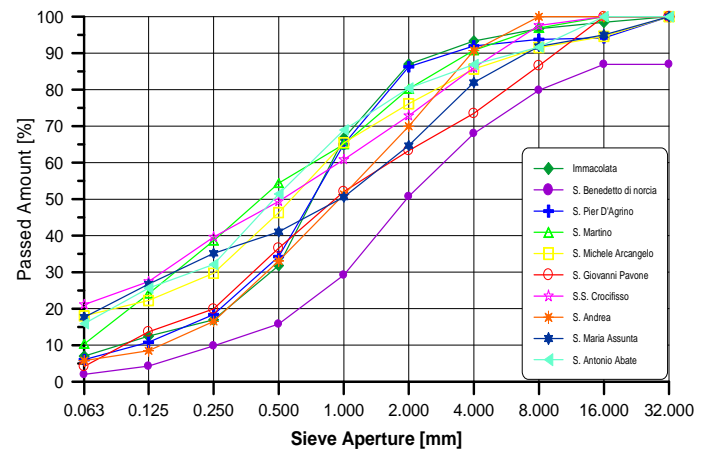
The mortars were submitted to chemical and physical analyses. The binder was separated from the aggregate by thermal attack and the grain size distribution was calculated as shown in Figure 26. Since the aggregate was mainly calcareous, it was

Figure 26. Grain size distribution of the tested mortar.

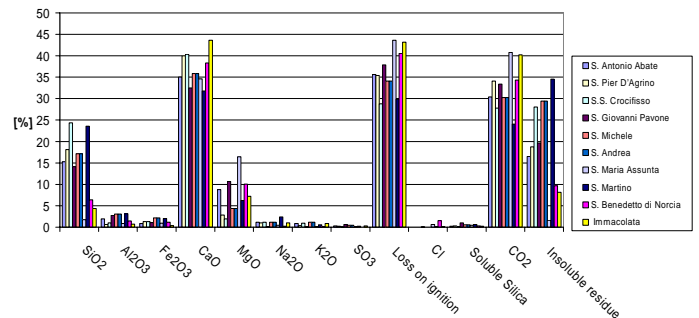
not possible to determine the binder/aggregate ratio chemically. Figure 27 shows the results of the chemical analyses: most of the mortars were similar, with the binder being hydrated lime.

Figure 27. Results of chemical analysis on mortars.
