Evaluation of Fukushima Daiichi Unit 1 Ex-Vessel Phenomenon Leveraging on Primary Containment Vessel Robotic Inspections

Michal Cibula, Marco Pellegrini, Masato Mizokami & Shinya Mizokami

^a*Tokyo Electric Power Company Holdings, Inc., Tokyo, Japan*

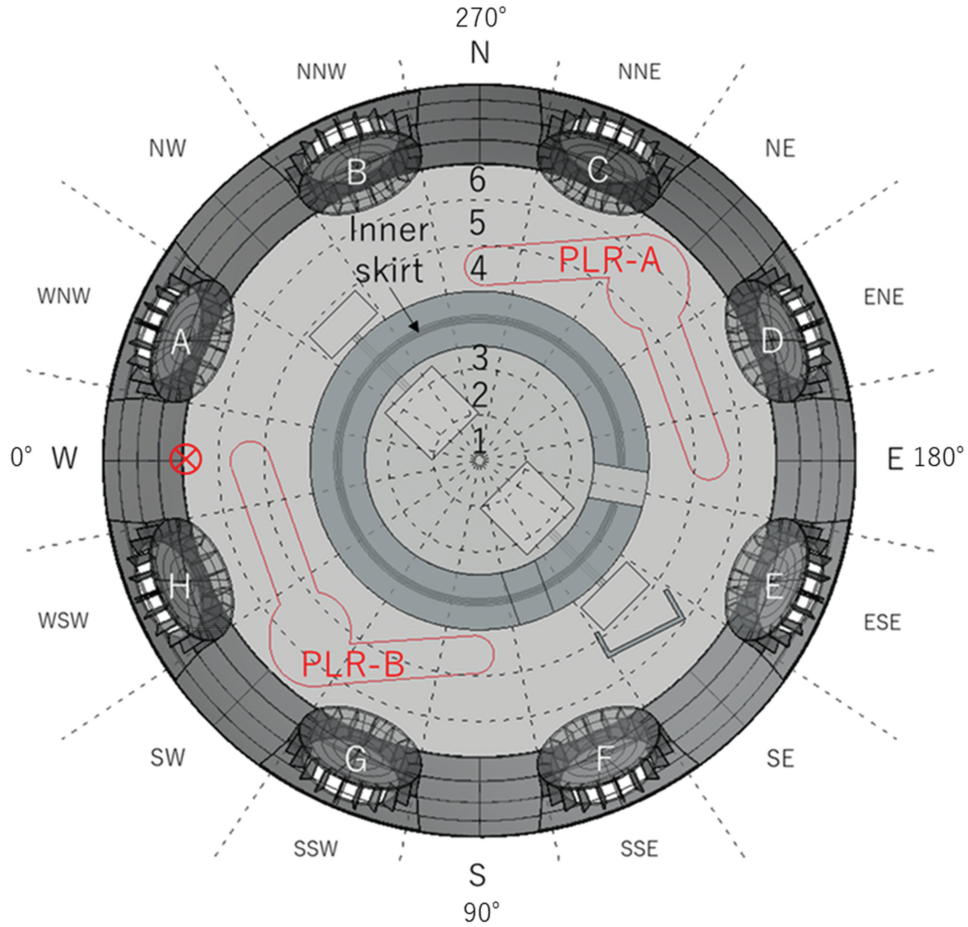
Fig. 2. Plane view of the D/W floor; cardinal directions and radial sections 1 through 6 used to indicate areas captured in the following figures; pedestal wall between sections 3 and 4; D/W floor pedestal opening in E-ESE direction; upper floor CRD exchange opening in SSE section. Red-colored lines denote outline of the PLR piping; rectangles in and outside of the pedestal area denote sump pits; white letters A through H denote jet deflectors; gray structure at SE-5 indicates shielding block; red circled X mark denotes ROV insertion point.

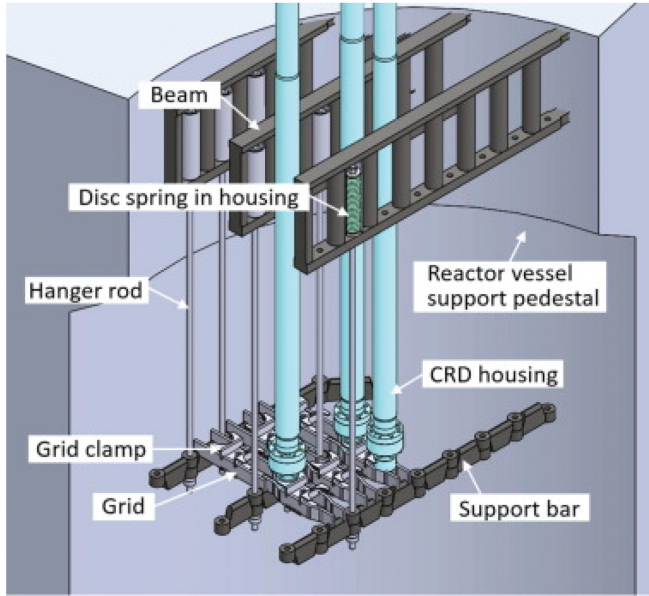
dripping of the cooling water from the damaged lower head (LH) of the RPV were observed both in the central area and in the peripheral areas of the pedestal. Multiple cylindrically shaped objects were found leaning on the wall, particularly the N-3 and W-3 sections, which were identified as CRD and in-core monitor (ICM) housings detached from the RPV LH (Figs. 3, 4, and 5). In some cases, the flanges were in the upper position, meaning they turned upside down during their relocation (Fig. 6). Although the CRD housing support bars and hanger rods are displaced and/or deformed to a big extent, some of the displaced housings remain supported by them in a suspended position above the water level (or partially above the water level). The total number of confirmed relocated housings, including those suspended above water level, was more than 10. The schematic diagram of the CRD housings, their support structures, and pedestal wall can be seen in Fig. 7.

Fig. 7. Schematic diagram of CRD housings, support structures, pedestal wall, etc.^[21]
