# **PROCEEDINGS OF THE FIRST INTERNATIONAL CONFERENCE ON RESTORATION OF HERITAGE MASONRY STRUCTURES**

## **On Site and Laboratory Investigation on Some Churches Hit by a Recent Earthquake, in order to Assess the Damages to Materials and Structures**

Binda L.<sup>1</sup>, Anzani A.<sup>2</sup>, Cantini L.<sup>3</sup>, Cardani G.<sup>4</sup>, Tedeschi C.<sup>4</sup>, Saisi A.<sup>4</sup>

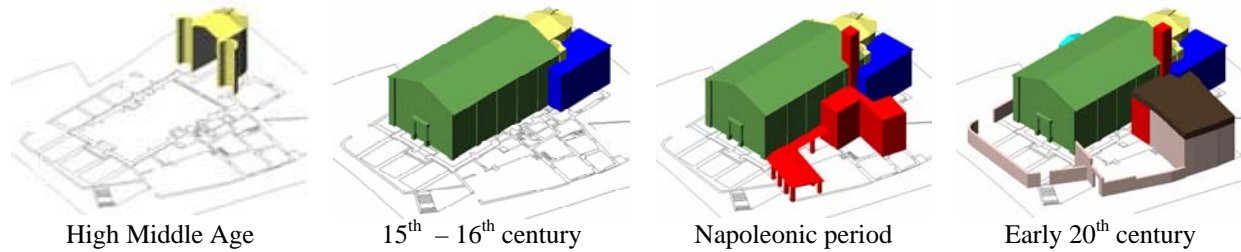
As a first step to provide a design for repair and preservation of the damaged churches a preliminary in-situ survey was considered useful to obtain details on the geometry of the structure, identifying irregularities (vertical deviations, rotations, etc.) and to single out the parts where more accurate investigations was needed. The building may have been subjected to the addition of several volumes in different times, and the possible discontinuities between the different volumes could affect the overall seismic behaviour. Therefore, for a reliable interpretation of the signs of damage, the geometrical survey is not enough but also the historical evolution of the structure in its complexity has to be investigated (Figure 1).

**Figure 1 - Construction phases of the church of S. Michele Arcangelo at Sabbio Chiese.**

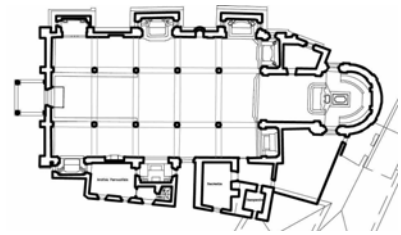
**Figure 2c– S. Pier d’Agrino at Bogliaco di Gargnano: three naves and chapels.**

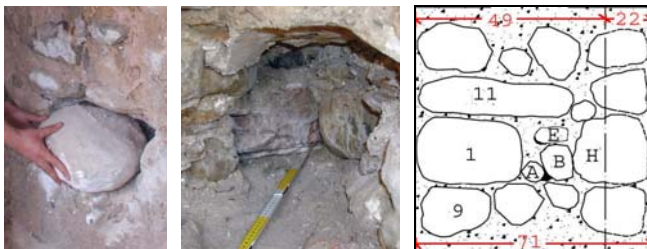
Dynamic tests on tie rods were also carried out in order to detect the level of tension. A complete characterization of the wall was achieved by measuring the sonic velocity, the state of stress, the modulus of elasticity, the coefficient of lateral expansion, the mortar and stones chemical, physical and mechanical properties and by surveying the morphology of the wall cross section, understanding whether the masonry was made of one or two leaf and the leaves were connected in some way <sup>10, 11, 12</sup>. This survey was carried out by drilling and taking off several stones in order to visually investigate the wall texture, sketch the inner aspect of the wall (Figure 14), and sample stones and mortars for laboratory testing.

**Figure 14 – Study of the masonry morphology**

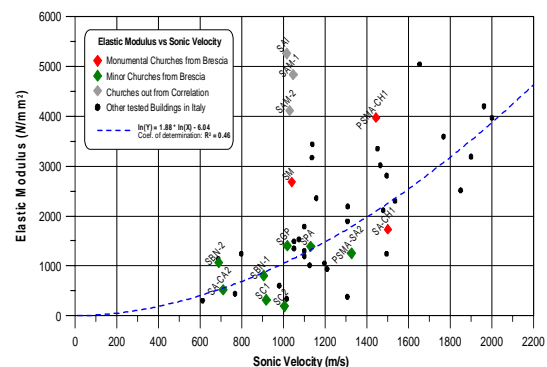
**Figure 15 - E vs. sonic velocity**

Figure 15 shows the relationship between the sonic velocity and the modulus of elasticity, compared to other values previously obtained from tests on different stone-masonry walls in historic centers.

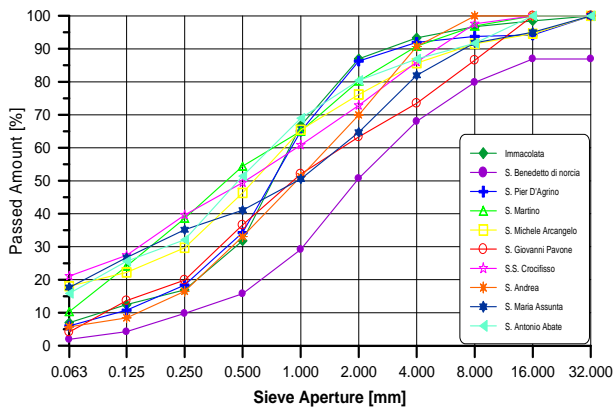
The sampled stones and mortars were tested in laboratory. The mortars were submitted to chemical and physical analyses. The binder was separated from the aggregate by thermal attack and the grain size distribution was calculated as shown in Figure 19. Since the aggregate was mainly calcareous, it was not possible to determine the ratio binder/aggregate ratio chemically. Figure 20 shows the results of the chemical analyses: most of the mortars were similar, with the binder being hydrated lime.

**Figure 19 – Grain size distribution of the tested mortar**

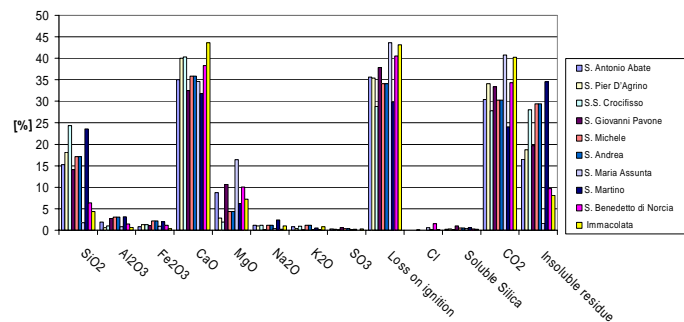
**Figure 20 – Results of chemical analysis on mortars**
