# Corrosion assessment of reinforced concrete elements of Torre Velasca in Milan

Federica Lollini\*, Elena Redaelli, Luca Bertolini

Politecnico di Milano, Department of Chemistry, Materials and Chemical Engineering "Giulio Natta", piazza Leonardo da Vinci 32, 20133 Milan, Italy

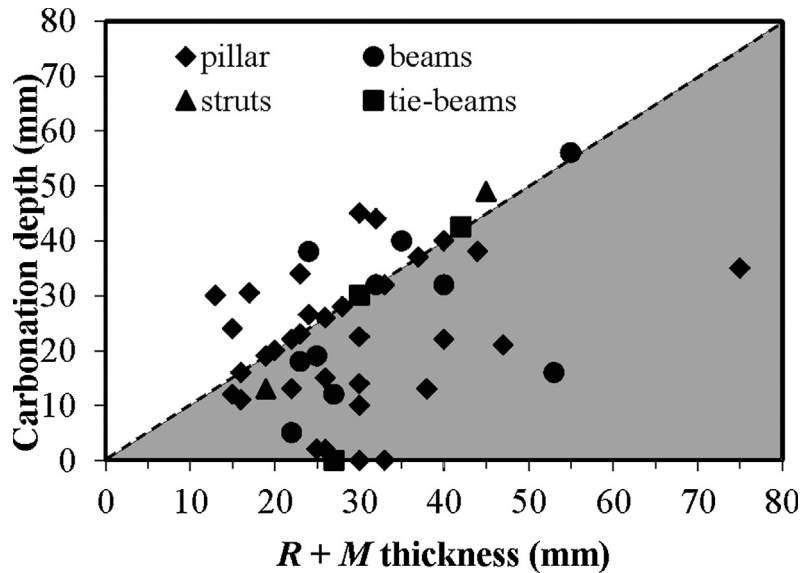
In order to investigate on the role of render and mortar layers on the penetration of carbonation, Fig. 5 shows the total carbonation depth as a function of the thickness of *R* + *M* layers: the grey area groups specimens with a carbonation depth that is lower than *R* + *M* thickness (i.e. concrete was alkaline), while the white area groups specimens where even concrete was carbonated to some extent. It can be clearly observed that in most specimens the carbonation front lays within *R* or *M* layers and, hence, the underlying concrete was barely carbonated. At the time of inspection, i.e. after about 50 years of exposure, even in the specimens with a *R* + *M* thickness of only 13 mm, the carbonation depth of concrete was lower than

Fig. 5. Relationship between  $R+M$  thickness and total carbonation depth.

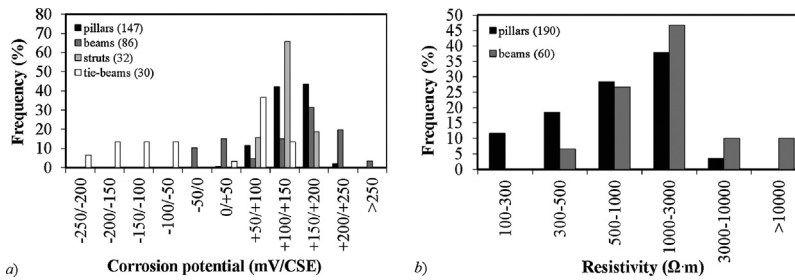
Potential values higher than 0 mV/CSE were measured on the rebars at floors below 15th and on some of the struts (Fig. 6a). The electrical resistivity, carried out on the external surfaces, without removing the render, was between 100 and 3000  $\Omega \times m$ , with predominant values higher than 1000  $\Omega \times m$  (Fig. 6b). On the tie-beams the steel potential was measured on the surfaces more exposed to the rain and values between  $-200$  and  $+150$  mV/CSE were measured (Fig. 6a). The rather high values of electrical resistivity and corrosion potential, revealing that the elements below the 18th floor were relatively dry, even during rainy weather, suggested that the layers of render and mortar acted as a “barrier” and contributed to keep the humidity low in the inner concrete.

Fig. 6. Frequency distribution of steel potential of the reinforcement (a) and electrical resistivity (b) (number of data in brackets).
