The Architectural Heritage in Seismic Area: Geometrical Survey for Damage Analysis and Strengthening Design

Giuliana Cardani¹(✉) and Paola Belluco²

¹ Department of Civil and Environmental Engineering, Politecnico di Milano,
Milan, Italy

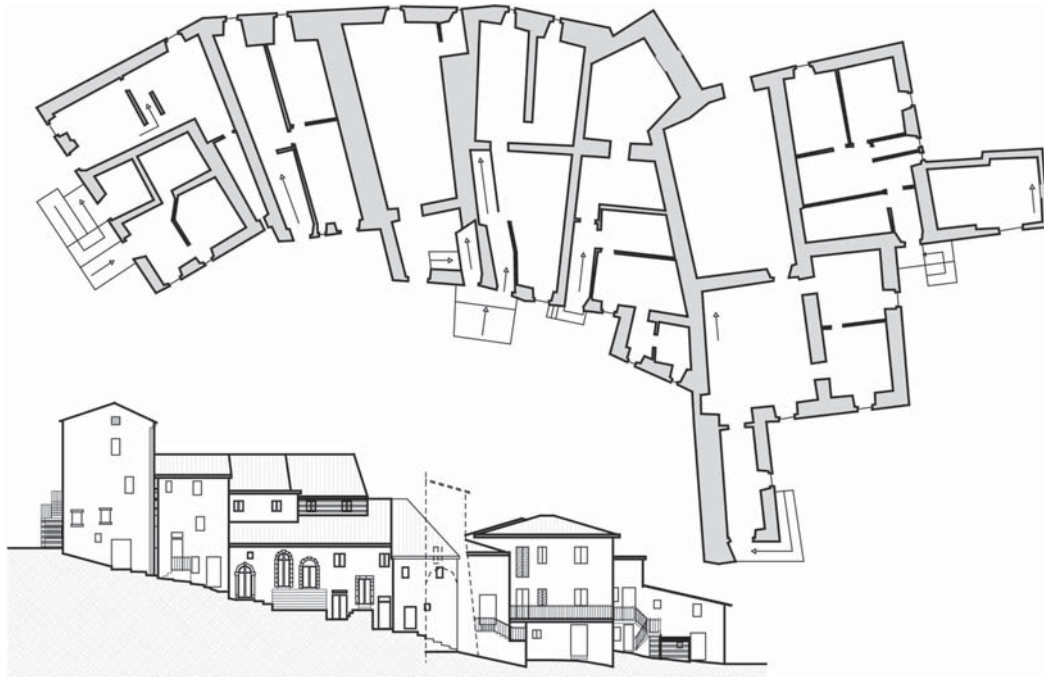
Fig. 1. Example of the map of an historic complex civil building [2, 3].

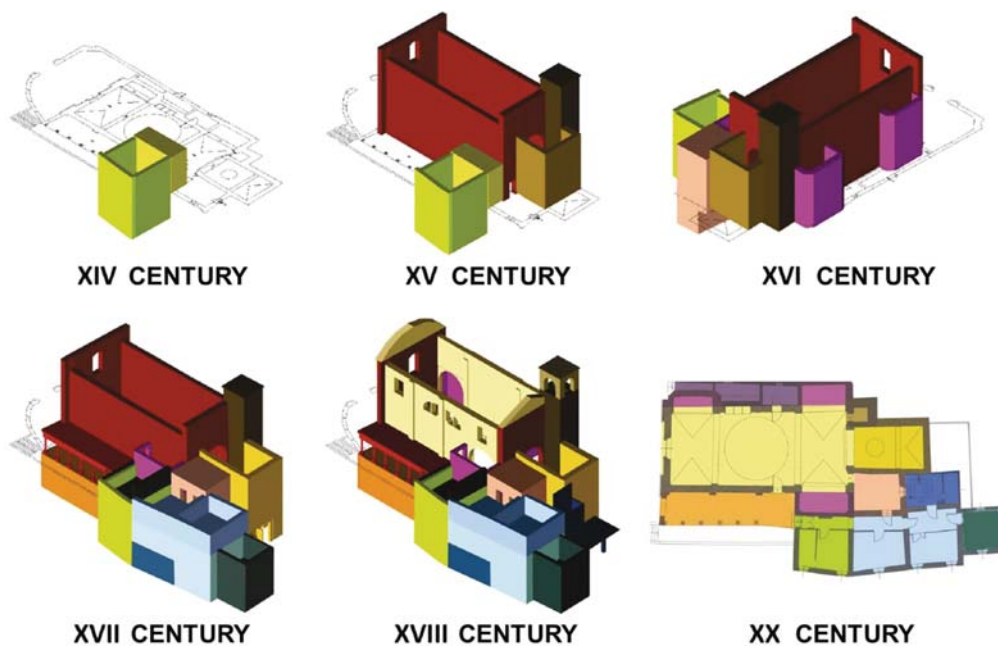
Fig. 2. Volumetric stratigraphic analysis made on volumes for the chronological evolution phases of a complex religious building [4].
