THE 2012 EARTHQUAKE: AN ABACUS OF SURVEYS AND INTERVENTIONS IN MANTUA CHURCHES

L. Fregonese ^a, A. Campera ^b, B. Scala ^a, A. Adami ^a

^a Politecnico di Milano, Mantua Campus

^b Diocese of Mantua, Cultural ecclesiastic heritage office

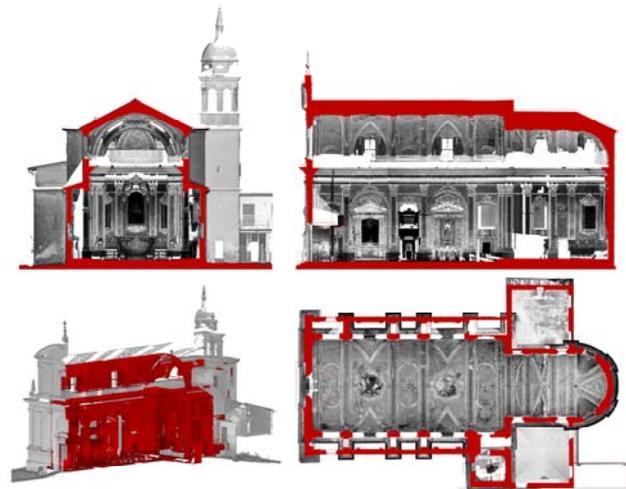
Figure 2: Church of Surcinesco: view of the pointcloud (interior in red, exterior in grey) and the outcomes of the survey. The photographic content is given by an orthophoto extracted from the point cloud.
