Assessment of Post-Earthquake Damage: St. Salvatore Church in Acquapagana, Central Italy

Abstract: This article proposes a multidisciplinary approach for the assessment of seismic damage from the perspective of conservation and prevention. A comparison of the state of damage has been carried out in a case study, St. Salvatore church in Acquapagana (MC), as an example of church, which underwent two important seismic events in the Central Italy area, the 1997 and the 2016 earthquakes. The comparison of the state of damage passes through the following stages: (a) the territorial seismic overview; (b) the historical description and material analysis; (c) the identification of macro-elements with activated damage mechanisms; (d) the comparison between the two seismic events both from a territorial- and building-scale perspective. This work puts together the archived and the on-site survey data with those elaborated starting from seismogenic information, available from the National Seismological Institute, and it provides a strategy also for other similar conditions. This work is to be considered a contribution to a wider study that could be carried out in the areas hit by the 2016 eart

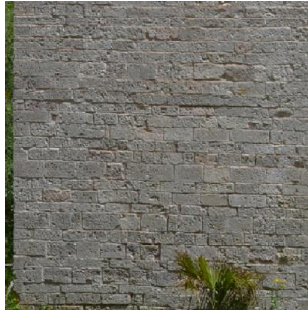
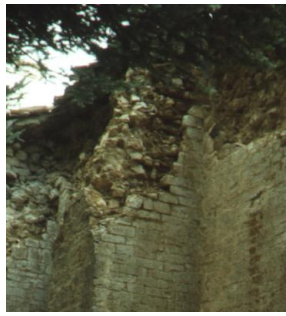
Table 2. Wall quality index evaluation. Source of the axonometry and section images: [49].

Regarding St. Salvatore church, stone elements do not exhibit degradation phenomena, have a regular and squared shape and well-defined edges (Figure 8a). This is clearly visible in lateral walls and in the principal façade, while the state of conservation and the pattern of the material are hidden by the plaster in the east front and in the annexed body in the north side of the church. Prevalent dimensions are a 30–50-cm length, a 10–25-cm height and a 10–20-cm thickness, but many elements are also present with a major dimension of 70 cm. The wall section, analyzed with the image of the 1997 earthquake damage, shows the presence of a rubble masonry: three leaves, two external layers with a filling material, linked with some cross blocks (Figure 8b). Mortar joints are in good condition and well preserved: large stone elements and thin layers of mortar are well proportioned. Horizontal rows (Figure 8c) characterize all the length of the wall without interruption, while the splitting of vertical joints is only partially respected (Figure 8d), because some joints are not in an intermediate position with respect to the stone element. Analyzing the corners, it is possible to observe the presence of cross blocks, which help to assume a good connection between lateral walls and the façade. The global evaluation of the masonry is summarized in Table 2: a section is dedicated to show the photographic details of the masonry, another to show the schemes, one more to show the descriptions of the techniques of construction and materials and one to show the geometrical stone characteristics; finally, the last section is dedicated to the correspondence of the seven factors with a final evaluation of the quality of the masonry, resulting in being of good quality.

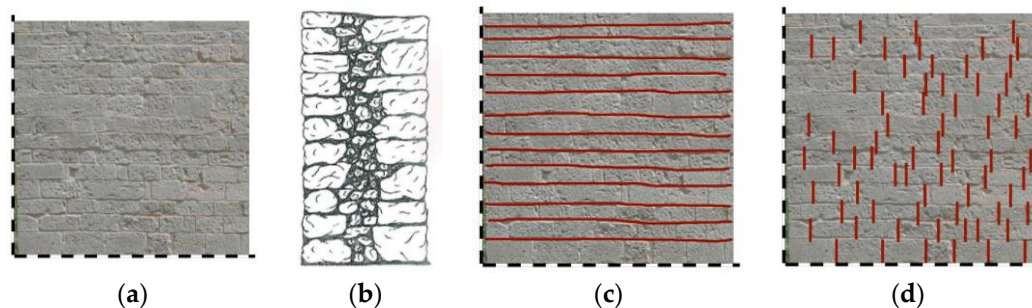
Figure 8. (a) Quality of mortar, form of resistant elements, dimensions of elements, quality of resistant elements; (b) presence of cross blocks [49]; (c) splitting of vertical joints; (d) presence of horizontal rows.
