DAMAGE EVOLUTION IN CHURCHES DUE TO REPEATED EARTHQUAKE SHOCKS

Maria A. PARISI¹, Claudio CHESI², Gessica SFERRAZZA PAPA³

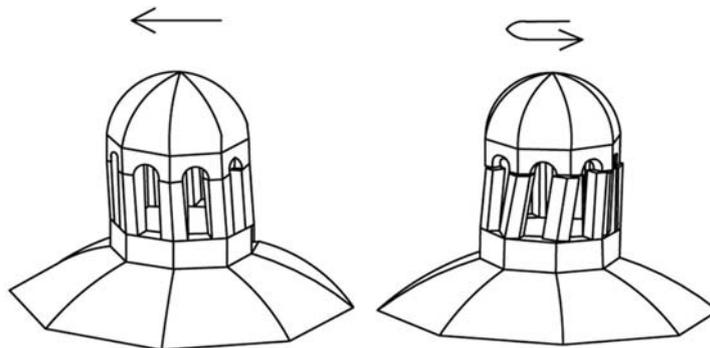
Figure 14. Lateral and torsional response and damage of the lanterns.

Lanterns were present in numerous churches in the area and often showed damage or incipient damage from torsion, as expected according to the relevant reference mechanism, in fig. 14.
