DAMAGE SURVEY OF A HISTORIC TOWN AND COMPARISON WITH PAST EVENTS AFTER THE 2016 CENTRAL ITALY EARTHQUAKE

Luca SBROGIO¹, Giuliana CARDANI², Maria Rosa VALLUZZI³

The paper presents a systematic damage survey supported by a GIS system and a specific form, both aimed at defining, if possible, a relation between the damage on each intervention and the damage of a building as a whole.

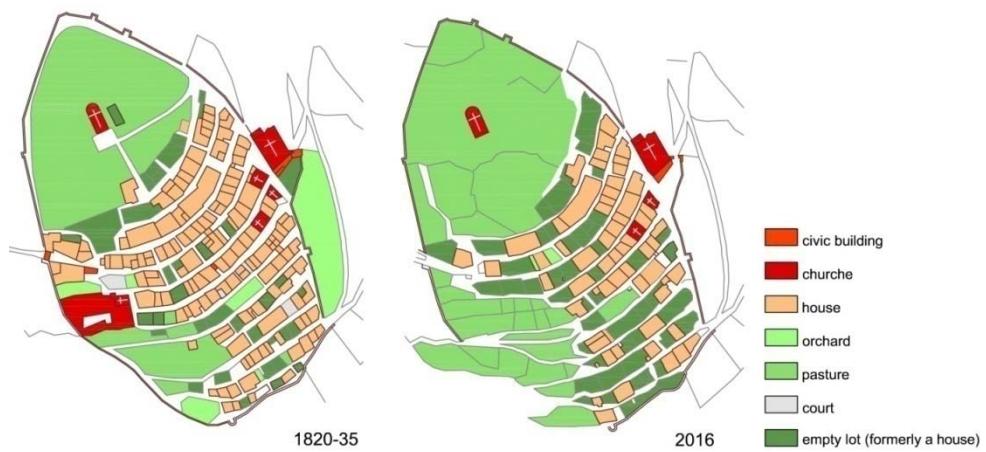
Figure 8. Town plan: comparison between early XIX cent. (1835) and current conditions.
Three important earthquakes (1859, 1979, 1997) occurred in between.

A synthetic view of Campi nowadays is shown in Figure 7. The village has suffered most damages in its public buildings (3 out of 4 churches still existing inside walls perimeter collapsed, the tower heavily damaged, the only surviving gate collapsed under the ruins of S. Andrea) and in the road system. Most of the damaged buildings are located in the lower and Western part of the town, a trend which is

confirmed by the comparison between 1835 and 2016 (previous to the earthquake) plans: the number of empty lots progressively increases as ruined houses are not rebuilt anymore (Figure 8).

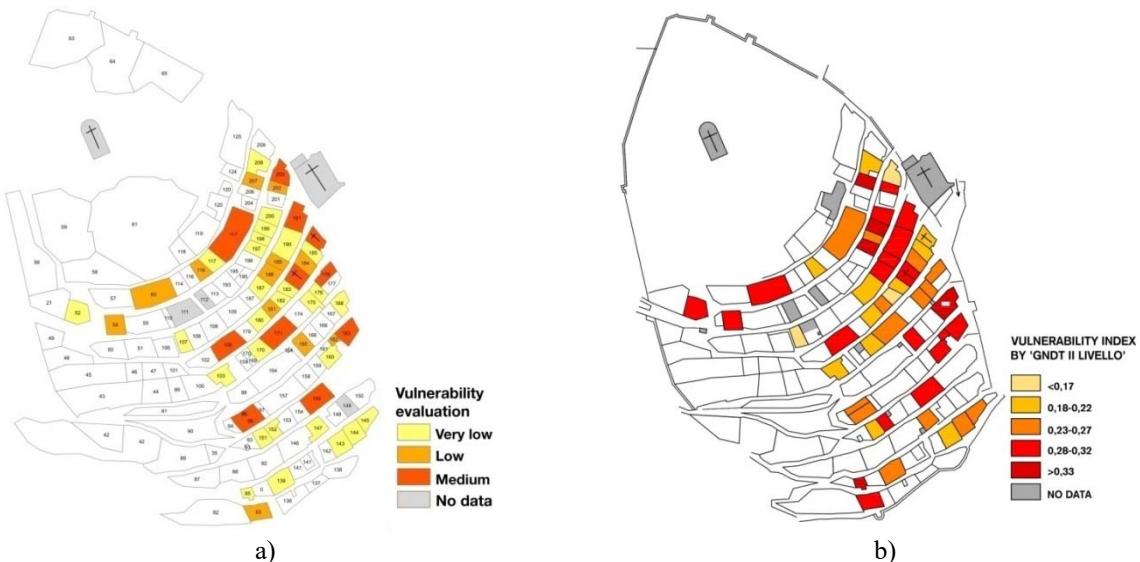
Figure 12. Vulnerability distribution: a) according to Vulnus VB procedure for $a/g=0,191$ (Munari 2010); b) according to GNDT vulnerability form

The comparison between on-site damage (Figure 11) and predictions (Figure 12) shows quite a number of differences. Vulnus and GNDT form both identify as highly vulnerable buildings which actually show slight or even no damage at all, such as those near S. Andrea church (Figure 7), except for the church inside the row which is collapsed (but which was evaluated as averagely vulnerable). In other situations, they may agree but sometimes not: the two isolated houses on the upper left part, which are totally ruined, are identified as almost not vulnerable by Vulnus and highly vulnerable by GNDT form (a glimpse of one of them is in Figure 5a).
