Influence of degradation at the base of a support post in a collapse of an old guardrail: A forensic analysis

Luca Sgambi*

Department of Civil and Environmental Engineering, Politecnico di Milano, Milan, Italy

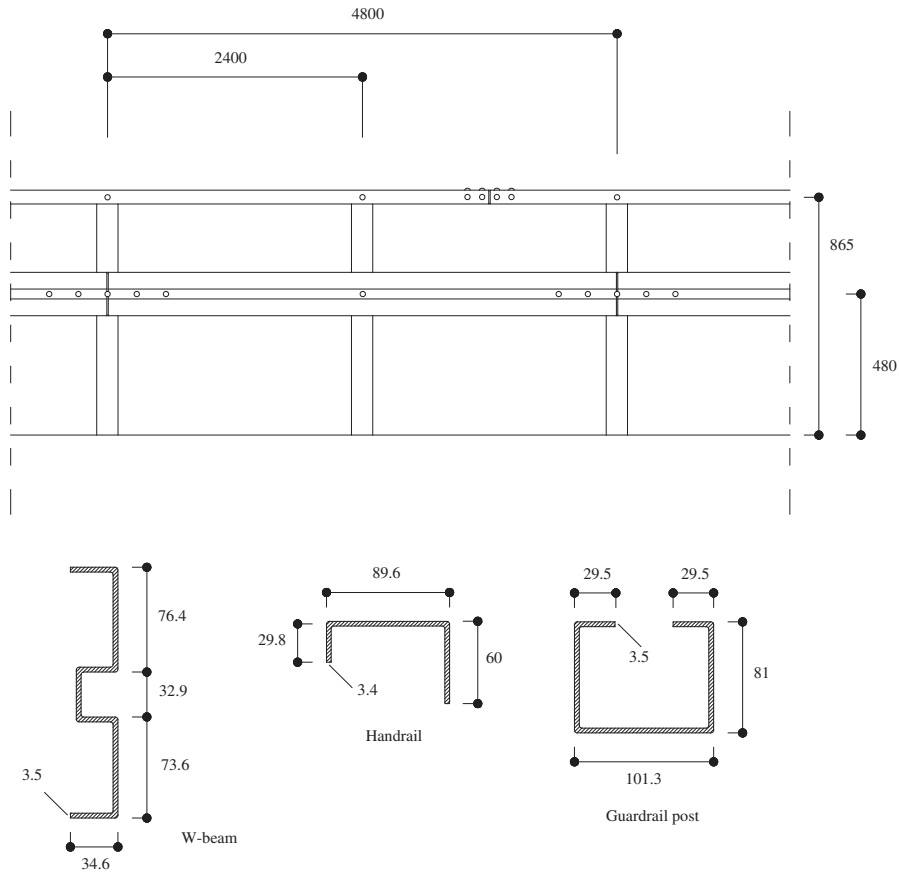
The guardrail subject of this work belongs to those designed with the criterion of strength and in Fig. 2 its geometry is reported. The guardrail is formed by a W-beam about 20 cm high and by a secondary beam, 6 cm high, having the function of handrail. The two beams are supported by a series of support posts having a C-section and positioned every 2.4 m. The

Fig. 2. Geometric dimensions of the elements of the guardrail (mm).

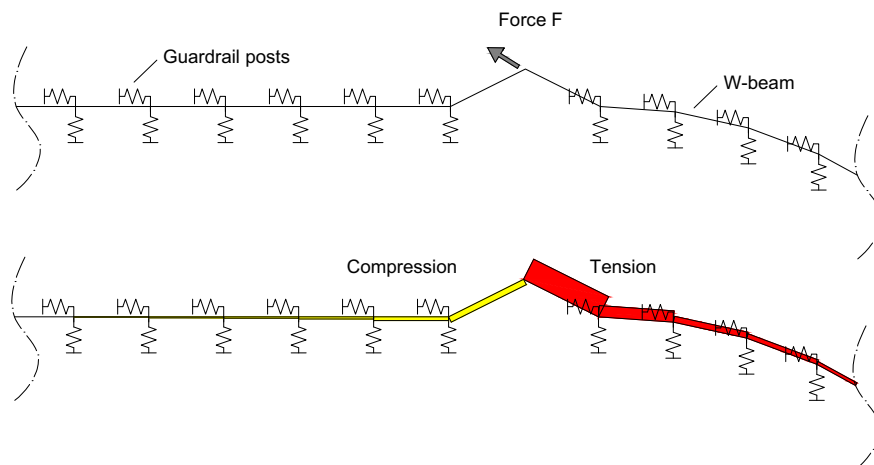
in which F is a force applied to a mass body M for a time ΔT and ΔV which represents the variation of speed over time. In the case analysed, force F is represented by the force of the impact, that is the force that the barrier transmits to the impacting vehicle. Such force cannot be greater than the value that causes the guardrail collapse. Based on the geometric configuration of collapse that can be inferred in Fig. 7 it is possible to determine, through a simple numerical static field, the relationship existing between the force of impact F and the axial action of joint D that causes breakage of the joint (Fig. 9).

Fig. 9 shows the numerical model used in which the W-beam is modelled with beam finite elements and the stiffness of the guardrail posts are modelled with equivalent elastic springs. At the point of application of the force, springs have not been inserted because the guardrail post C is considered broken. The numerical model indicates that if the impacting force has a value equal to 1, the axial action in the joint D is 0.79.

Fig. 9. Numerical model and axial stresses in the guardrail.

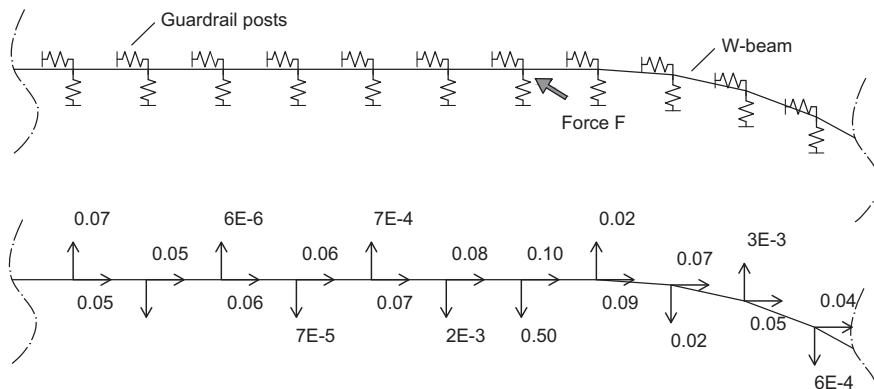
To evaluate the speed of the vehicle before the collapse of the guardrail post C, it is necessary to use a second numerical model. In this case the guardrail is assumed to be not deformed (Fig. 10) and the guardrail post C is modelled using elastic springs similar to the other support posts. In order to model a serious state of corrosion at the base of the guardrail post, the design thickness (3.5 mm) is evenly reduced to 1 mm. If the impacting force has a value of 1, the numerical model provides, on the guardrail post C, a force equal to 0.1 in a longitudinal direction and 0.5 in a transversal direction.

Fig. 10. Numerical model of the guardrail before the impact and assessment of the forces on the guardrail post C.

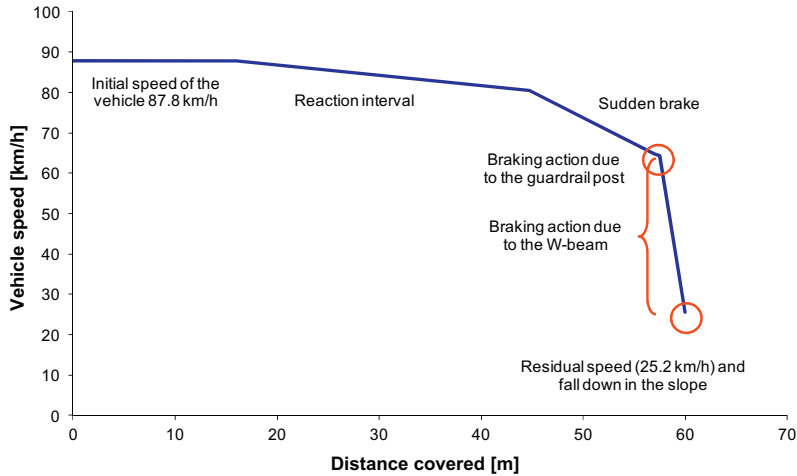
Fig. 11. Diagram of the speed variation of the vehicle from the moment of entering into the bend until collapse of the guardrail (thickness of the deteriorated support pole C).

Fig. 11 shows the values of speed evaluated in these sections. As can be seen from the diagram, the vehicle is subject to two significant decreases of speed: the first one during the abrupt braking and the second due to the resistant mechanism of the W-beam. In terms of reduction of speed the contribution guardrail post C is negligible.
