Post-earthquake diagnostic investigation of a historic masonry tower

Antonella Saisi ^{a,b}, Carmelo Gentile ^{a,b,*}

^a Politecnico di Milano, Milan, Italy

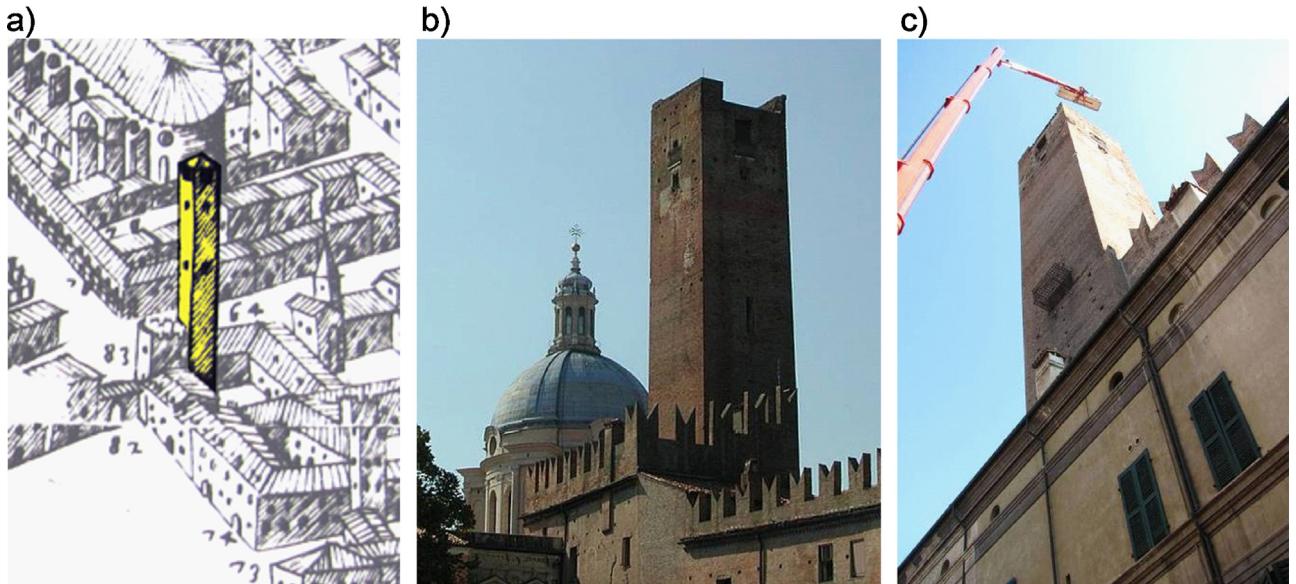
The paper presents the main results of a recent post-earthquake assessment of a masonry tower. The investigated tower (Fig. 1), about 54.0 m high and dating back to the XII century, is known as Gabbia Tower [18,19] and is the tallest tower in Mantua, Italy. The tower is a symbol of the Cultural Heritage in Mantua so that the fall of small masonry pieces from its upper part, reported during the

Fig. 1. The Gabbia Tower in Mantua, Italy. a: view of the XVII century [15]; b: recent view; c: view during the inspection (31/07/2012).

earthquake of 29/05/2012, provided strong motivations for deeply investigating the state of preservation and the seismic vulnerability of the building. Hence, an extensive research program was planned and performed to evaluate the structural condition of the tower.

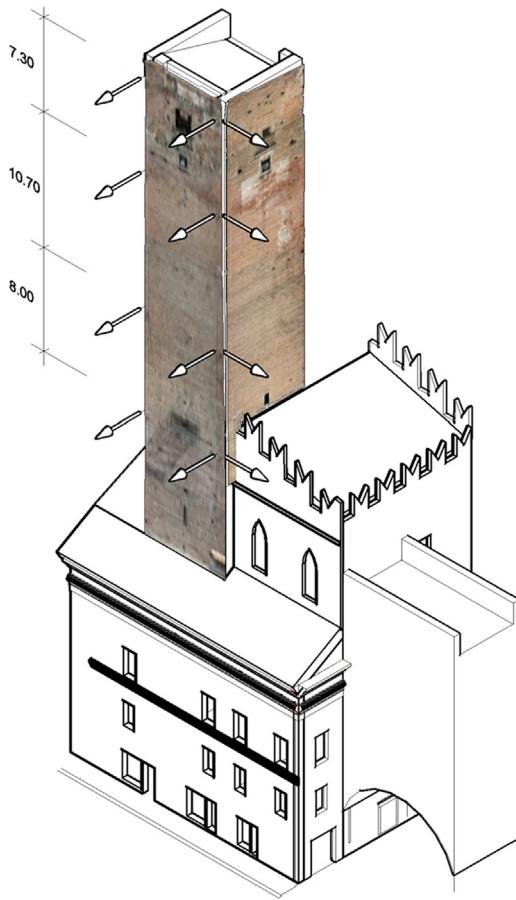
The response of the tower was simultaneously measured in 12 selected points, belonging to 4 different cross-sections along the height of the building, according to the single set-up shown in Fig. 7. It should be noticed that the positioning of the accelerometers at the upper levels was aimed at checking if the change of masonry texture detected in visual inspection (and the thickness decrease of load-bearing walls, Fig. 2) affects the dynamic characteristics of the tower. Hence, the upper instrumented sections (Fig. 7) were at the crowning (about 2.0 m from the top and 52.0 m from the ground level) and just below the change of masonry texture (about 9.3 m from the top).

Fig. 7. Sensor layout adopted in ambient vibration testing of the tower (dimensions in m).

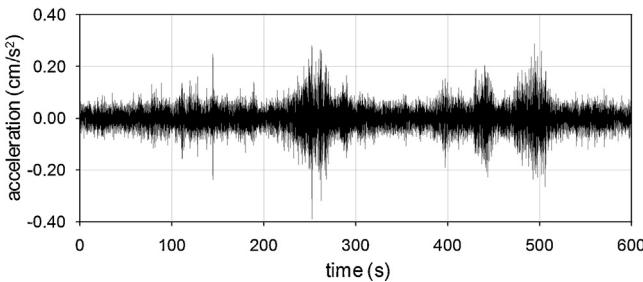
The excitation was only provided by wind and micro-tremors and acceleration data were acquired for 28 hours: from 16:00 to 23:00 of 31/07/2012 and from 9:00 of 01/08/2012 to 6:00 of 01/08/2012. One typical sample of acceleration time series recorded at the upper instrumented level is illustrated in Fig. 8: it should be noticed that very low level of ambient excitation was present during the tests, with the maximum recorded acceleration being always lower than 0.4 cm/s^2 .

Fig. 8. Sample of acceleration recorded at the top of the tower.
