Minimally Invasive Detection Technologies for the Defects in Ancient Timber Structural Building

Keywords: Defects, Timber, Minimally invasion, Micro drill resistance, Stress wave

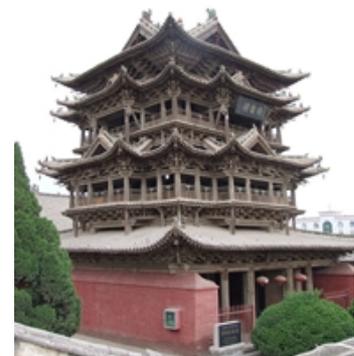
Fig. 1 Feiyun Pagoda

However, little research has been conducted on the overall condition examination of a multiple floor timber structural building (such as Feiyun Pagoda shown in Fig. 1). In this paper, on the basis of predecessors' experiences, stress-wave tomography and resistographic drilling are combined together to detect the internal defects of timber structures so that a detailed investigation and analysis of related defects could be clearly presented.
