## REDUCING THE SEISMIC VULNERABILITY OF TIMBER ROOFS: A CASE STUDY

Maria A. Parisi<sup>1</sup>, Chiara Tardini<sup>2</sup>

A complex roof, covering a large, century-old mansion which had not been recently maintained, has now been examined as case study. The objective is dual: on the one side, testing the applicability of the procedure on a large roof and its effectiveness in showing the possible critical points in an organized way; on the other, considering the capability of the procedure, which synthetically indicates the need for interventions and their importance, as a basic tool for comparing and estimating costs and benefits of different intervention strategies. For the case examined, the seismic vulnerability has been estimated according to the procedure; criticalities have been pointed out; on this basis, the analysis of a possible intervention strategy and consequent reduction of vulnerability levels has been performed.

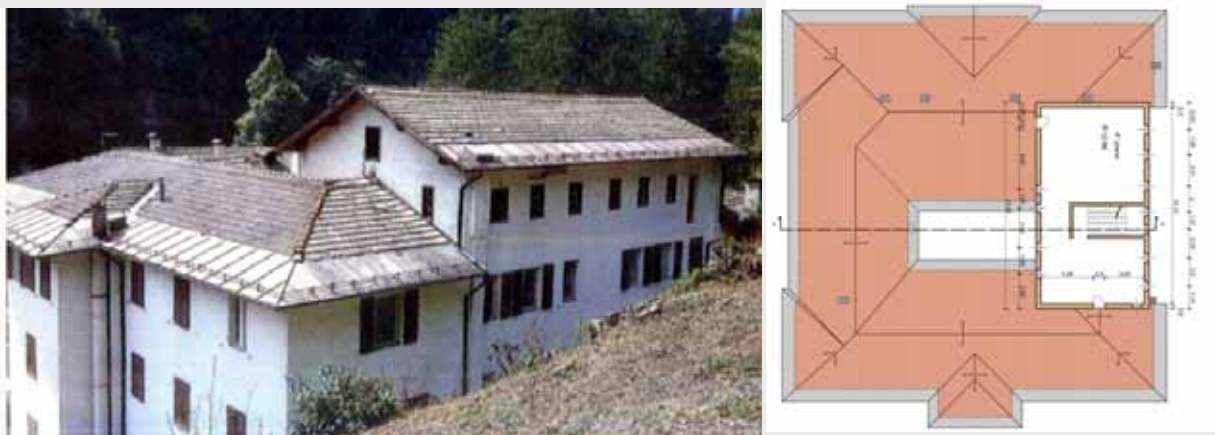
Figure 1 shows an exterior view of the building and of the roof. At a lower level the roof covers a C-shaped area, around a courtyard, while on one side the building elevates with an additional storey, which has a rectangular base and an independent roof. The study has been carried out for the lower level only, as the degraded conditions of the building did not consent safe access to the upper storey. In real cases a full evaluation would have been necessary, but in the current situation of a study that was not intended to arrive to the actual restoration of the asset, the limitation was acceptable. The relevant area with the structure plan is also shown.

The roof structure is formed by 13 trusses disposed in the three sides of the C base. They have slightly different structural schemes; they are interconnected at the building corners by diagonals and rafters. Spans range between 7 to 8 meters, with spacing between 3.2 and 4.4 meters, in order to follow the irregularities of the base area.

Figure 1: The roof under study covers the lower building area, with a C-shape

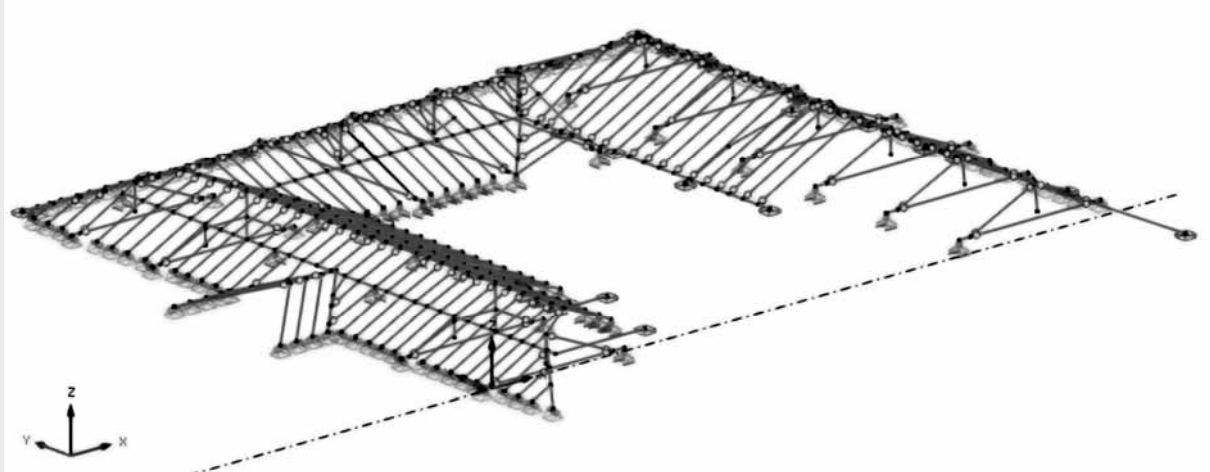
A numerical model of the roof structure has been developed assuming to have carried out the interventions for its improvement. A seismic analysis has been performed with reference to the response spectrum indicated by the design code for the location of the building. The response of the structure has appeared regular and all verifications were satisfied. Safety mar-

gins were relatively high. As the seismicity requirements at the building site were moderate, this result indicates that requirements are likely to be satisfied also for higher seismicity levels. This extension is in progress. This result indicates that the improved structure fully satisfies the seismic conditions. The class A/B hypothetically to be reached after the interventions may be confirmed.

Figure 6: Model for numerical analysis
