# Damage assessment of three medieval churches after the 2012 Emilia earthquake

**Abstract** The architectural heritage was severely damaged by the seismic sequence that occurred in Emilia (Northern Italy) in May 2012. This paper investigates the seismic behavior of three masonry churches that were damaged by the 2012 Emilia earthquake. The analyzed churches are located in the South-East area of the province of Mantua: they are representative of some churches, denoted as “Matildic churches”, belonging to the territorial area between Lombardia, Emilia Romagna and Toscana and built during the Matilde di Canossa domain, between the X and the XI centuries. The study was based on detailed field surveys, in situ tests, visual inspections and existing archives in order to obtain an accurate knowledge of the churches and a proper evaluation of the damage caused by the earthquake. Then, detailed finite element models of the churches were developed and non-linear dynamic analyses with different peak ground accelerations were performed. The numerical simulations provided a deep insight into the seismic behavior of the analyzed churches, identifying the damage patterns and the main collapse m

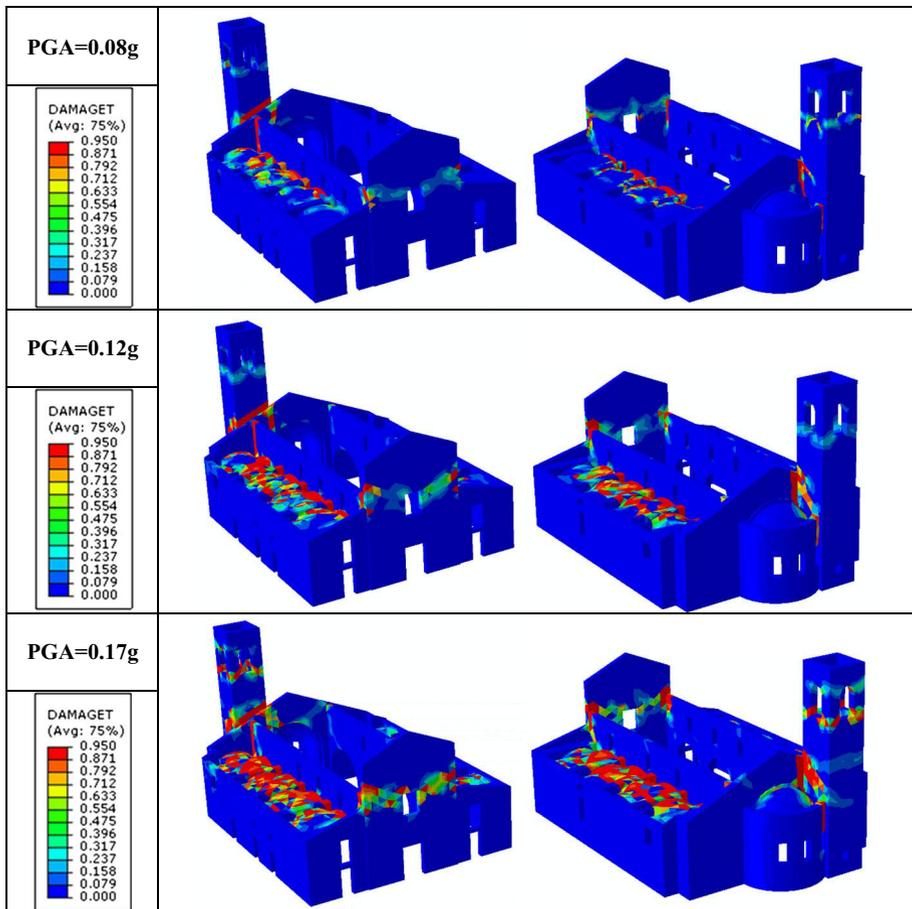
**Fig. 29** San Fiorentino Martire church: tensile damage contour plots at the end of the non-linear dynamic analyses for different peak ground accelerations

## 8.2 San Fiorentino Martire church in Nuvolato

The non-linear dynamic analysis under  $PGA = 0.08\text{ g}$  shows a significant damage in the vaults of the aisles chapels, localized mainly in the connection region with the walls of the central nave and along the arches connecting the different chapels: such damage is consistent with what observed in situ, (Fig. 17e, photos 09–10; Fig. 17f, photos 11–12). A slight damage starting from the central opening is visible on the façade. A vertical damage is registered between the façade and the longitudinal walls of the central nave, as observed during the damage survey, (Fig. 17a, photos 01–02). A localized damage is observed between the bell tower and the hall wall and between the bell tower and the apse wall, as documented by the damage survey, (Fig. 17h, photos 14–15). The bell tower presents a slight damage near the openings of the belfry, as reported by the in situ survey, (Fig. 17h, photos 14–15).

The non-linear dynamic analyses under higher values of PGA show a considerable enlargement of damage, involving the entire vaults system. In particular, it is possible to

observe a widespread damage along the ribs of the vaults of the side chapels, a possible detachment of the aisles vaults from the walls of the central nave and a significant damage in the arches of the masonry vaults. A localized damage can be noted in the contact region between the bell tower and the walls of the church. Furthermore, a clear damage is registered near the connection region between the façade and the walls. The façade presents a significant horizontal damage near the central opening and an extensive damage with sub-horizontal distribution is visible in the belfry, above all in the analysis under  $PGA = 0.17\text{ g}$ . The apse does not present damage in the external wall, but a severe damage can be noted along the contact region between the apse wall and the bell tower, visible also in the analysis under  $PGA = 0.08\text{ g}$ .

A specific evidence has not been found for the damage reported in the walls of the central nave, (Fig. 17b, photos 03–04; Fig. 17g, photos 13–14), of the apse, (Fig. 17c, photos 05–06), and of the transept, (Fig. 17d, photos 07–08). It is worth mentioning that the damage observed in the wall of the central nave from the in situ survey may be related to the Romanesque origin of the macro-element (which may consist of a multi-wythe

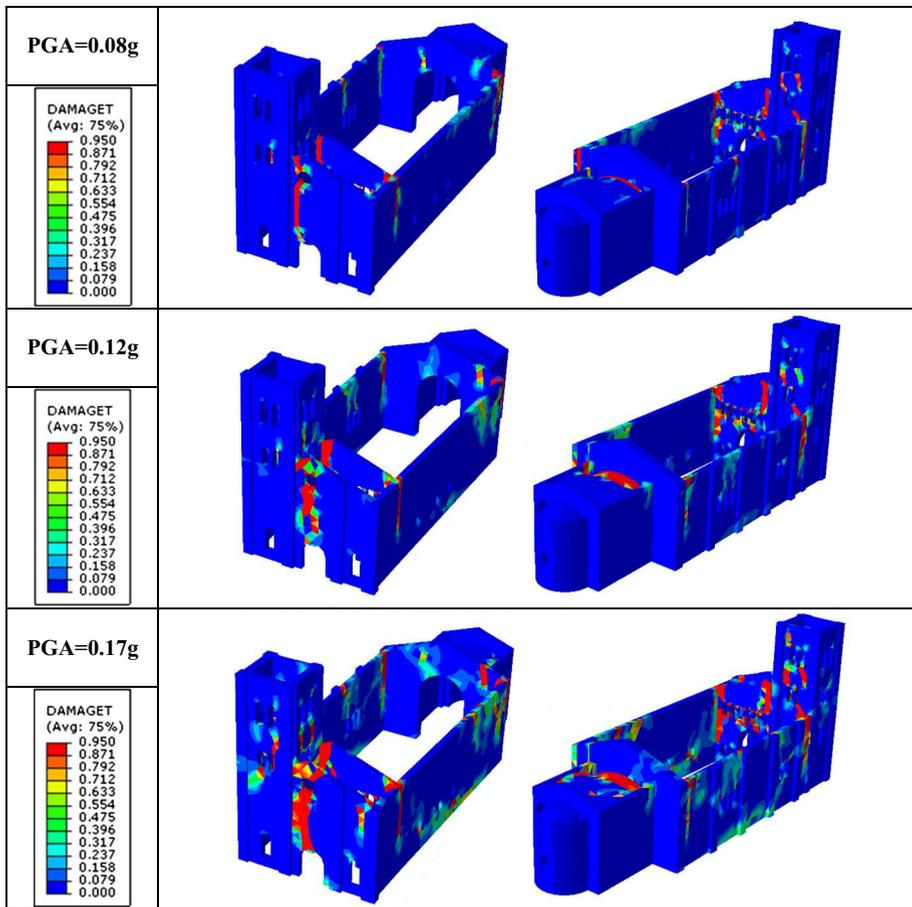
**Fig. 30** Santa Maria Assunta church: tensile damage contour plots at the end of the non-linear dynamic analyses for different peak ground accelerations

The non-linear dynamic analysis under  $PGA = 0.08$  g shows that damage is mainly concentrated in the regions where the bell tower interacts with the walls of the church, involving the main façade and the transversal and longitudinal walls of the nave: such damage may be explained considering the different geometrical and dynamic features of the adjacent elements. A vertical damage is detected in the connection regions between the bell tower and the façade and between the bell tower and the perimeter wall: it is consistent with what was observed in situ, (Fig. 19f, photos 13–16). Moreover, a significant vertical damage is recognizable in the corner between the southern longitudinal wall and the transversal one: it was partially observed in situ, (Fig. 19e, photo 09). A visible damage along the connection between the vaults of the atrium and the supporting walls emerges and it reflects the real damage, (Fig. 19c, photo 05). A clear damage is visible along the arch connecting the presbytery and the hall: it does not represent exactly what was detected in situ, (Fig. 19d, photos 07–08). A localized damage is concentrated in correspondence with some openings along the longitudinal and transversal walls of the hall, the bell tower and the atrium: it was partially observed in situ, (Fig. 19b, photo 04; Fig. 19e, photos 11–12).

The non-linear dynamic analyses under higher values of PGA show an enlargement of damage in the façade and in the connection region between the bell tower and the perimeter wall. The perimeter walls exhibit a clear vertical damage that increases with increasing levels of PGA: such damage is compatible with in situ survey, even though it is less marked. The analysis under  $PGA = 0.17$  g reveals a localized damage near the openings of the belfry, not visible in the real crack pattern. The damage maps clearly show a considerable damage in the masonry vault of the presbytery, which may indicate an incipient detachment between the vault system and the wall, not registered during the in situ survey. An extension of damage is also observed: (1) in the counter-façade, with damage that develops mainly close to the openings, as observed in situ, (Fig. 19a, photos 01–02); (2) in the chapels walls, with damage generally close to the arches, as observed in situ, (Fig. 19a, photo 03); (3) in the longitudinal and transversal walls, with vertical damage spreading from the top of the walls; (4) in the connection regions between the masonry vault of the *Cappella Gemella* and the longitudinal wall, with clear evidence of the detachment of the vault from the wall.

Figure 30 shows the evolution of the tensile damage in Santa Maria Assunta church for different values of peak ground accelerations.
