# An insight in the late Baroque architecture: An integrated approach for a unique Bibiena church

This paper investigates the case study of *Sant'Antonio Abate* church in Villa Pasquali. This building was realized by Antonio Luigi Galli da Bibiena in the second half of the XVIII century.

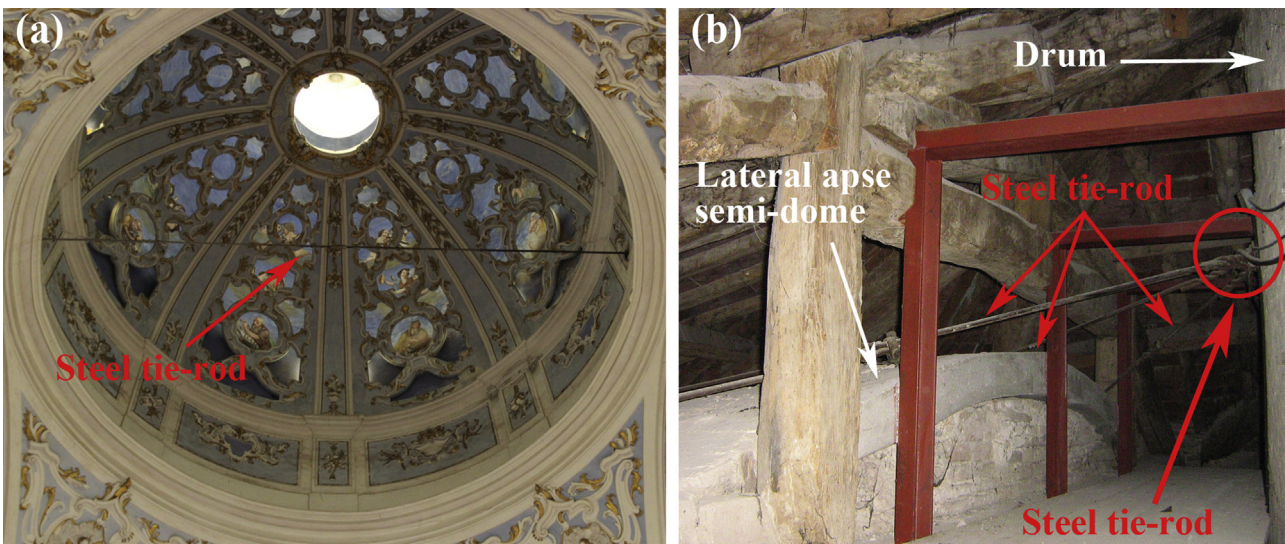
After construction, the stability of the church was jeopardized mainly by geological problems. Owing to the presence of an aquifer under the floor of the church, some foundations settlements and cracks are documented beginning with the third decade of the XX century. To address this, in the Thirties two tie-rods were inserted for containment of the arches and the double vault in the presbytery and apse [29,31,32]. Successively, in the Sixties, strengthening interventions of the foundation level were suggested, to solve

Fig. 2. Central dome and east-west direction tie-rod passing through the drum; (b) system of tie-rod in the lateral apses at the under-roof level.

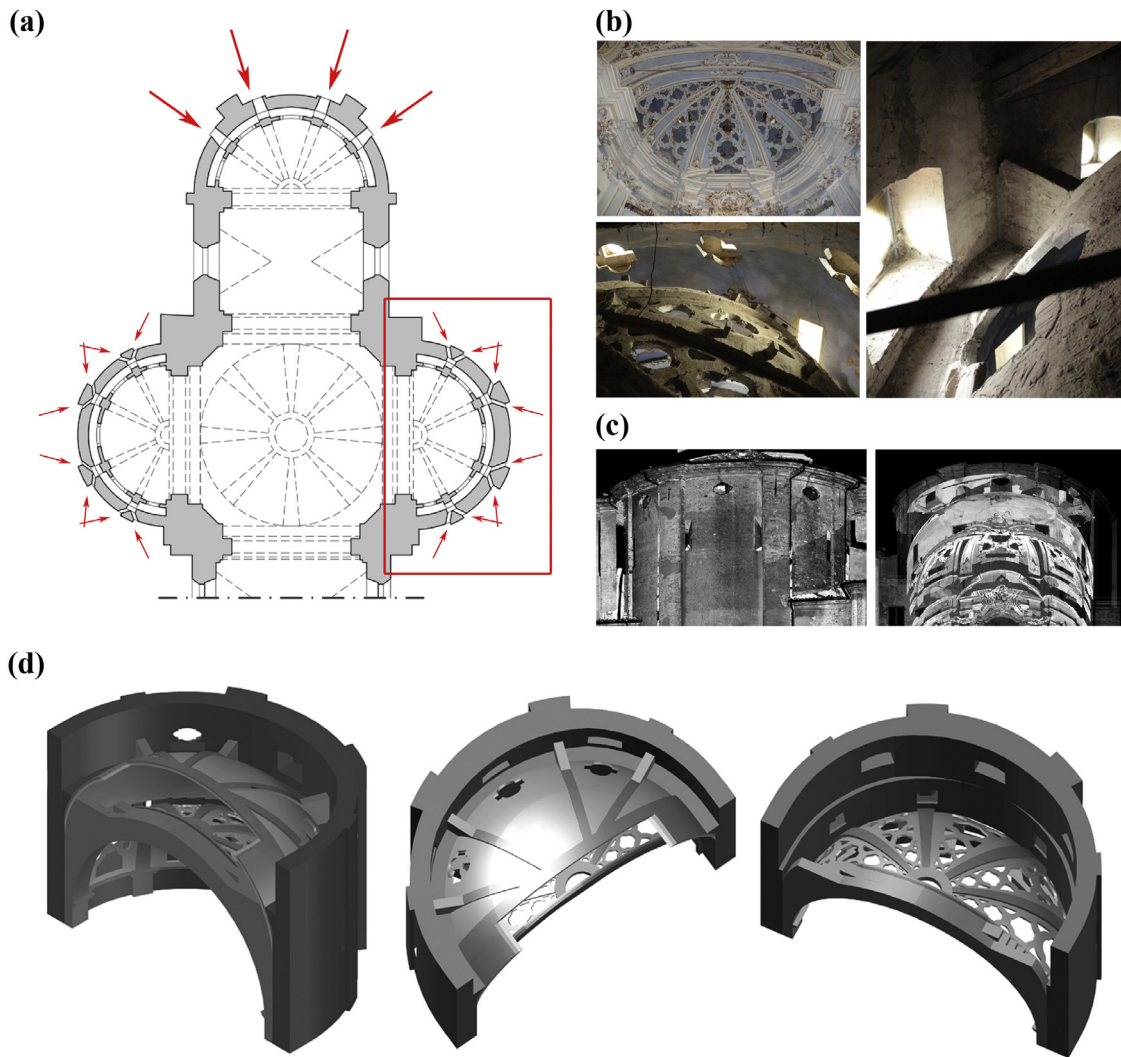
Fig. 4. East apse semi-domes. (a) Scheme of the lightning system; (b) visual inspection; (c) geometrical survey; (d) 3D model.

- *Cracks on the vaults and arches.* On the barrel vaults of the nave and the presbytery cross cracks between the vaults and the arches are evident. A large crack pattern was observed also at the haunches and crown of the vaults and, in particular, some diagonal cracks with a northeast–southwest direction were concentrated in the area closest to the bell tower. Some minor cracks were observed on the perforated vaults of the apse and on some small masonry domes of the lateral chapels. A significant crack pattern characterized by both vertical and diagonal cracks was detected on the continuum vaults of the apse and pseudo-transsept. Moreover, despite the tie-rods, all the triumphal arches that support the main dome and the one between the apse and the presbytery are characterized by cracks in crown.
