Snail Trails and Cell Microcrack Impact on PV Module Maximum Power and Energy Production

This paper analyzes the impact of the snail trail phenomena on photovoltaic (PV) module performances and energy production. Several tests (visual inspection, maximum power determination, dielectric withstand, wet leakage current, and electroluminescence test) were carried out on 31 PV modules located in a PV plant in Italy. The electroluminescence test highlighted the strong correlation between the appearance of snail trails and presence of damaged cells in PV modules. The daily energy produced by four PV modules affected by snail trails ranged between 68% and 88% of the energy produced by a damage free commercial PV module over the same period.

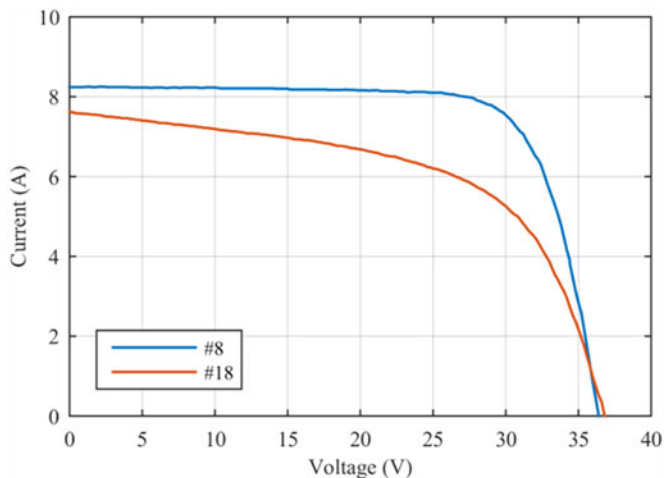
Fig. 2. Measured I - V curves of PV modules without major visual defects (#8) and with several snail trails (#18).

In Fig. 2, the measured I - V curves of two PV modules #8 and #18 are reported. The two curves show significant differences in the MPP, as well as resistance values: the shunt and series resistances in the equivalent electric circuit derived for the PV module #8 are 332.8Ω , respectively, 0.4Ω . For the PV module #18, the shunt resistance reduces to 23.6Ω and the series resistance increases to 0.8Ω . This is in agreement with the results reported in [17]. The same trend was outlined also for all the other modules affected by microcracks, but the graphs are not reported here for the sake of brevity.

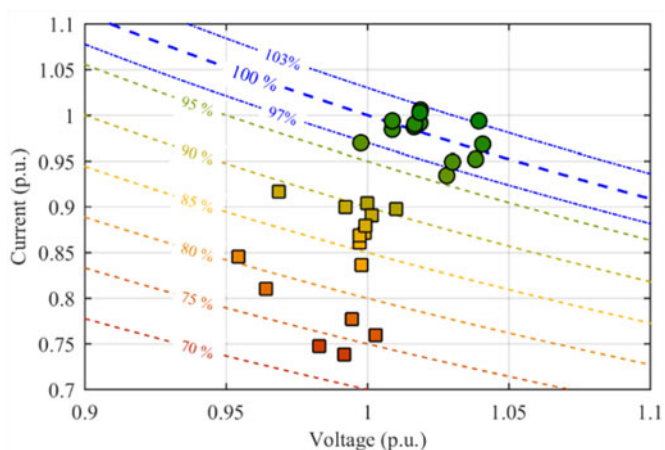
Fig. 3. MPP of the PV modules under analysis (except the one affected by diode failure) measured at STC in comparison with datasheet value (100%).

value below the nominal power; the reduction ranges from -9% to -27% with respect to the nominal power available from the datasheet.¹ In particular, a decay of the current at MPP can be outlined, while the I_{SC} and voltages are only marginally affected.

Fig. 3 summarizes the voltage and current at MPP referred to the values indicated on the datasheet of the PV module.

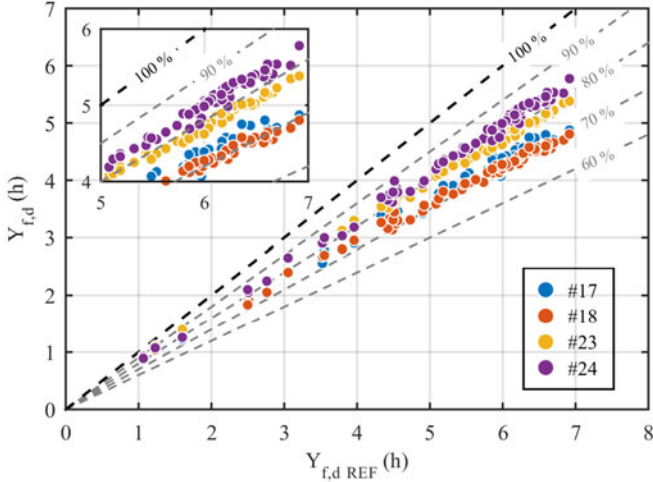
Fig. 7. Daily final yield of the PV modules #17, 18, 23, and 24 in the period April 2015–August 2015 referred to the daily final yield of the reference PV modules.

The energy produced by the PV modules in the period from April 2015 to August 2015 was recorded to quantify the influence of snail trails/cracks in terms of daily and total energy within the conducted test period. The daily energy generation—in terms of final yield ($Y_{f,d}$)—by PV modules referred to the final yield of REFPV module ($Y_{f,d REF}$) is summarized in Fig. 7. The energy generation of the REFPV module, in terms of equivalent hours at peak power, is the black-dashed line.

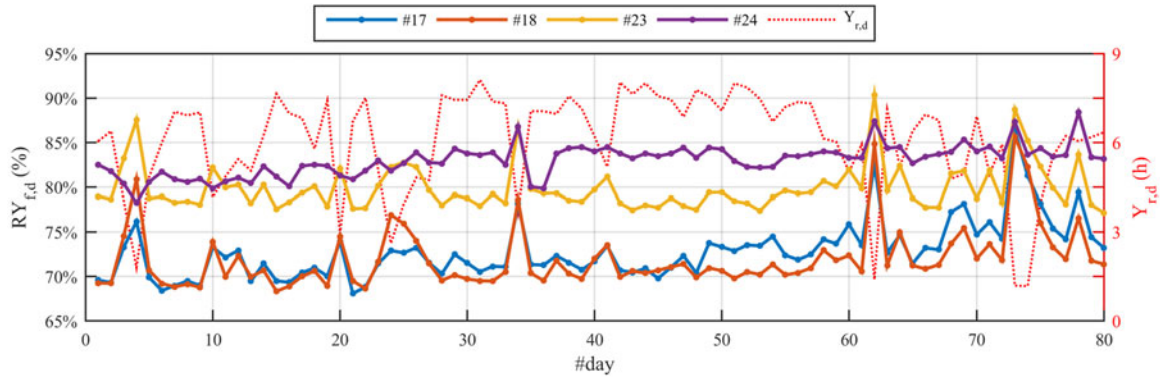
Fig. 8 illustrates the variation of relative daily final yield index ($RY_{f,d}$) for the four affected PV modules (#17, #18, #23, and #24) for each measured day. As illustrated in Fig. 8, the performance decay is higher during high solar radiation days characterized by high $Y_{r,d}$. Table II summarizes the final yield and relative final yield for the different months and the entire period of analysis. It is important to underline that the numbers of days in which the data are available are different for each month. PV modules #17 and #18 presents the highest reduction in energy production by about 30% than the REFPV module. Modules #23 and #24 show a lower energy reduction: they produce about 20% less in term of energy than the REFPV. These results are similar to the ones obtained by the maximum power tests. Besides diverse measurement accuracies and references adopted (REFPV instead of datasheet), the energy analysis represent the average behavior of the module under real operating conditions, which can differ from the ones at MPP. The energy results outline that the average behavior cannot be easily predicted: two modules (#17 and #18) have an energy reduction higher than the one at MPP, while the opposite occurs for #23 and #24.

Fig. 8. Relative daily final yield index of the four PV affected modules #17, #18, #23, and #24 for 80 days in the period of analysis. The daily reference yield index for the same days has been reported on the secondary y-axes.
