ASSESSMENT OF A FIRE DAMAGED CONCRETE OVERPASS: THE VERONA BUS CRASH CASE STUDY

Roberto Felicetti¹

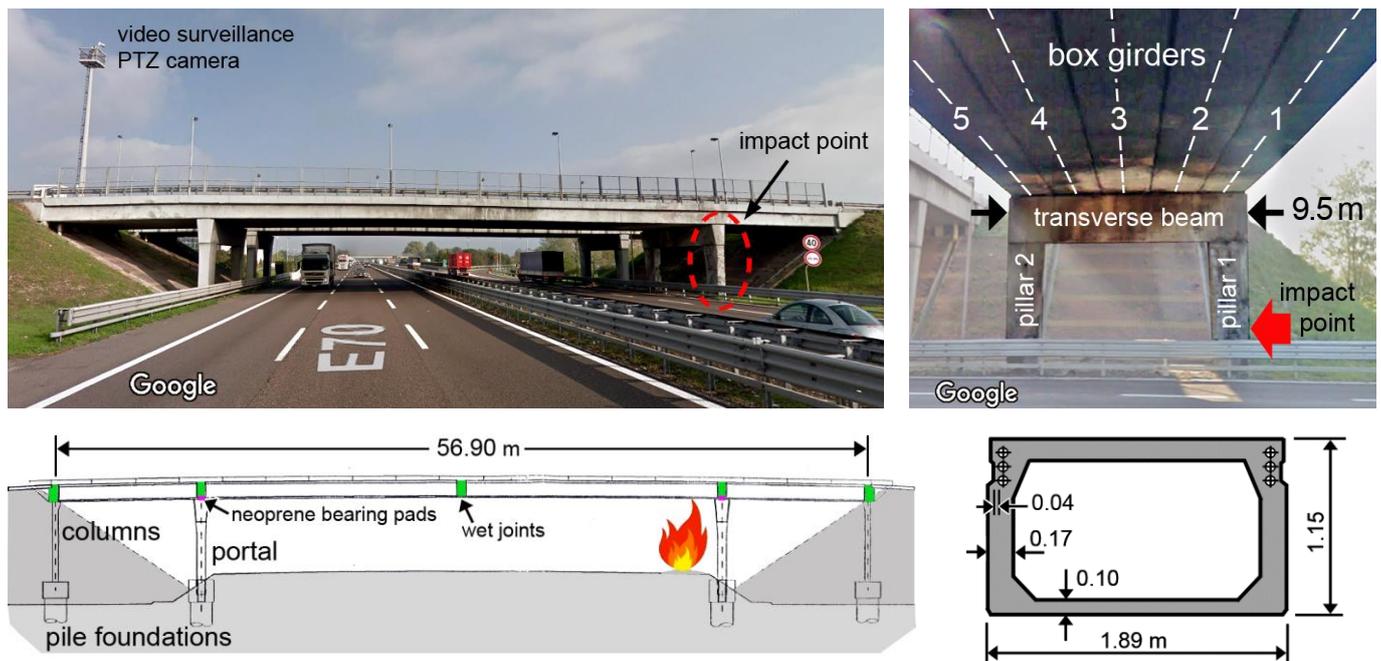
The impacted structure is a semi-integral concrete bridge built in 1992 (Figure 1). The deck includes 5 post-tensioned box girders sustained by two intermediate precast portals and restrained by sets of 6 columns at the abutments. Each girder is made of 4 precast segments assembled with wet joints and post-tensioned with 6 concordant cables (7 x 0.6" strands each). Adjacent girders are connected with shear keys obtained by filling two lateral recesses with non-shrink grout. To be mentioned is a note on the original drawings prescribing the addition of polypropylene fibre to the C40/50 concrete mix (possibly to control early age cracking). As will be discussed, this may explain why no spalling was observed on these elements.

The precast portals consist of two inverted tapered pillars (cross section 0.6x1.1m to 0.7x1.5m) and a transverse beam with 1.5m deep trapezoidal cross-section (width 0.7 to 1.0m). The moment resisting connections are obtained by grouting groups of 7x26mm rebars protruding from each corner of the pillars.

Figure 1. General views of the overpass under study, elements nomenclature and size.

In all elements, fire protection of the reinforcement is provided by a rather thick cover (axis distance of stirrups = 35mm, minimum surface distance of cables at the lateral recess = 40mm, see Figures 1 and 6).

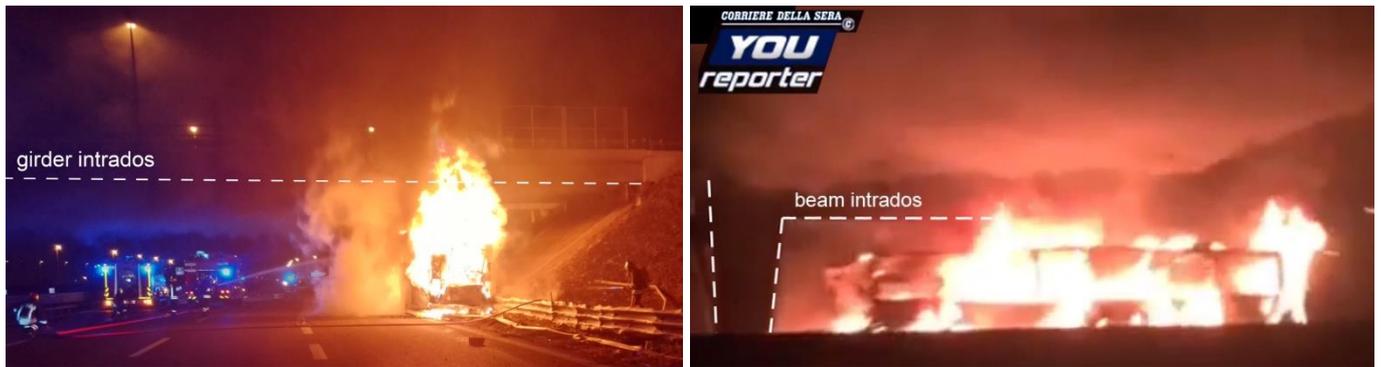
Figure 5. Pictures showing the flame height in the fully developed stage of the fire.

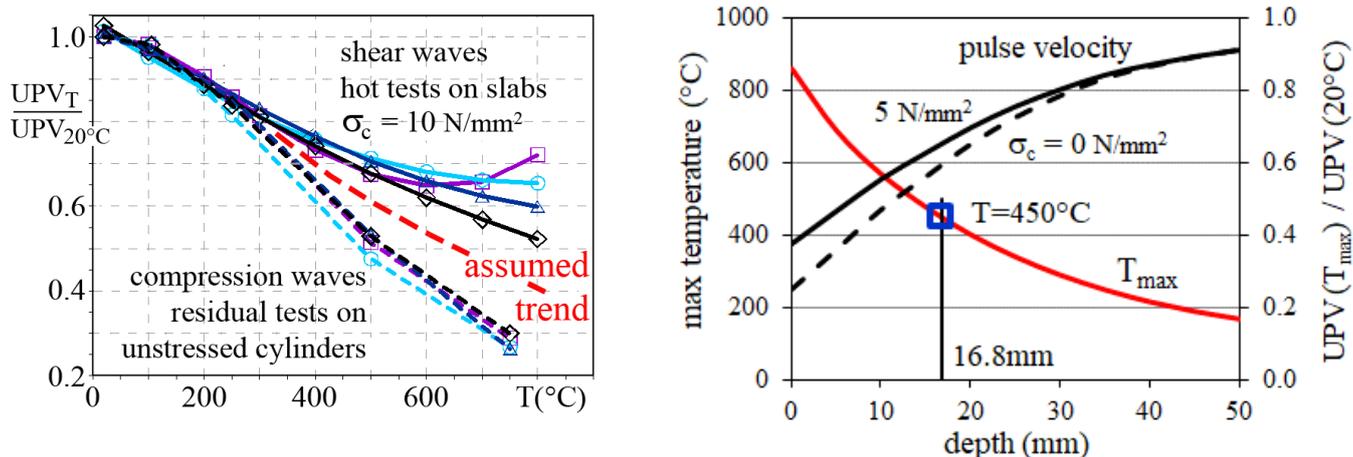
Figure 9. Decay of Ultrasonic Pulse Velocity with temperature as a function of the sustained stress [12]; profiles of the max temperature and corresponding UPV for a 100mm thick plate submitted to the localized fire discussed in section 3.

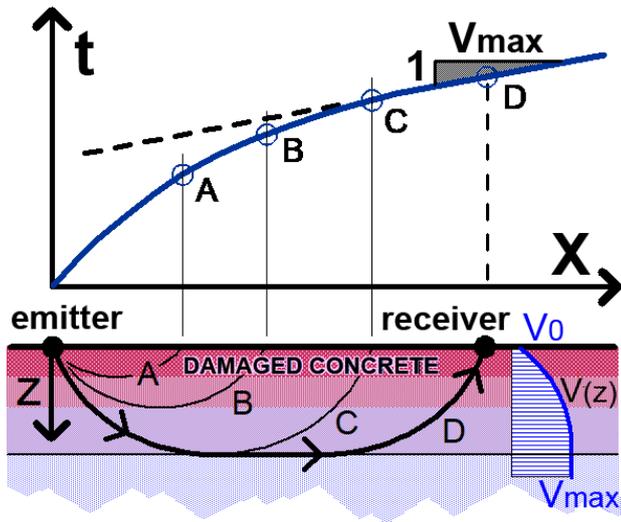
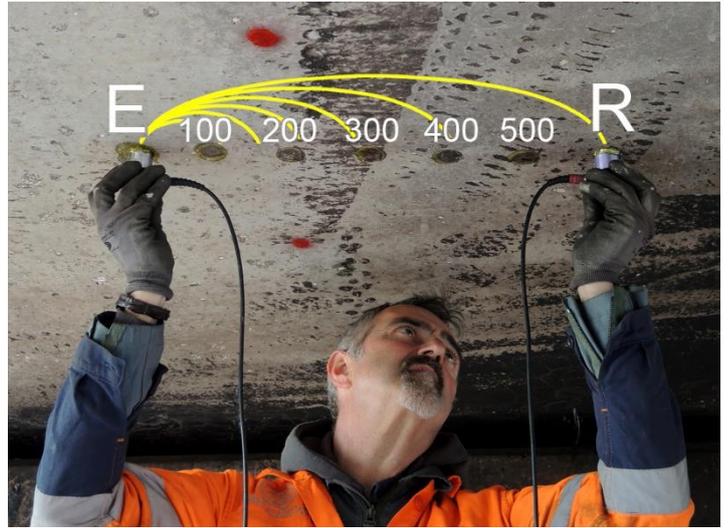
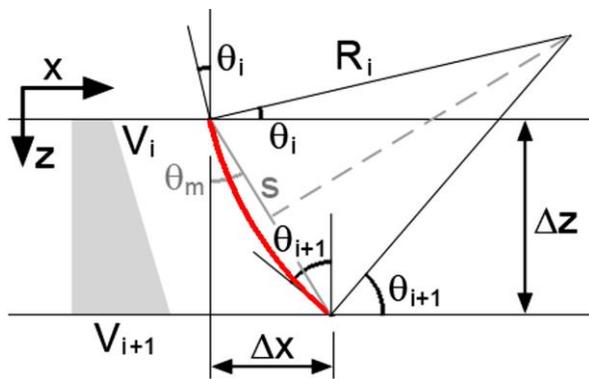
The above procedure was implemented with reference to the localized fire scenario depicted in section 3. The maximum temperature envelope profile [11] within the 100mm thick bottom flange of the box girders was calculated via a 1D finite difference procedure, which was continued until all terms in the temperature vector had reached the cooling stage. The velocity profile was then obtained, based on the expected decay for slightly compressed concrete (reference pulse velocity for pristine concrete $V_{20^\circ\text{C}} = 4.3\text{km/s}$). The intermediate curve in Figure 9 was adopted, being about 5 N/mm^2 the average compressive stress sustained by the bottom flange under dead loads. Finally, the refracted ray paths and the corresponding X-t curve were traced by keeping the same discretization as the thermal model (Figure 11).

In-situ measurements were taken along the central axis of each box girder, at 1m and 2m distance from the edge of the supporting transverse beam. The comparison against the theoretical trends (Figure 11) shows that all results lie between the plots pertaining to undamaged concrete (a straight line of slope $1/V_{20^\circ\text{C}}$) and to the maximum expected damage above the localized fire source. A good correspondence is observed between damage depth and the location in the general velocity maps of Figure 7, with smoothly decreasing effects in beams 4 and 5. The effectiveness of spot measurements at $X=150\text{mm}$ nominal probe distance in discriminating damage levels in this range is also highlighted.

It has to be remarked that the theory of waves refraction allows establishing a direct connection between velocity profiles (and then mechanical damage) and field results. This is the basis behind the semi-empirical correlation proposed in [13], providing an indication of the damaged thickness, with no specific assumptions on the fire scenario and the inherent material sensitivity to fire. However, the limited thickness of the flanges under study would require to adapt the proposed relation, since the depth at which a 20% decay of pulse velocity is assigned is overestimated by about 10mm (see Figures 9 and 11).
