# Static monitoring of a masonry arch bridge: Evaluating the effects of changing environment

P. Borlenghi & C. Gentile

**ABSTRACT:** The paper presents selected results obtained in the continuous monitoring of the *Candia* bridge – a historical masonry arch bridge crossing the Sesia River in the north of Italy – to detect scour-induced effects. Generally speaking, hydraulic processes are the main cause of bridge failure, and masonry arch bridges are particularly vulnerable to scour-induced settlements. Consequently, the early detection of anomalies associated to scour is of outmost importance to ensure the safe operation of river bridges. In the present study, measurements of the piers rotation are performed using tiltmeters; in addition, environmental parameters, such as temperature, water level and riverbed changes, are measured to check possible correlation with the monitored rotations. The results from the first two years of monitoring highlight anomalous changes in the rotation-temperature correlation of various piers.

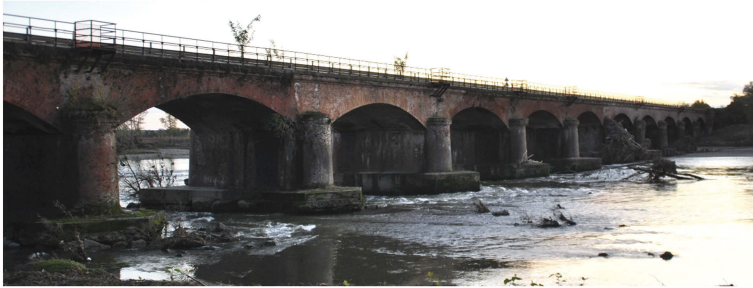
On-site inspections revealed that all pier footings resting on the riverbed underwent strengthening interventions, highlighting the vulnerability to scour actions. In addition, the bridge experienced an intense flood event in October 2020.

Figure 1. The *Candia* bridge: view from the upstream of Sesia River.

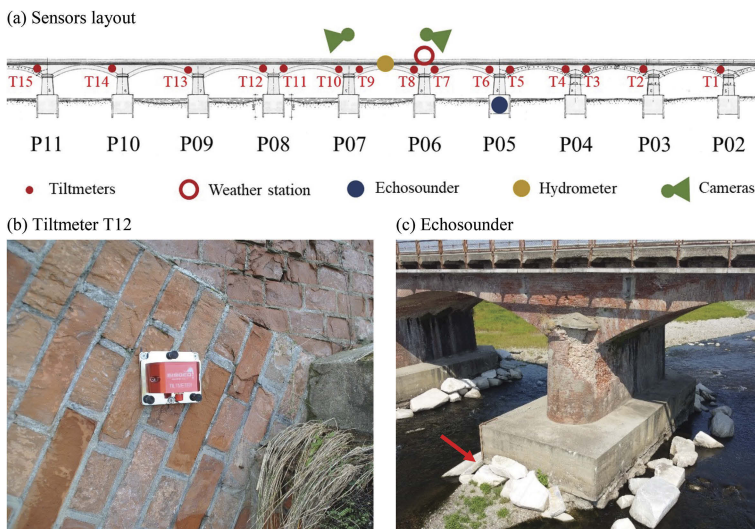
The monitoring system installed in the *Candia* bridge (Figure 4a) is composed by: (a) 15 uniaxial MEMS analog tiltmeters (SISGEO model 0S541MA0202, accuracy  $\pm 0.008^\circ$ ); (b) 1 weather station (measuring temperature, humidity, rainfall intensity, wind speed and direction); (c) 1 hydrometer; (d) 1 echo-sounder and (e) 2 cameras.

Figure 4b shows typical installation of one tiltmeter (before the cable connection). The tiltmeters were installed at the skewback of the arches on the upstream side of the bridge, measuring positive transverse rotations along the direction of the river flow. It is worth noting that the pier rotation due to a scour-induced settlement is expected to occur in the opposite direction of the river flow (Tubaldi et al. 2018) and therefore with negative measured rotations. As shown in Figure 4a, the tiltmeters were installed only on the piers located in the riverbed and the piers from P04 to P08 – the ones most affected by the deviation of the main river flux from the left- to the central-channel (Figure 2) – are monitored with two tiltmeters: one for each skewback.

Figure 4. The quasi-static monitoring system: (a) sensors layout; (b) mounting of tiltmeter T12; (c) position of the echosounder.

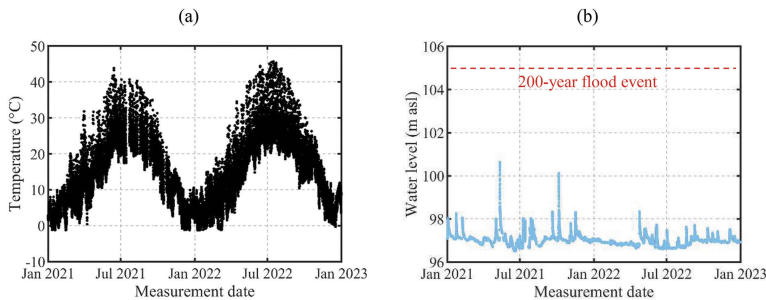
Firstly, the main environmental parameters, i.e. outdoor temperature and water level, are processed. Figure 6a illustrates the evolution of the outdoor temperature measured from the internal thermistor of one tiltmeter. The maximum and minimum recorded temperatures in the selected period are equal to 45.7°C and -7.3°C, respectively. However, the temperatures below -1.2°C were ignored in the present paper due to an occasional sensor malfunctioning.

Figure 6b presents the time evolution of the river water level measured with the hydrometer in terms of elevation above sea level (m asl). The average recorded value in the selected period is 97.0 m asl while the maximum value is equal to 100.6 m asl (12 May 2021). It is worth considering that during the expected 200-year event, the river water level can reach an elevation of about 105 m asl, namely, rising about 8 m from the average water level. In the selected period the maximum detected rising is about 3.6 m from the average water level.

Figure 6. Time evolution of environmental parameters: (a) measured temperature and (b) water level.
