Article

In Situ Monitoring of Powder Bed Fusion Homogeneity in Electron Beam Melting

Abstract: Increasing attention has been devoted in recent years to in situ sensing and monitoring of the electron beam melting process, ranging from seminal methods based on infrared imaging to novel methods based on backscattered electron detection. However, the range of available in situ monitoring capabilities and solutions is still quite limited compared to the wide number of studies and industrial toolkits in laser-based additive manufacturing processes. Some methods that are already industrially available in laser powder bed fusion systems, such as in situ detection of recoating errors, have not yet been investigated and tested in electron beam melting. Motivated by the attempt to fill this gap, we present a novel in situ monitoring methodology that can be easily implemented in industrial electron beam melting machines. The method is aimed at identifying local inhomogeneity and irregularities in the powder bed by means of layerwise image acquisition and processing, with no external illumination source apart from the light emitted by the hot material underneath the currently recoated layer.

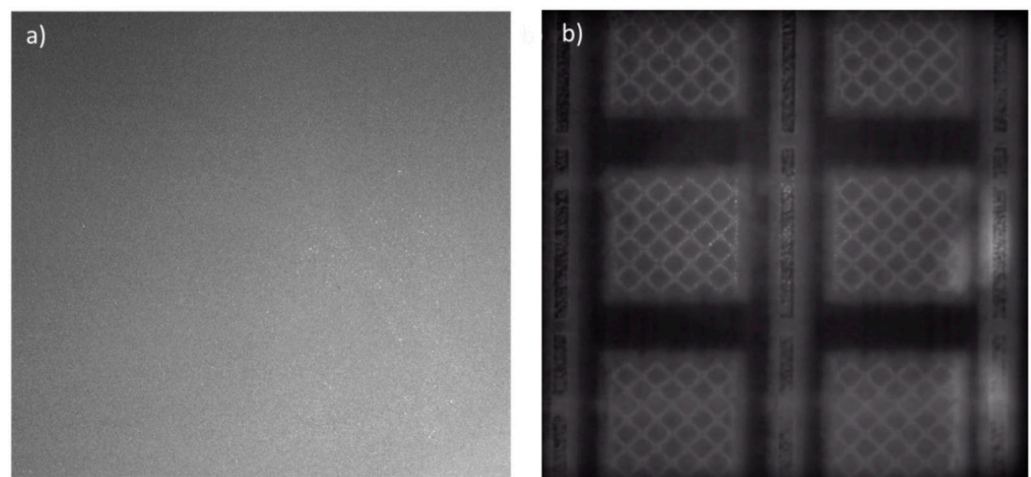
Figure 1. Example of defect-free post-recoating powder bed images in L-PBF (a) and EB-PBF (b).

The capability to detect local inhomogeneity in the powder bed has been explored mainly (or almost exclusively) in L-PBF, whereas almost no study has been devoted to electron beam PBF (EB-PBF, also known as electron beam melting or electron beam selective melting). One main reason is the different nature of powder bed images acquired in L-PBF compared to those acquired in EB-PBF. An example is shown in Figure 1. The two panels of Figure 1 show powder bed images acquired with an off-axially mounted camera in the visible range just after powder recoating in one layer in L-PBF (Figure 1a) and EB-PBF (Figure 1b).

Figure 1a is a typical example of a post-recoating image in L-PBF, where no powder recoating error is present. Apart from smooth pixel intensity variations caused by nonuniform lighting within the build area, the homogeneous pattern shown in Figure 1a aids the detection of discontinuities and local deviations. The nature of the powder bed image shown in Figure 1b is quite different. In EB-PBF, a layerwise preheating operation is carried out before starting the selective melting of the material. This operation is performed by means of high-speed electron beam scanning of the top surface, resulting in a quite homogeneous preheating temperature for the whole duration of the build and at all build heights. Such an operation raises the powder bed temperature up to a level that is sufficient to pre-sinter the powder and counteract disruptive phenomena related to excessive surface charge accumulation (also known as “smoke” events). The preheating temperature may range from hundreds of degrees Celsius to more than 1000 °C, depending on the manufactured material. If a color image was acquired, it would show a powder bed of intense red color, because of such high temperature. When a new layer of cold powder is spread over the previous one, the underneath temperature is so high that the hotter regions of the previous layer (i.e., the bright areas in Figure 1b) are still well visible through the new one. Hot areas consist of solidified regions and their surroundings, i.e.,

The nature of power bed images like the one in Figure 1b makes the design of a robust and automated method to detect anomalies in the powder spread more challenging than in L-PBF, while also considering that the extension, shape, and intensity of underneath hot areas may change from one layer to another. A preliminary approach to detect powder bed irregularities in EB-PBF was proposed in [22]. A different approach relying on the use of fringe projection was proposed in [18,23]. The proposed system involved a single-view architecture, i.e., a monocular vision. The fringe projection measurements were taken both after powder recoating and after the melting phase. The most recent study from the same authors [19] showed that, by combining the fringe projection approach with an intelligent technique to deal with large variations of the reflective characteristics of the surface, enhanced topographic results could be achieved with a quite reduced measurement time. The method was tested by reconstructing both the powder bed and the solidified layer.

As shown in the example in Figure 1, a robust identification of areas where an anomalous powder recoating occurred may be challenging if the post-recoating image alone is analyzed. Combining the pre- and post-recoating images, instead, enhances the capability to distinguish natural patterns from anomalous ones.

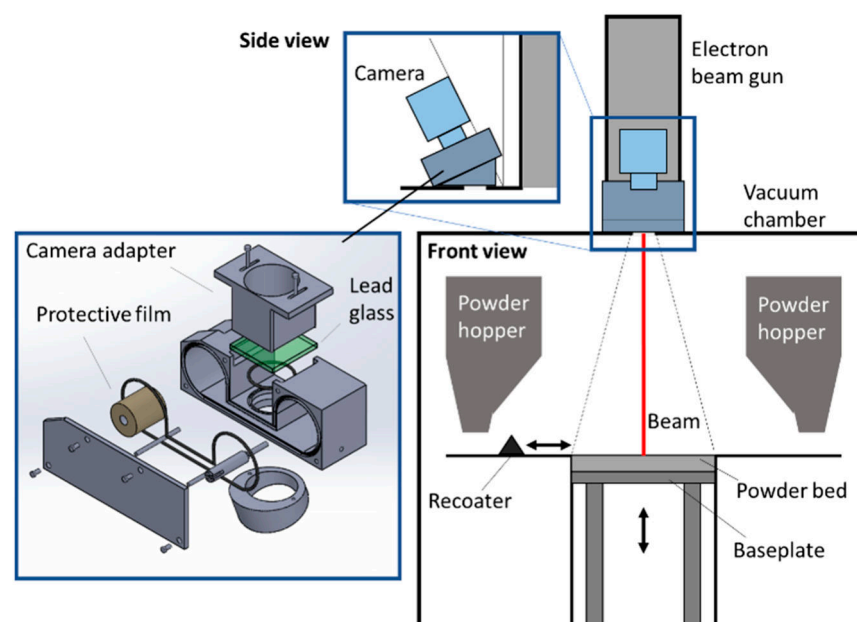
Figure 3. Customized camera mounting with rolling protective film on an Arcam A2 system.

The proposed sensing setup takes advantage of the viewport on the top of the build chamber, which is available in industrial EB-PBF systems. An example is shown in Figure 3, where the machine configuration refers to the Arcam A2/A2X system.

Any machine vision equipment for EB-PBF process monitoring should be protected from metallization. In this study, we present a custom camera mounting device where a rolling film is used to avoid camera lens metallization. As an alternative, a mechanical shutter can be used, which is activated only during image acquisition. The custom camera mounting proposed here includes a 45 mm width Kapton[®] Type 100 HN rolling film and a $60 \times 60 \times 5.5$ mm lead glass to shield the X-ray emissions. The protective film is shifted once per layer before image acquisition. A high-spatial-resolution camera equipped with a sensor in the visible range was used (see Section 3 for specifications). A near-infrared filter may also be used as a possible extension of the proposed approach to reduce the spectrum bandwidth and the dynamic range.

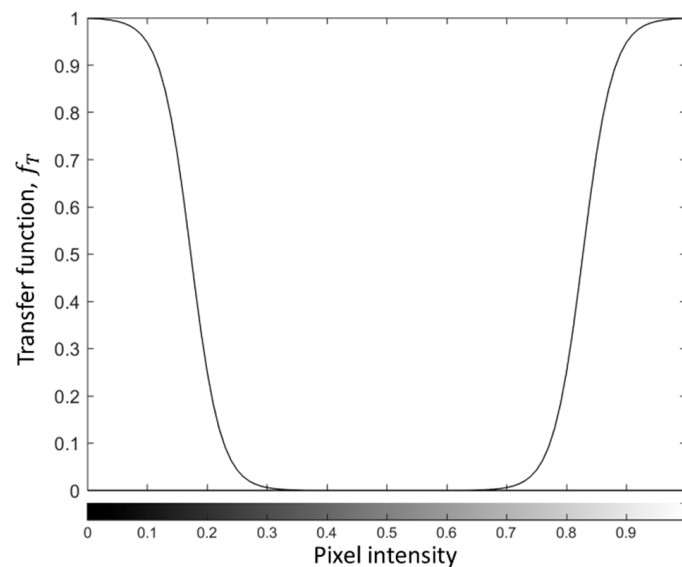
Figure 4. Transfer function for the conversion of the image I_{tr} .

where the function $f_T(\cdot)$ is a reverse sigmoid function for $i_{tr} < 0.5$ and a sigmoid function for $i_{tr} \geq 0.5$, as shown in Figure 4. The function $f_T(\cdot)$ transforms pixel intensities $0 \leq i_{tr} \leq 1$ into $0 \leq i_{tr*} \leq 1$. It can be defined as follows:

where a and b are two weight parameters that determine the shape of the function; a is just a centering parameter to transform intensities in the range 0–1 to intensities in the same range, whereas b is a parameter that controls the slope of the sigmoid function. The function shown in Figure 4 is such that $a = 1e^{-3}$ and $b = 40$, resulting in inflection points at $i_{tr} < 0.2$ and $i_{tr} > 0.8$, and i_{tr*} values that quickly drop to zero in the range $0.3 < i_{tr*} < 0.7$. The reader is referred to Section 3 for a discussion on the influence of the expression and parameters of the function $f_T(\cdot)$ on the performance of the proposed approach.

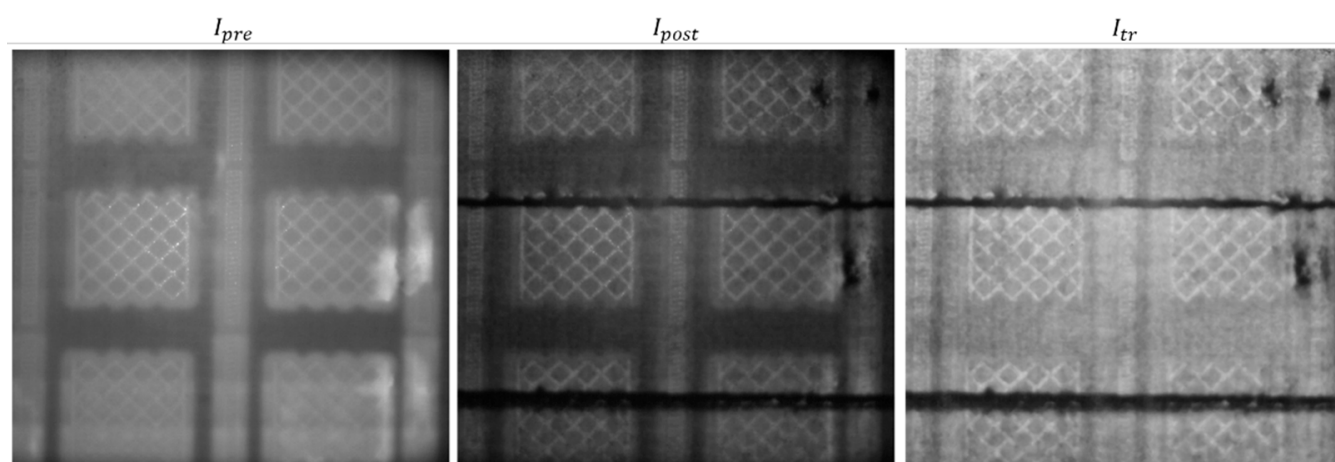
Figure 6. Example of pre- and post-recoating image in one layer where the mid- and high-severity damages of the powder recoating images produced visible discontinuities; the right panel shows the transformed image I_{tr} .

Figure 6 shows an example of pre- and post-recoating images, I_{pre} and I_{post} , as well as the corresponding transformed image, I_{tr} . Figure 6 clearly shows two dark horizontal tracks, corresponding to an excess of powder along the line where the powder recoater was damaged with mid and high severity. Evidence of the low-severity damage is instead not visible in the image. Table 1 shows that the spatial resolution was about 130 micron/pixel. Considering that one tooth of the powder recoater has a width of about 1 mm, the spatial resolution should be sufficient to capture a powder recoating error on the order of 1 mm. However, the visual inspection of the powder bed after the process confirmed no actual presence of any discontinuity associated with the low-severity damage. Indeed, one single tooth damaged was not sufficient to have any detrimental effect on the powder bed homogeneity.

Figure 6 also shows that, in addition to the horizontal discontinuities induced on purpose, some discontinuities were present on the righthand side of the image (they are clearly visible as darker spots in the transformed image, I_{tr}). The images in Figure 6 represent an example of what happened during the production of the first few layers of the parallelepiped specimens, once the supports were completed. During the deposition of the first layers, not only were the purposely created discontinuities more evident than in following layers, but other discontinuities were generated on the righthand side, whenever the last recoating pass was performed from right to left. In those locations, for the duration of few consecutive layers, a slower cooling transitory was observed after the melting phase, as can be seen from Figure 6 (left panel); the brighter regions on the righthand side of the image correspond to areas that stayed hot for a longer time after the melting of the previous layer. All this evidence suggests that some irregularities in the powder deposition occurred in the first few layers in that region, affecting the local thermal history.

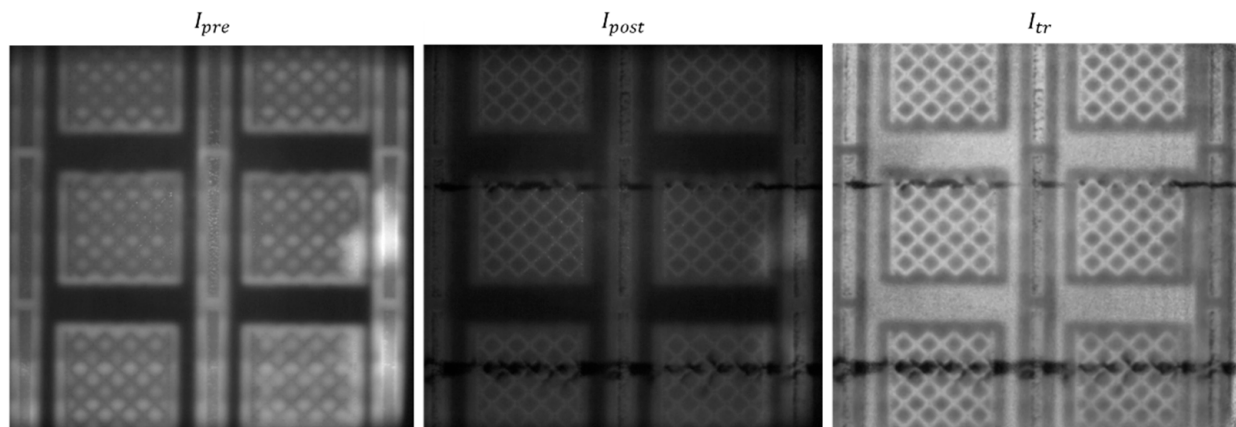
Figure 8. Example of pre- and post-recoating images with the corresponding transformed image I_{tr} .

Figures 8 and 9 show another example from the same build, corresponding to one layer produced 1 mm above that captured in the previous figures. In this case, the purposely introduced anomalies were also detected by the method, and no false alarm was produced elsewhere. It is also worth noting the difference in the pixel intensity histograms shown in Figures 7 and 9. They refer to two different layers, where pixel intensity variations may have been due to variations in the heat input to the material. Despite such a difference, the proposed approach resulted effective in detecting the mid- and high-severity anomalies. Some portions of the dark track left in correspondence of the mid-severity damage were not signaled as alarms. This was due to the pixel intensity in those portions not being sufficiently low to be distinguished from natural pixel intensities observed during the training phase.

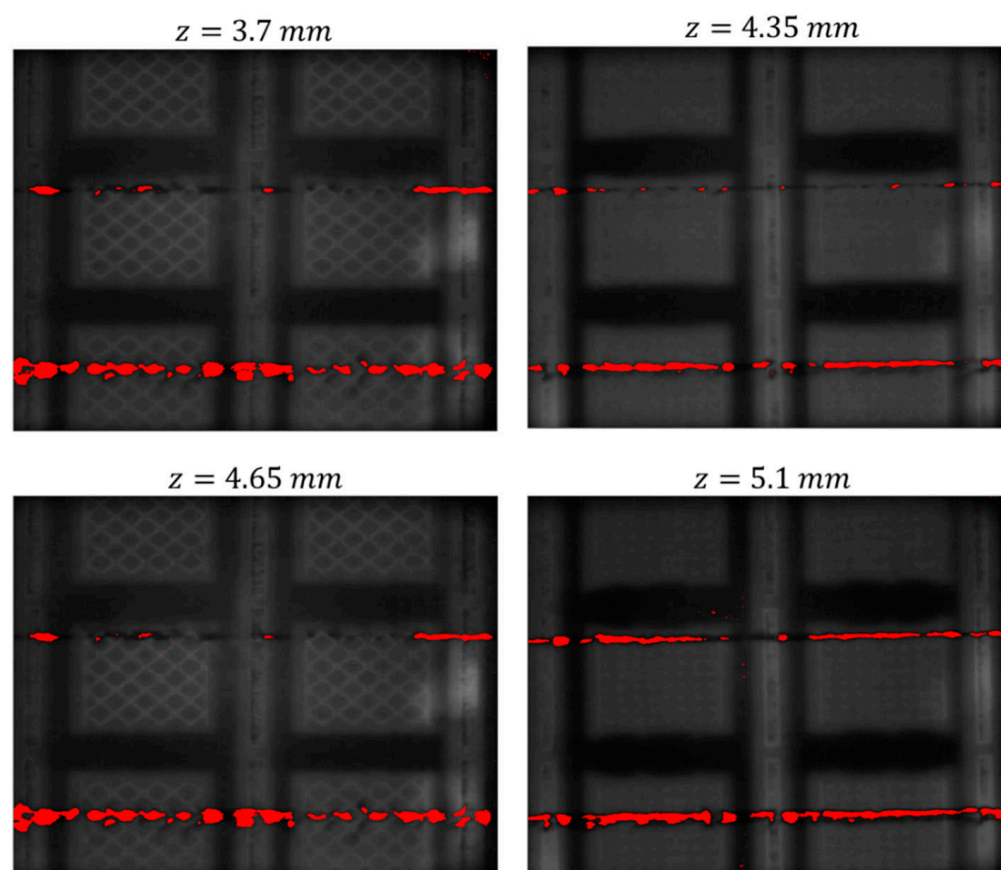
Figure 10. Additional examples of anomaly detection results in different layers.

Other examples of anomaly detection result in other layers of the same build are shown in Figure 10. The image in the bottom-right panel of Figure 10 also shows a few sparse pixels highlighted in red outside the purposely induced discontinuities. Since no evidence of anomalies was found by visually inspecting the layerwise image, they can be classified as false alarms.

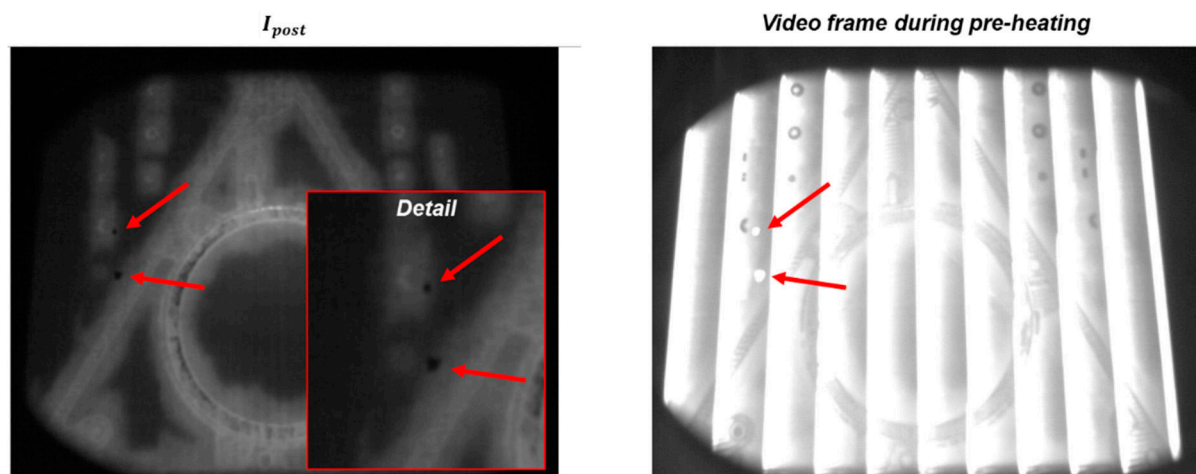
Figure 13. Example of powder bed contamination caused by metallization slivers: (**left panel**) post-recoating image with a detailed view of the slivers on the powder bed and (**right panel**): video frame acquired during the preheating phase, highlighting the metallization slivers that became hot spots.

One example is shown in Figure 13. In this case, a large and complex shape was produced together with a few small specimens. During the production of one layer, a detachment of portions of the metallization coating from the heat shield was observed. In EB-PBF, the metallization phenomenon results from the vaporization of metal alloying elements with a lower vaporization point. A thin layer of metallization coating is deposited on all the surfaces that surround the build area for the entire duration of the process. Sometimes, portions of this metallization may detach and fall on the powder bed, with potentially detrimental effects, as they may contaminate the powder bed and interfere with the electron beam. In the example shown in Figure 13, two small metallization slivers fell on the powder bed just after the powder recoating operation (apparently, they detached from the flaps of the heat shield). They are visible as dark spots in the post-recoating image (Figure 13, left panel). The smaller one had an equivalent diameter of about 10 pixels (1.3 mm), whereas the larger one had an equivalent diameter of about 20 pixels (2.6 mm). During preheating, they became hot spots, which stayed hot for a longer time compared to the surrounding pre-sintered powder (Figure 13, right panel). In this example, the metallization material fell on a region of the build area where no electron beam melting was performed, with no consequences for the part quality. If they had fallen over a melting zone, they could have prevented the correct melting of the material, possibly leading to a volumetric defect.

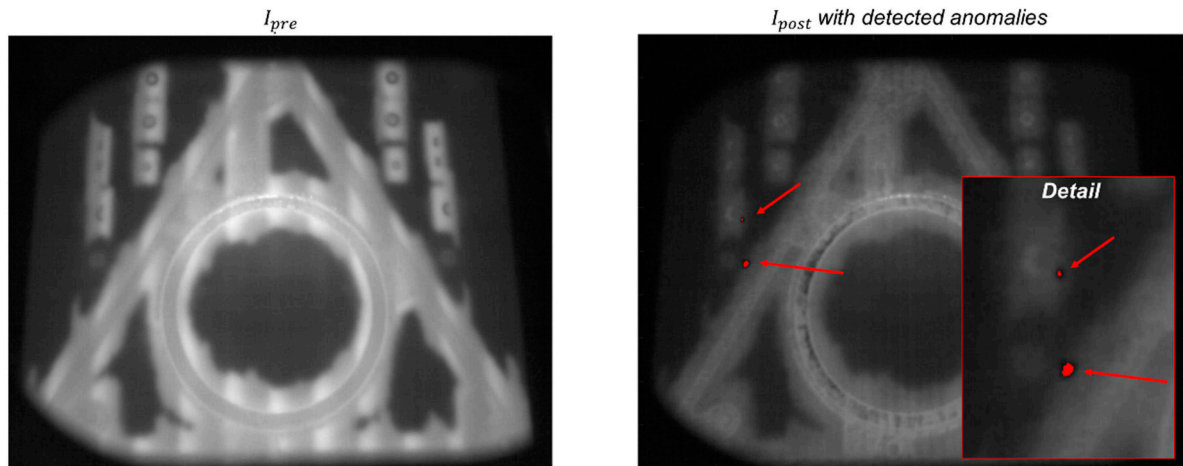
Figure 14. Pre-recoating (left panel) and post-recoating (right panel) images in the layer affected by the metallization contamination; the result of the anomaly detection is superimposed on the post-recoating image, showing the capability of the proposed approach to detect the two metallization slivers.

Figure 14 shows the pre-recoating image and the post-recoating image, where the automated anomaly detection is highlighted in red, as done in the previous subsection. Figure 14 shows that the two local anomalies were correctly detected by the proposed approach, despite their quite small size. This result is an example of the potential suitability of the methodology in identifying not only macroscopic anomalies but also much smaller and local ones.

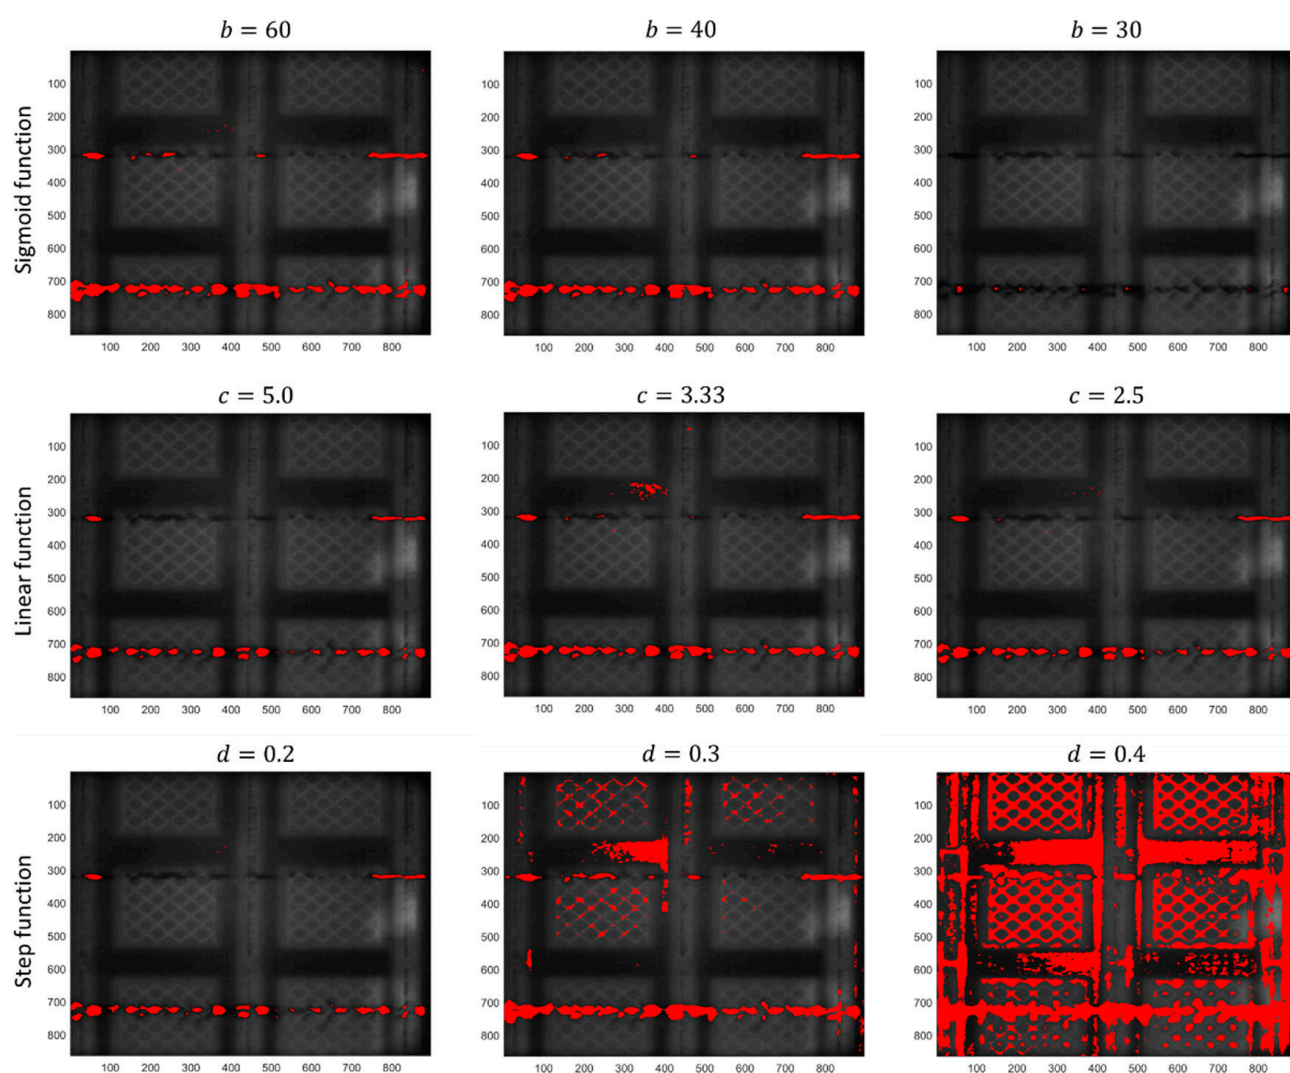
Figure 16. Example of outputs of the proposed approach with different definitions of the function f_T and for different choices of its parameters.

An example of anomaly detection in one layer resulting from the choice of different transfer functions, f_T , and from different choices of the associated parameters b , c , and d is shown in Figure 15. Additional results on the percentage of false alarms obtained for different functions and different choices of their parameters are shown in Table 3.

Regarding the sigmoid function, a smaller value of b implies a less restrictive condition on the range of pixels whose intensity is set to approximately null values in I_{tr*} . The result is an image where the range of pixel intensities is wider even in the absence of actual powder bed anomalies, with a consequent increase in the limit k_α in Equation (4). By increasing such a limit, only pixels with the most extreme intensities that belong to actual anomalies can be detected. This results in reduced detection capability, as shown in the top right panel of Figure 16 (sigmoid function with $b = 30$). By increasing the value of parameter b , the detection capability remains about the same for a large range of values of b . Indeed, as long as too small values are avoided, the performance of the method when a sigmoid function is adopted is quite robust and insensitive to the choice of parameter b .

A similar result was also obtained for the linear function. In this case, the range of values of c that lead to a good detection capability is even higher, although a slightly higher percentage of false alarms was observed, as shown in Table 3.

A quite different result was achieved by using the step function. As the output of the transfer function f_T is a binary image, there is no need for the alarm rule defined in Equation (4). However, this prevents the user from having a control on the percentage of false alarms, leading to the results shown in the bottom panels of Figure 16. A reasonable result can only be achieved by setting the dual threshold very close to extreme intensities, i.e., close to 0 and 1, as in the case with $d = 0.2$.
