## Acoustic emission-based monitoring of fatigue damage in CFRP-CFRP adhesively bonded joints

M Carboni and A Bernasconi

# Acoustic Emission Based Monitoring of Fatigue Damage in CFRP-CFRP Adhesive Bonded Joints

**Abstract.** Adhesive bonded joints are more and more applied in modern structures. However, manufacturing defects and particularly harsh operative conditions might cause local de-bonding and catastrophic failures. Structural Health Monitoring and Non-destructive Testing procedures are, then, needed for evaluating the in-service structural integrity of adhesive bonded joints.

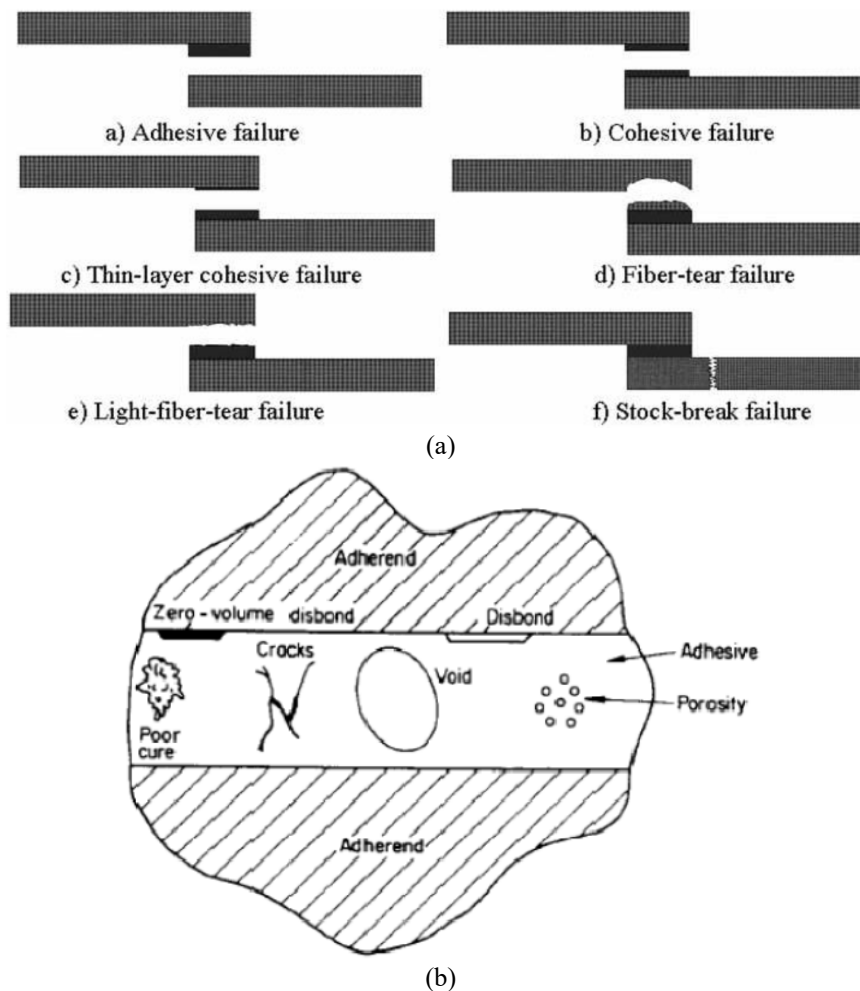
**Fig. 1.** (a) Possible failure modes of a single lap adhesive bonded joint between CFRP adherends [1]. (b) Common defects of the adhesive layer [1].

A primary role, in the competition between the different failure modes, is taken by the typical manufacturing defects originating within the adhesive or at the interface between the adhesive and the adherends. Fig. 1b [1] shows the main cases: the presence of such inhomogeneities and discontinuities in adhesive bonded joints requires, then, the application of maintenance, inspection and monitoring procedures able to guarantee the needed in-service reliability [3]-[5]. Many research studies are available, in the literature, on non-destructive testing (NDT) and structural health monitoring (SHM) of adhesive bonded joints. Summarizing, the most used NDT methods are [4]: visual testing, infrared thermography, ultrasonic testing, radiography and computed tomography (CT). On the other hand, the paradigm is recently shifting towards SHM, because it does not require service interruptions and allows a reduction of maintenance costs of components and systems up to 30% [5]. Today, the most widespread SHM methods applied to adhesive bonded joints are [5] acoustic emission (AE), strain measurement by strain gages or optical fibers and ultrasonic guided waves.

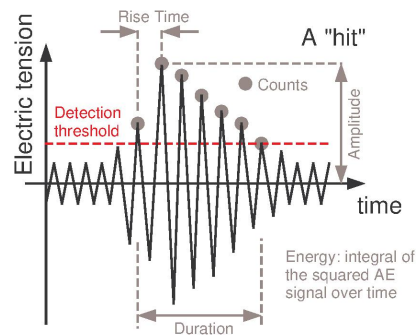
**Fig. 3.** Scheme of an AE hit (case of burst event) and its relevant features for the present case [17].

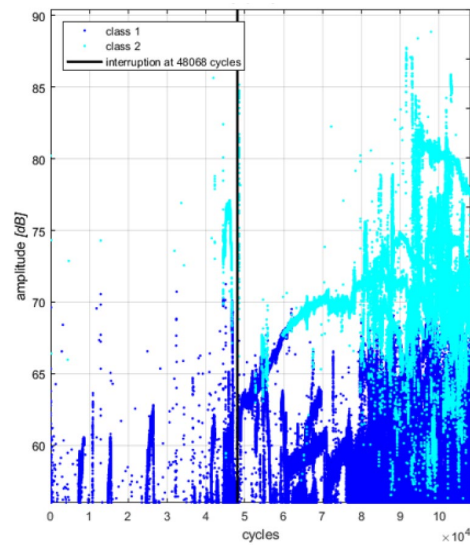
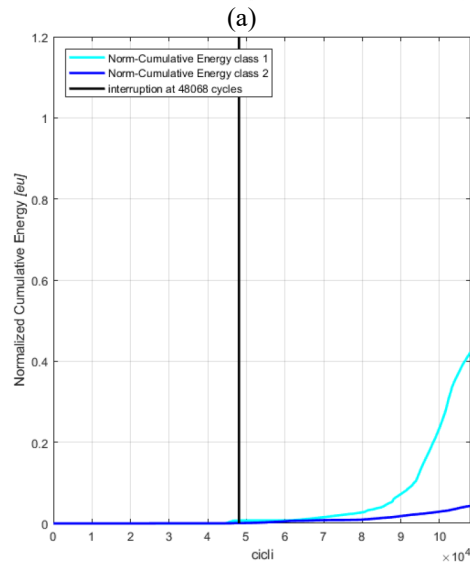
**Fig. 4.** Trend of classified AE events against the number of fatigue cycles (example of channel 1). (a) Fatigue cycles against amplitude in dB. (b) Fatigue cycles against cumulated energy.

The complete set of the classified recorded AE data, for the case of channel 1, is shown in Fig. 4a in terms of amplitude in dB against the number of fatigue cycles, and in Fig. 4b, in terms of cumulated energy against the number of fatigue cycles. Channel 2 showed analogous results. As can be seen, Class 1 is more uniformly distributed in the low-amplitudes region (mean amplitude value equal to 60.3 dB for channel 1 and to 60.2 dB for channel 2) and spans the whole axis of the number of cycles (the typical expected behavior of noise), while Class 2 is more concentrated and variable in the high-amplitudes region (mean amplitude value equal to 71.6 dB for channel 1 and to 74.3 dB for channel 2) and its activity increases with the accumulation of fatigue cycles (the typical expected behavior of fatigue damage). Moreover (Fig. 4b), the cumulated energy of Class 1 shows an almost linear and time-independent trend (typical, again, of noise), while that of Class 2 shows sudden variations of slopes and is time-dependent (typical, again, of damage development). Considering, then, channel 1, 66.6% of AE acquisitions were classified into Class 1, while the remaining 33.4% into Class 2. Likewise, for channel 2, 69.8% of AE acquisitions were classified into Class 1, while the remaining 30.2% into Class 2.

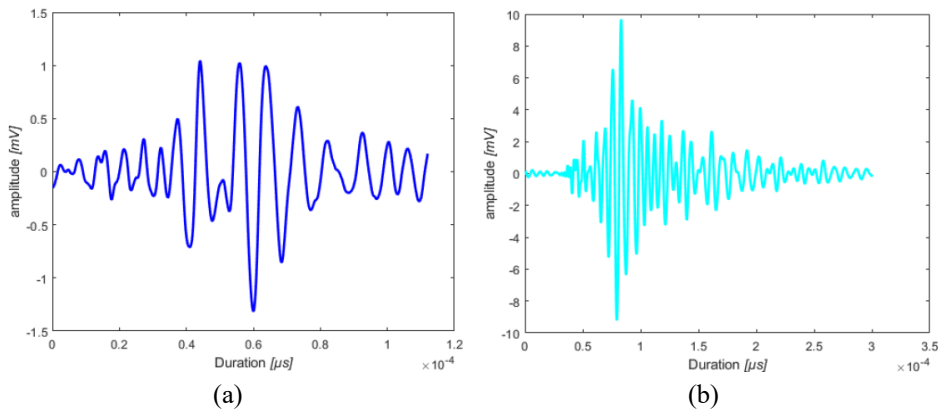
**Fig. 5.** Typical waveforms included into the two classes. (a) Class 1. (b) Class 2.

A further simple check consisted in the visual analysis of the morphology of the waveforms included into the defined classes. Fig. 5 shows some emblematic examples: Class 1 includes the typical waveforms related to background noise, while Class 2 those related to damage phenomena (particularly, fracture).

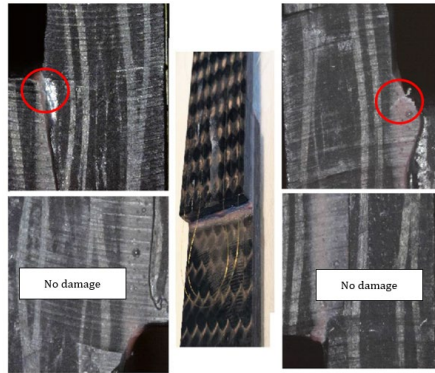
**Fig. 6.** Visual testing of the edges of the overlapped region of the adherends after 49100 fatigue cycles.

A final validation of this conclusion and of the proposed SHM approach is the comparison to the results obtained by the NDT techniques applied during the fatigue test. Particularly, in order to check if the proposed SHM approach is able to detect the first stages of damage development, the fatigue test was interrupted, for the first time, at 49100 cycles, i.e. just after the first AE events classified in Class 2 were observed (Fig. 4a). Fig. 6 shows the results of visual testing applied at the edges of the overlapped region of the adherends after 49100 fatigue cycles. As can be seen, the upper edge presents the initiation of micro-cracks which were not detected by the same inspection carried out at 0 fatigue cycles, while the lower edge was still intact. This is confirmed by the  $\mu$ CT analysis of the overlapped region of the adherends after 49100 fatigue cycles (Fig. 7) and suggests that, actually, the first recorded AE events classified in Class 2 could be due to the initiation of fatigue cracks in the specimen.

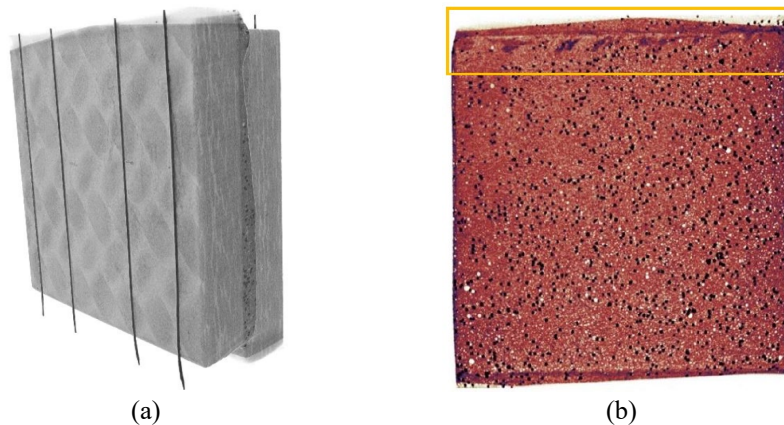
**Fig. 7.**  $\mu$ CT analysis of the overlapped region of the adherends after 49100 fatigue cycles. (a) Region of interest. (b) Slice of the fatigue damaged region (false colors).

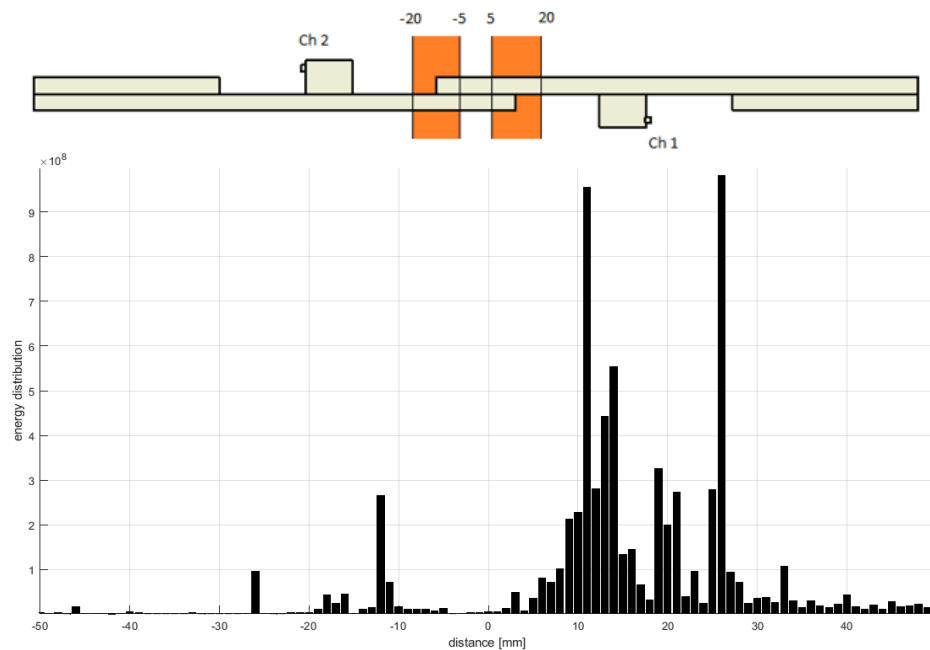
Fig. 8. Localization of AE events.

The analysis was carried out considering just the AE events classified in Class 2, i.e. the one here assumed to be related to the developing fatigue damage. Fig. 8 shows, then, the energy distribution of the localized events as a function of the position along the specimen. As can be seen, the cumulative energy, i.e. the most energetic AE events, tended to gather in correspondence of the overlap ends, where damage initiated and propagated, as observed by VT and  $\mu$ CT. In particular, most of the energy was released at the overlap end close to channel 2, i.e. the one presenting, at the end of the fatigue test, the highest AE activity. It can be concluded that localization furtherly validates the proposed classification algorithm and proves to be effective in the perspective of in-field SHM application to the considered kind of lap-joints.
