*In situ* cleaning of diagnostic first mirrors: an experimental comparison between plasma and laser cleaning in ITER-relevant conditions

2017 Nucl. Fusion 57 046014

A. Maffini<sup>1</sup>, L. Moser<sup>2</sup>, L. Marot<sup>2</sup>, R. Steiner<sup>2</sup>, D. Dellasega<sup>1,3</sup>, A. Uccello<sup>3</sup>, E. Meyer<sup>2</sup> and M. Passoni<sup>1,3</sup>

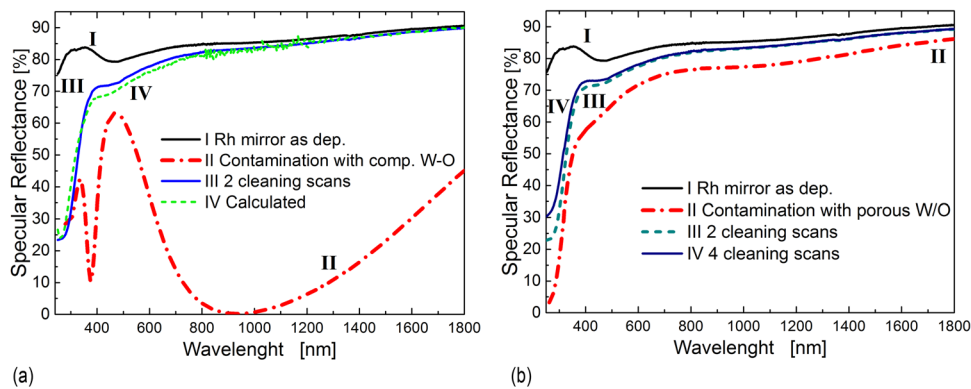
**Figure 11.** (a)  $R_{\text{spec}}$  of a Rh mirror before contamination (I, solid black), contaminated with compact W/O (II, dashed red) and after 2 laser cleaning scans (III, solid blue). The dashed green line (IV) shows the reflectance calculated by supposing a 5 nm thick WO<sub>3</sub> film (Cauchy layer with  $n = 2.17$  at  $\lambda = 550$  nm) on top of the Rh film. (b)  $R_{\text{spec}}$  of a Rh mirror before contamination (I, solid black), contaminated with porous W/O (II, dashed red), after 2 laser cleaning scans (III, dashed light blue) and after 4 laser cleaning scans (IV, solid dark blue).

In figure 11(a) we report the specular reflectance of a pristine Rh mirror (solid black line, I), of a Rh mirror contaminated with compact W/O (dashed red line, II) and of the same mirror after 2 laser cleaning scans (solid light blue line, III) are reported in figure 11(a).

Owing to the laser cleaning treatment,  $R_{\text{spec}}$  was well recovered in the NIR–vis region (>90% of the pristine value). For  $\lambda < 400$  nm, however, a sharp drop in  $R_{\text{spec}}$  is evident. This threshold wavelength corresponds to the optical band-gap of W/O contaminants, as can be estimated from dashed red lines in figures 11(a) and (b), which describe the specular reflectance of contaminated mirrors before the cleaning treatment (the optical band gap of crystalline WO<sub>3</sub> is about 2.8 eV,

The specular reflectance of the mirror contaminated with porous W/O after 2 laser cleaning scans is shown in figure 11(b) (dashed light blue line, III). It is remarkably similar to the one obtained considering the cleaning of compact W/O contamination, despite the dramatic differences in contaminant morphology and optical properties.  $R_{\text{diff}}$  was below 1% in the whole 250–1800 nm range.

After the first laser cleaning session, the same sample was cleaned again with two additional scans. The corresponding  $R_{\text{spec}}$  is plotted as the solid dark blue line (IV) in figure 11(b). By comparing dashed light blue and solid dark blue curves, we conclude that the additional cleaning cycles had a beneficial effect on the  $R_{\text{spec}}$  recovery in the UV region. The Rh coating appeared intact after the whole cleaning treatment (4 scans).

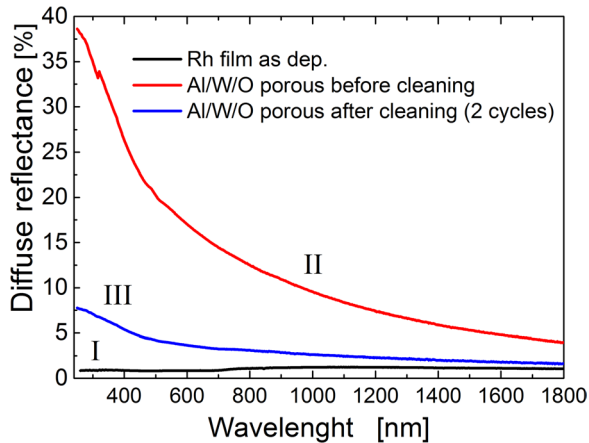
**Figure 15.**  $R_{\text{diff}}$  of a bare Rh mirror as deposited (I, black), after contamination with porous Al/W/O (II, red), after 2 scans of laser cleaning (III, blue).

By comparing the diffuse reflectance before (figure 15, line II red) and after the laser cleaning (figure 15, line III blue), it is clear that the recovery in  $R_{\text{spec}}$  was essentially due to a decrease in  $R_{\text{diff}}$  as a consequence of the cleaning process.
