Effect of Surface and Subsurface Defects on Fatigue Behavior of AlSi10Mg Alloy Processed by Laser Powder Bed Fusion (L-PBF)

Abstract: The fatigue behaviour of an AlSi10Mg alloy processed by laser powder bed fusion (L-PBF) and subjected to different surface finishing processes was investigated paying special attention to the residual defects on the surface and the dominant fatigue failure mechanisms. Roughness measurements and qualitative surface morphology analysis showed smooth surfaces in the case of vibro-finishing and machining followed by polishing. The fatigue performance did not reveal to be directly related to surface roughness, but residual intrusions left on the finished surfaces. Post-mortem analysis showed single- or multiple-crack nucleation from pores opened on the surface, un-melted powders, or spatters considered as typical L-PBF defects. A fatigue limit of 195 MPa for machined and polished samples was obtained by substantial removal of surface and subsurface defects.

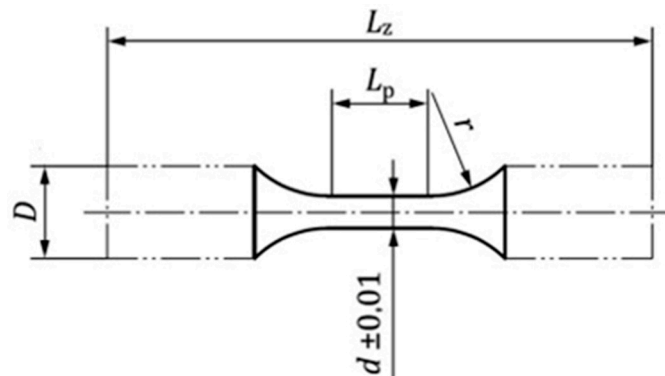
Figure 1. Technical drawing of the AlSi10Mg tensile and fatigue specimens (ISO 1099:2017).

Near-net shape cylindrical specimens were additionally printed for fatigue testing, with their longitudinal axis oriented along the z direction. The specimens featured a gauge diameter of $d = 8$ mm and a gauge length of $L_p = 40$ mm, according to the design recommended by ISO 1099:2017 standard for fatigue testing (Figure 1).

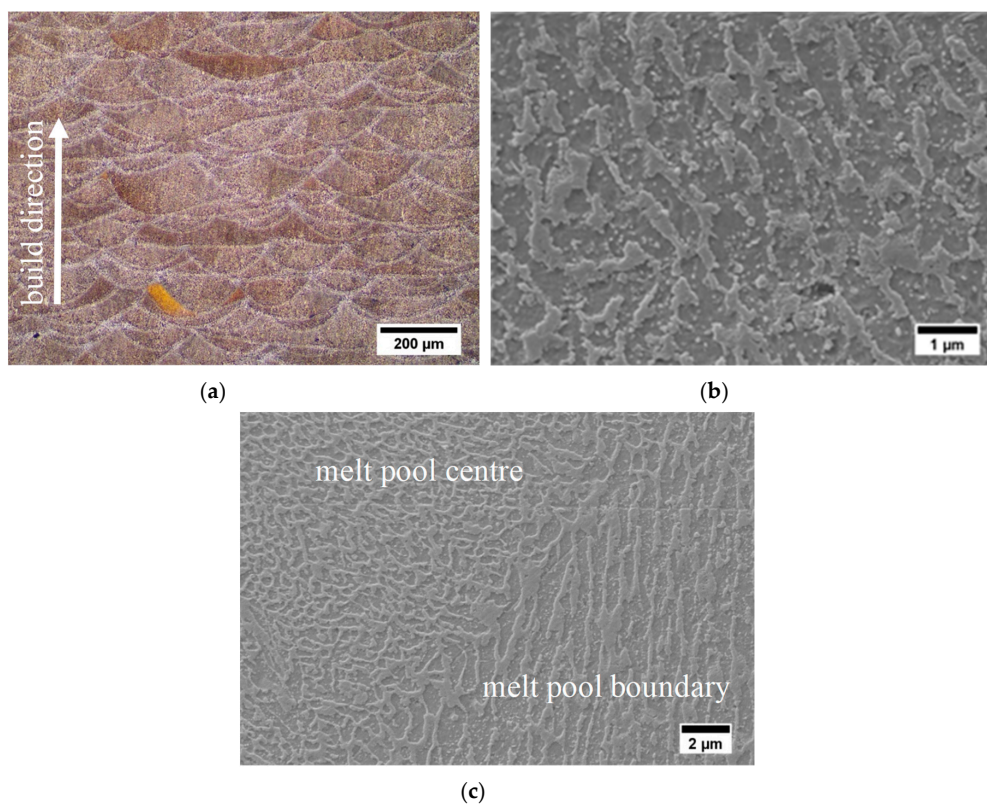
Figure 2. Microstructure of the investigated AlSi10Mg alloy. (a) Optical image of the melt tracks; (b) scanning electron microscope (SEM) image of the melt pool boundaries, and (c) of the melt pool center.

Representative optical and SEM micrographs of the as-built AlSi10Mg alloy are depicted in Figure 2. From low magnification images (Figure 2a), the distinct tracks of the melt pools are visible, showing the amount of overlapping both along lateral and z directions (vertical direction in Figure 2a). Higher magnification views (Figure 2b,c) reveal the presence of a fine cellular solidification structure consisting in submicrometric primary α -Al cells decorated by a network of Si. Further precipitates, also rich in Si, are detected inside the cells as isolated particles [23]. It is noticed, crossing the boundary of the melt pool, the size of the cells is subjected to a change (Figure 2b) owing to the reheating effects produced by the subsequent passes and to local changes in solidification conditions [8,26]. The observed microstructure is fully consistent with description available from literature [1,27].

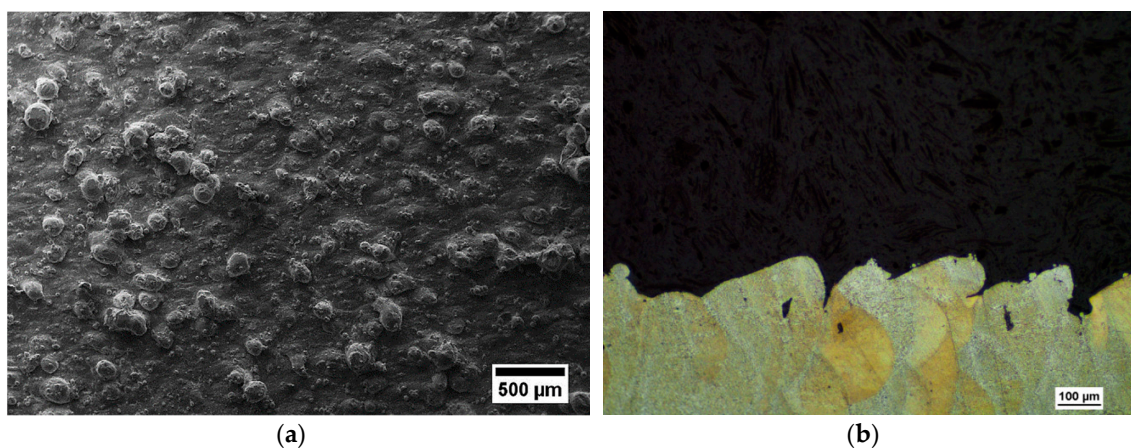
Figure 3. Surface morphology of the as-built AlSi10Mg specimens. (a) SEM view of side surface; (b) optical micrograph of a cross-sectioned sample showing a view of surface profile; the build direction (z-axis) is horizontal.

The surface appearance of the AlSi10Mg alloy in the as-built condition is depicted in Figure 3. Views of the side surface of printed samples (Figure 3a) reveal the typical features generated during melting of the powder such as a population of spherical particles having a wide range of sizes that have been identified in the literature as partially melted metal powders, ballings, and spatters, depending on the mechanisms of their formation [8,9]. These features are also recognized by the analysis of cross-sectioned samples observed close to the surface profile (Figure 3b) and the confocal microscopy images from the surface presented afterwards.

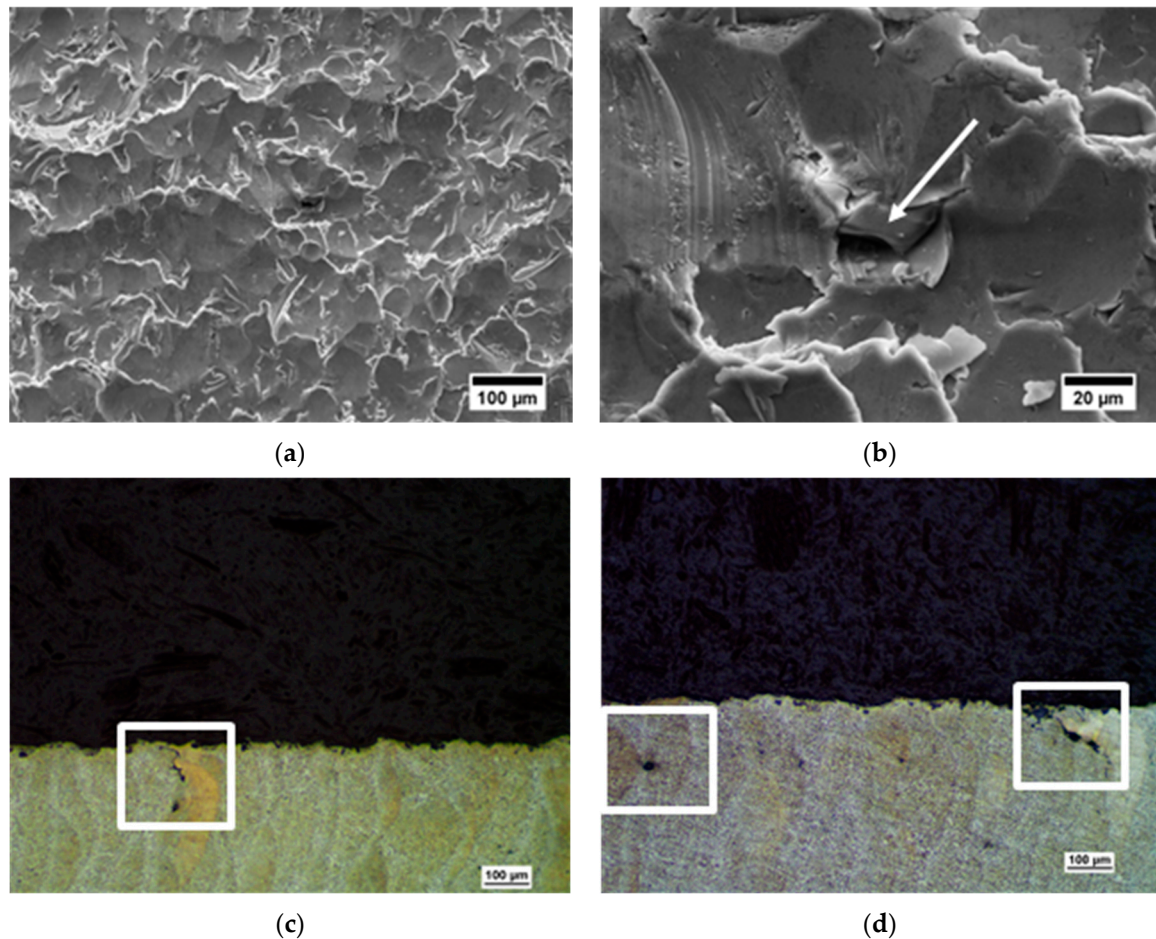
Figure 4. Surface morphology of the sandblasted (SB) specimens. (a,b) SEM views of the top surface; (c,d) optical micrographs of a cross-sectioned sample showing a view of the surface profile.

Similar images collected for the SB, VF, and MP specimens are depicted in Figures 4–6, respectively, followed by their height images in Figure 7. Observations of Figures 4 and 7b suggest that the typical surface features of as-built L-PBF samples are replaced in SB specimens by shallower indentation craters of collided particles created during sandblasting. Occasional evidence of fragmented debris of these particles are noticed on the surface (see arrowed fragment in Figure 4b) [28,29]. Cross-sectional profiles (Figure 4c,d) agree with the SEM images exhibiting the waviness as a result of craters and subsurface porosities generated during the sandblasting attributed to the plastic deformation of the surface and closure of the deep valleys in as-built surfaces (see white squared defects in Figure 4c,d).

surface (refer to Figure 4c,d). In a few instances the failure was due to open pores exposed on the surface. This can be assigned to the nature of the sandblasting process, which plastically deforms the surface, causing the closure of open pores in most of the cases and generating a beneficial compressive stress field on the surface of the treated specimens [14,33]. It is believed that this could be the main reason for the improved fatigue limit shown by SB samples over the VF samples, especially in the high-cycle regime.

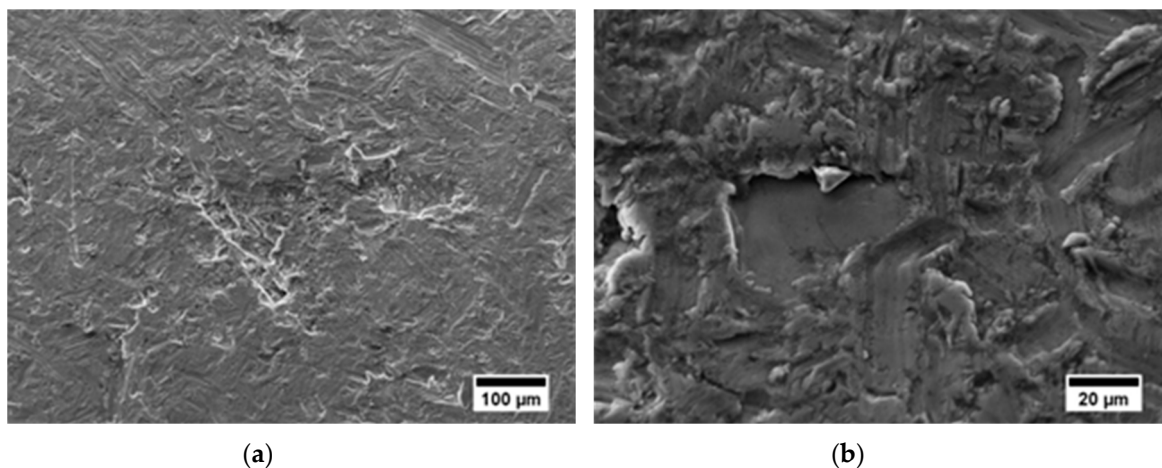
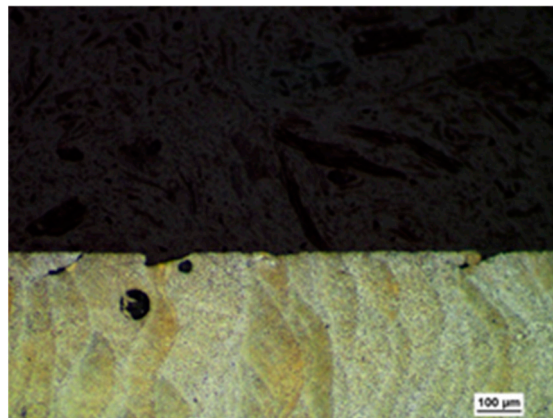
Figure 5. Surface morphology of the vibro-finished (VF) specimens. (a,b) SEM views of the top surface; (c) optical micrograph of a cross-sectioned sample showing a view of the surface profile.

Figures 5 and 7c represent the surface aspects of samples after vibro-finishing. The original features of the as-built surface and the waviness corresponding to the tracks are gone. However, several open pores can still be identified on the surface profile (see Figures 5c and 7c). These are supposed to be inherited from surface or subsurface defects formed during L-PBF processing and are typically

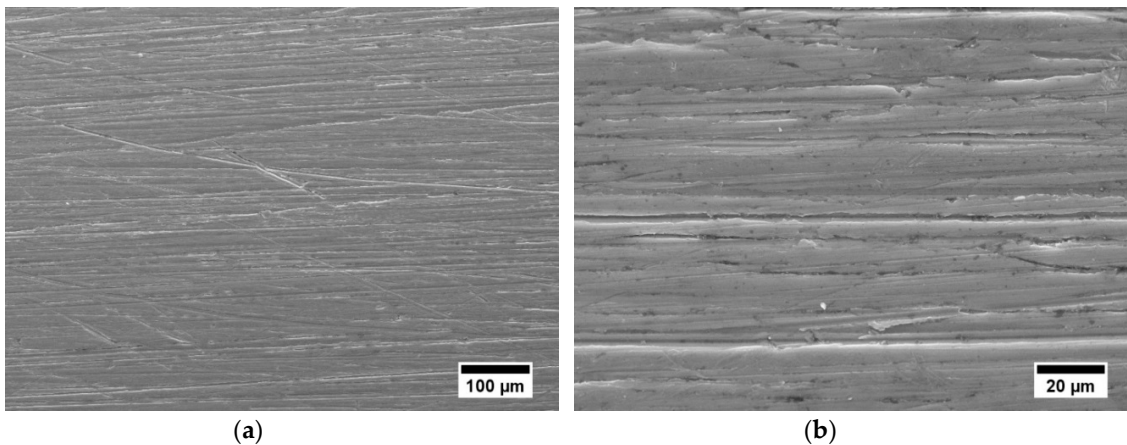
Figure 6. Surface morphology of the machined and polished (MP) specimens. (a,b) SEM views of the top surface.

Finally, the surface of the machined and polished specimen shown in Figures 6 and 7d reveal the shallow polishing marks oriented along the specimen axis. Any evidence of the original surface features created by the L-PBF process is eliminated by the removal of a layer of 0.5 mm of material by machining [15,22,30].

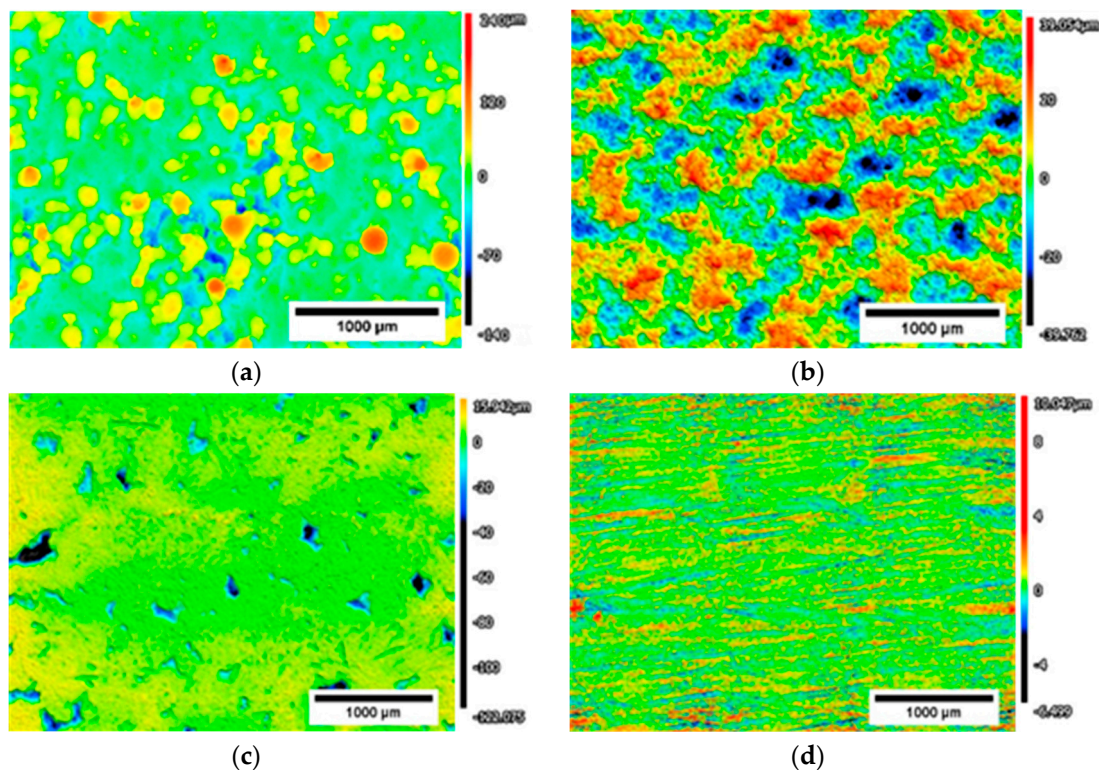
Figure 7. Topographies of the specimens measured by the confocal microscopy: (a) as-built; (b) SB; (c) VF; (d) MP.

A similar effect was produced in MP samples but here, a layer of 0.5 mm of material was cut by machining, substantially removing any intrusion or subsurface defect. The substantial material removal resulted in elimination of almost all of the surface and subsurface defects achieving a significant reduction in maximum height value (S_v) (from 85 to 6 μm). This improvement achieved a notable boost in the fatigue strength of MP samples over the full range of fatigue lives here investigated (see Figure 10) and in the shift from a multiple crack nucleation mode (from surface and subsurface defects) to single crack nucleation starting from formerly bulk defects (porosity) that are exposed on the surface after the layer removal. The skewness value for MP specimens ($S_{sk} = 0$) suggests a symmetrical topography with random height distribution being in harmony with microscopical analysis.

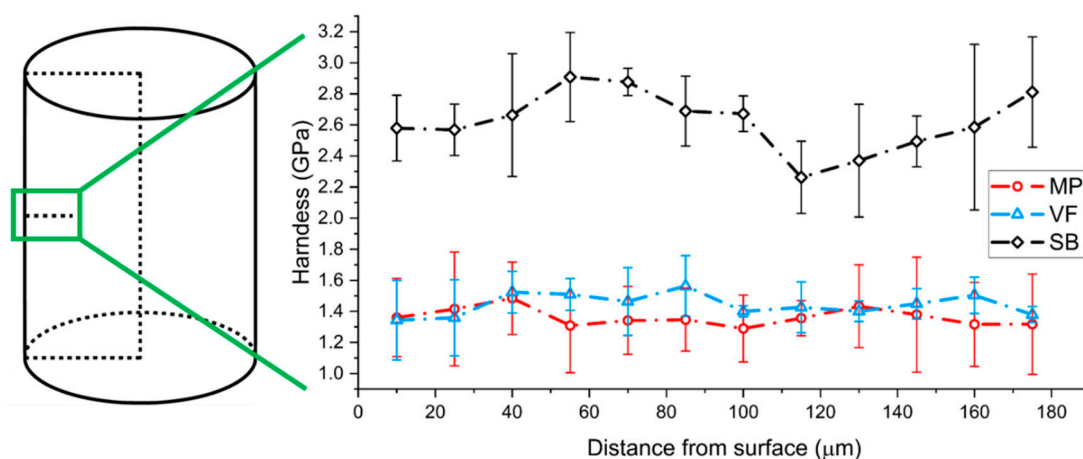
Figure 8. Nano-indentation profiles for the different surface conditions investigated; origin of distance corresponds to the surface of the specimen.

Nano-indentation profiles for each surface condition are provided in Figure 8. The hardness value of SB specimens significantly improved due to the strain hardening brought by the sandblasting process at least up to the depth of 175 μm from the surface. No notable difference was observed in the MP and VF surface conditions.

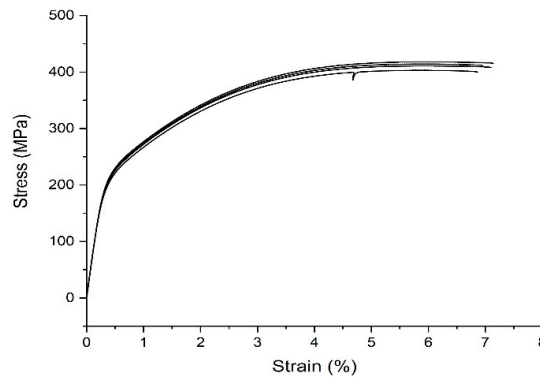
Figure 9. Tensile curves of the L-PBF AlSi10Mg alloy with a platform temperature of 160 °C.

Table 4 summarizes the main tensile properties of the manufactured AlSi10Mg alloy via L-PBF with a platform temperature of 160 $^{\circ}\text{C}$, while Figure 9 shows the recorded tensile curves. The tensile properties were comparable or even superior to the recorded values in the literature [1], suggesting that the presence of bulk defects is not a concern in this study.

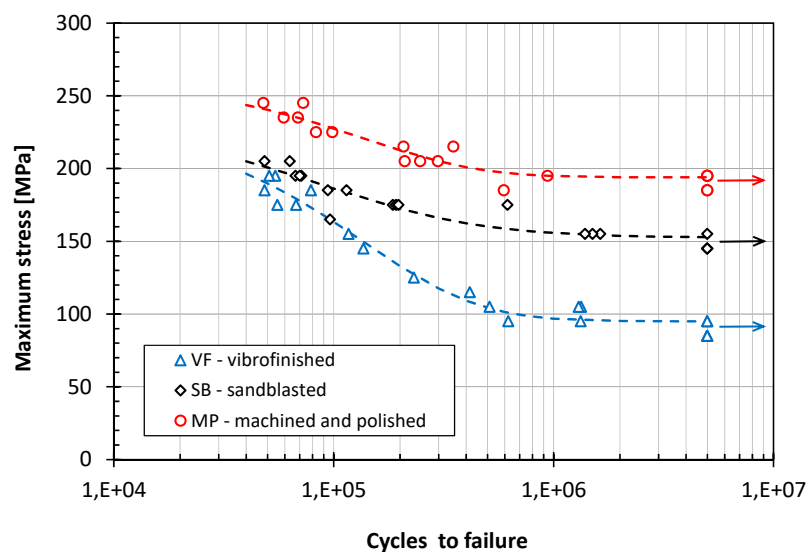
Figure 10. Effect of surface condition on fatigue curves of the L-PBF AlSi10Mg alloy.

Curves of maximum stress vs. number of cycles to failure for the three surface conditions investigated are presented in Figure 10. A quantitative analysis of the fatigue data was performed by applying the Basquin’s numerical fit to the S-N data plotted in the log-log scale [31]. This is achieved by fitting the stress amplitude (σ_a) and the number of cycles to failure (N_f) in the form $\sigma_a = A (N_f)^B$. The obtained parameters are reported for each surface condition in Table 5. Smaller absolute B values (i.e., reduced slope) represent a higher fatigue performance. The fatigue limits for runouts fixed at 5×10^6 cycles, are also reported in the same table. Additionally, the fatigue limits of the as-built surfaces were added from literature for the sake of comparison.

From the data collected, it is inferred that the VF materials show the lowest fatigue limit (95 MPa), which is attributed to the presence of occasional open surface and subsurface defects. The SB specimens exhibit a higher fatigue limit (152.5 MPa) and improved behavior in the high-cycle fatigue regime. Both these sets of specimens show a similar behavior in the low-cycle range. The MP sample group showed a significant improvement of the fatigue response in the whole range of fatigue cycles, recording a fatigue limit of 194 MPa. In all cases, a substantial improvement in the fatigue limit over as-build surfaces in literature was achieved.

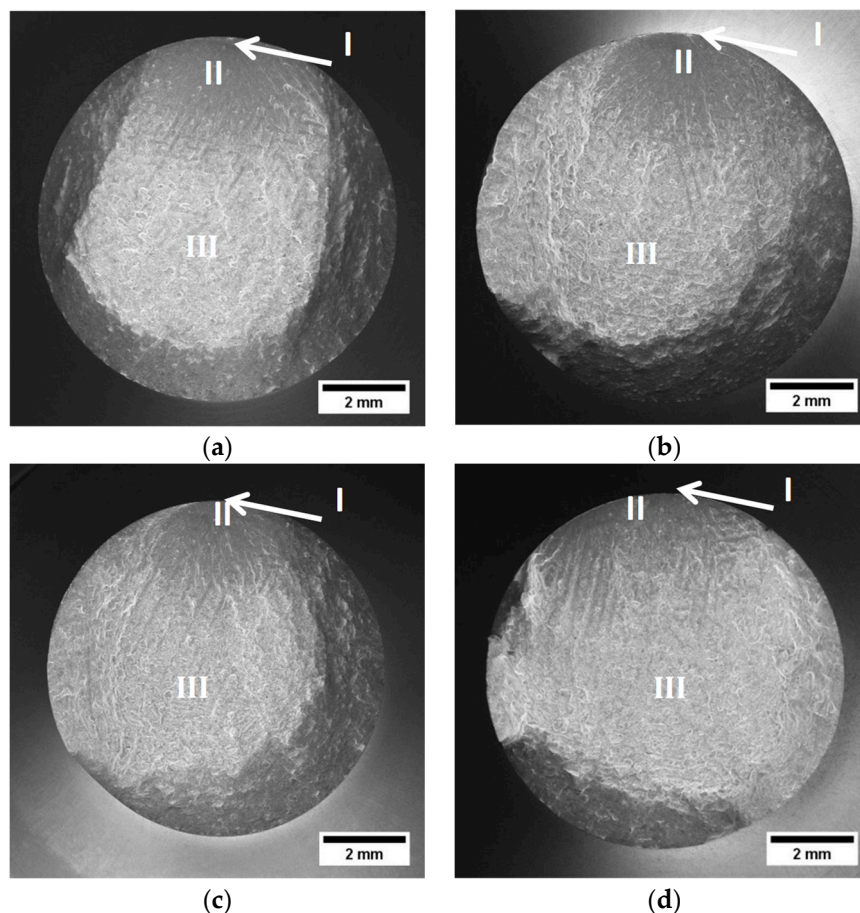
Figure 11. Views of fatigue fracture surfaces of MP samples loaded at a maximum stress of (a) 185 MPa, (b) 205 MPa, (c) 225 MPa, and (d) 245 MPa.

For the analysis of the fatigue mechanisms, the fracture surfaces were ideally divided in their main regions, namely (I) crack initiation, where the crack nucleates and grows slowly in its first stage; (II) steady crack propagation; (III) final overload and fracture of the specimen. The extension of the steady crack growth (II) can roughly be evaluated on the basis of the fracture appearance, as observed from general views (Figure 11) and better defined from more accurate analyses. Region II’s size depends on the applied stress, decreasing it when increasing the applied stress, as observed in Figure 11 for a set of representative MP samples. Here, the crack growth surface area decreases when moving from a maximum stress at failure of 185 MPa (approximate area of region II of 4.9 mm²) to 245 MPa (approximate area of 2.6 mm²).

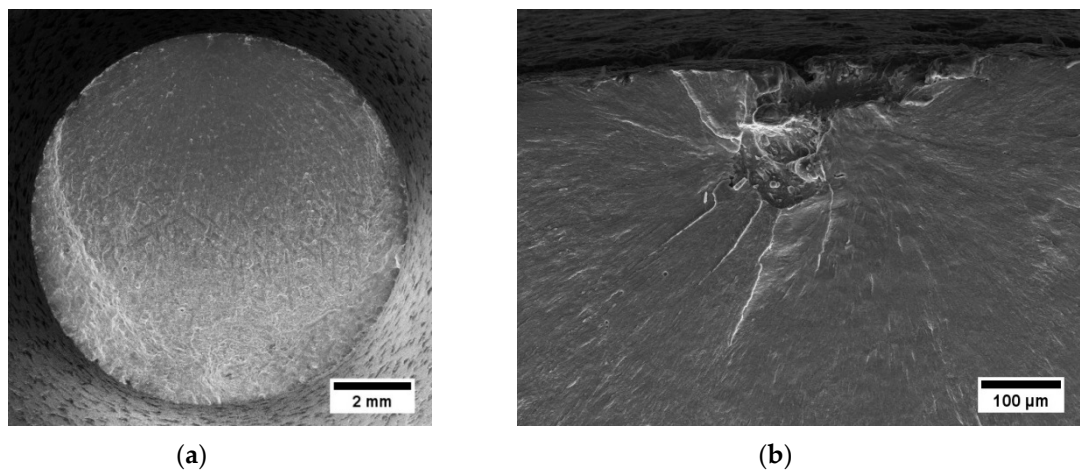
Figure 12. Fracture surface of a VF sample failed at the maximum stress of 95 MPa; (a) general view; (b) main crack nucleation site.

Figures 12 and 13 depict the fracture surfaces of two VF samples failed at the stress levels of 95 and 175 MPa, respectively. VF samples substantially always failed by crack nucleation from open surface or subsurface defects which are considered to be residuals of the original L-PBF defects. As a

rule, VF samples failed by single crack nucleation at lower stress levels (Figure 12) and by multiple crack nucleations at higher stress levels (Figure 13).

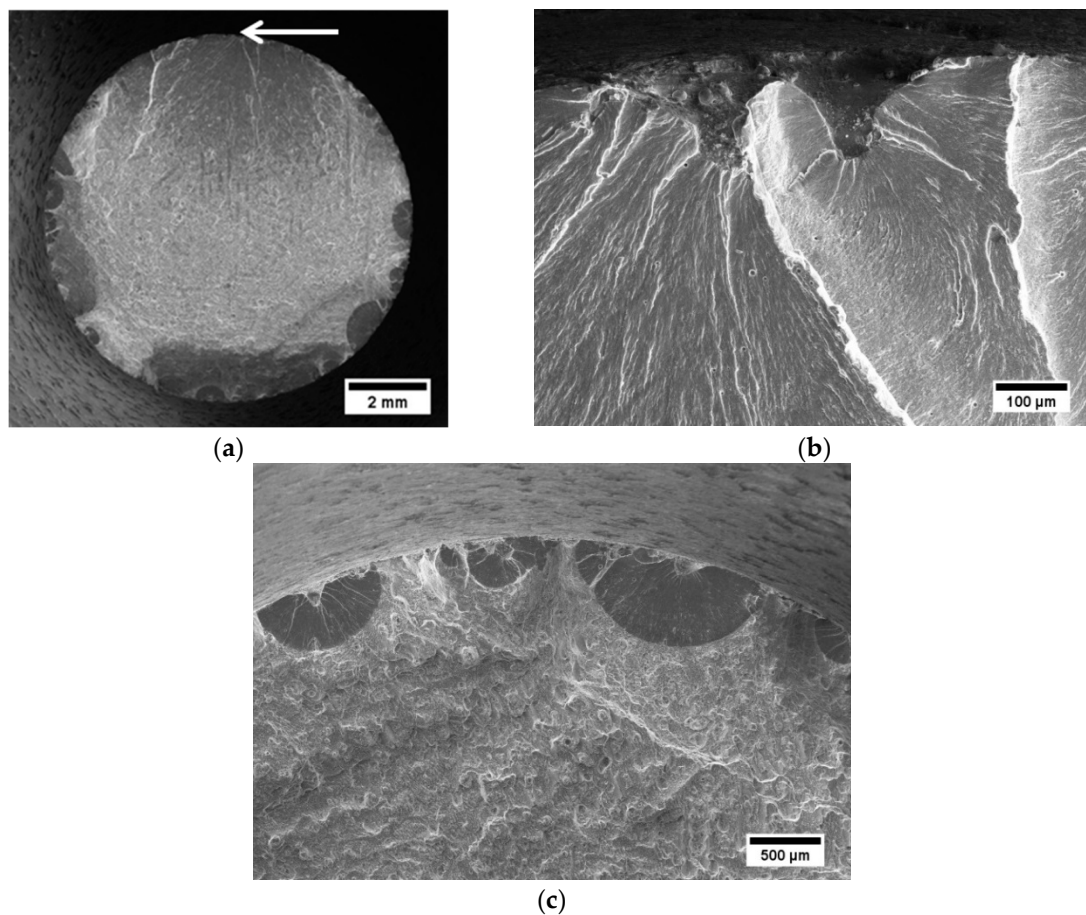
Figure 13. Fracture surface of a VF sample failed at a maximum stress of 175 MPa; (a) main crack nucleation site (arrowed); (b,c) secondary multiple crack nucleation sites.

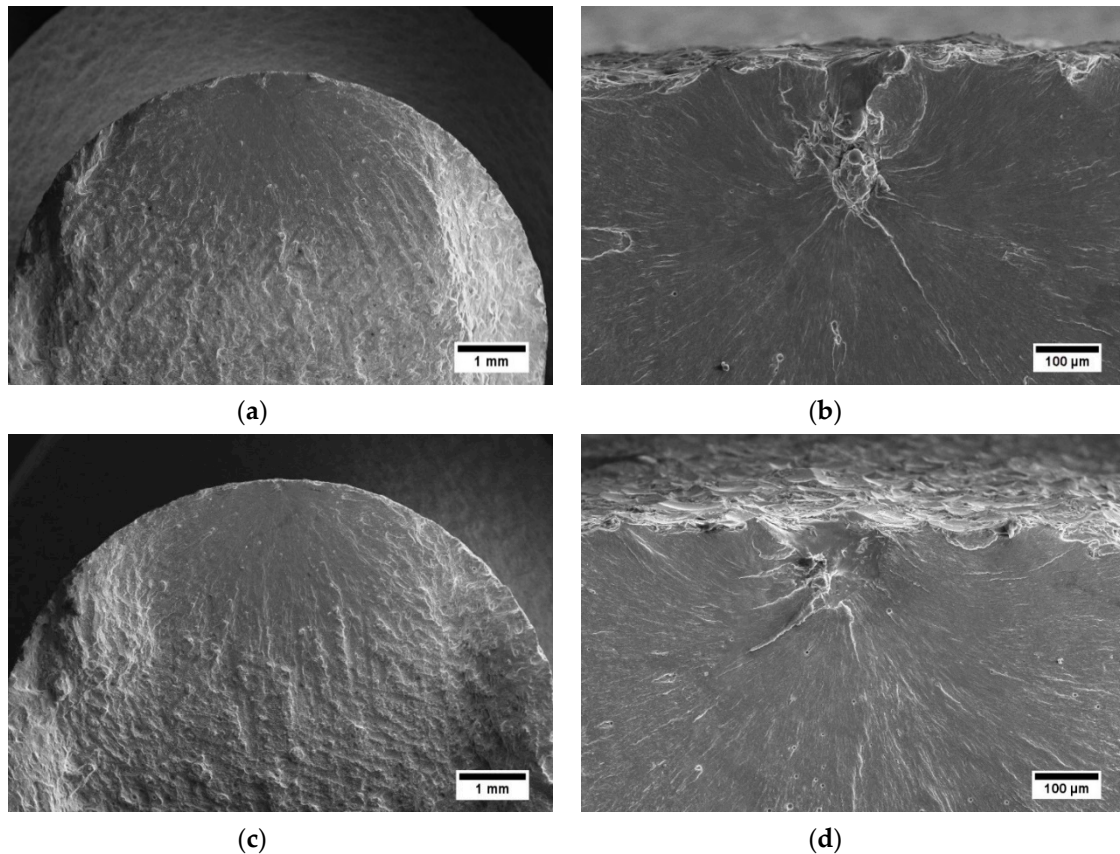
Figure 14. Fracture surfaces of SB samples failed at maximum stress level of 175 MPa; (a,b) the specimen failed by crack nucleation from a subsurface defect; (c,d) the specimen failed by crack nucleation from a surface defect.

Figure 14 collects views of fracture surfaces of the SB samples. SB samples always failed by a single nucleation site, irrespective of applied stress level. Most of these nucleation sites generated by occasional residual subsurface defects found within a thickness of around 200 μm from the specimen

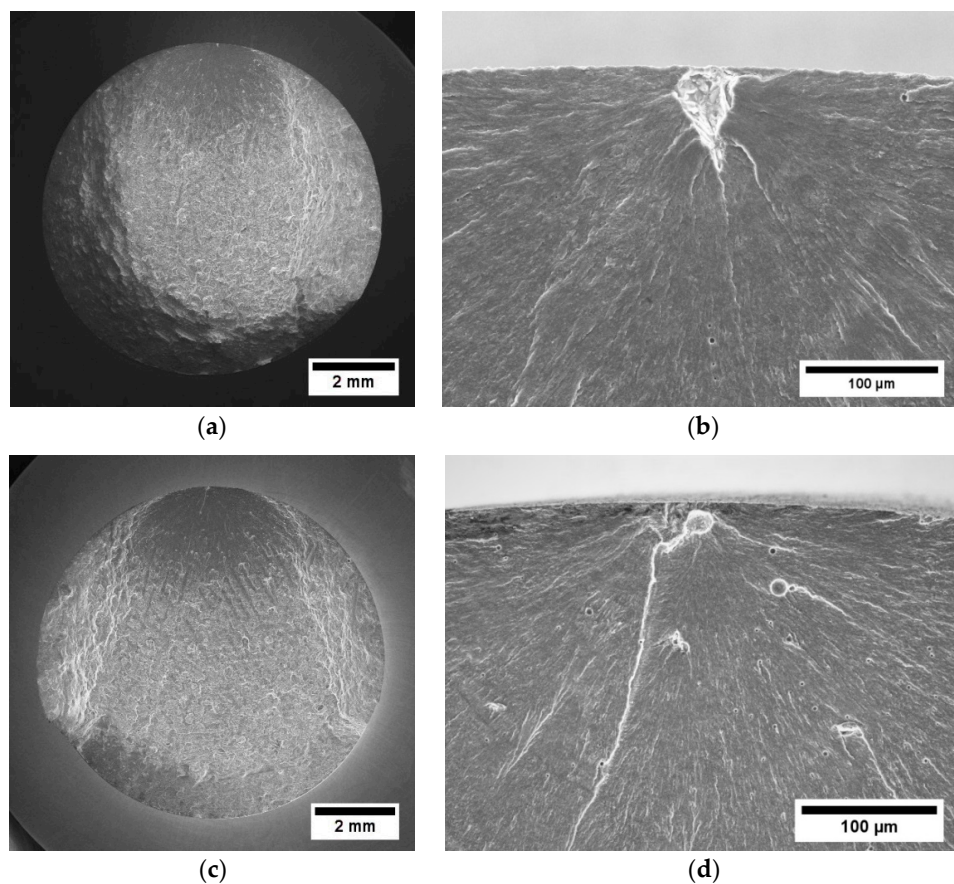
Figure 15. Fracture surfaces of the MP samples: (a,b) failed at the maximum stress of 215 MPa; (c,d) failed at the maximum stress of 195 MPa.

Finally, Figure 15 exhibits the fracture surfaces of the MP samples. In these samples the effects of any original L-PBF surface feature were removed by machining and polishing. Specimens generally failed from single defects corresponding to the occasional bulk pores which became exposed on the surface due to the machining operation.

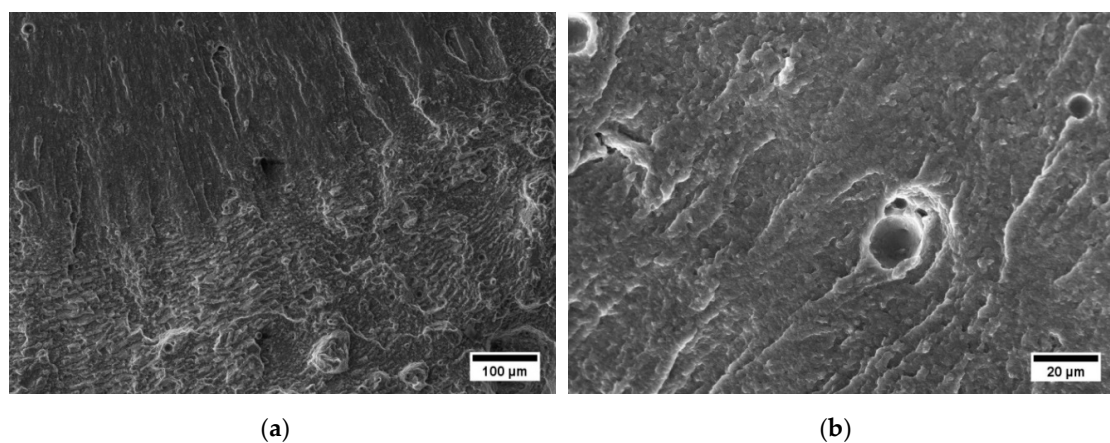
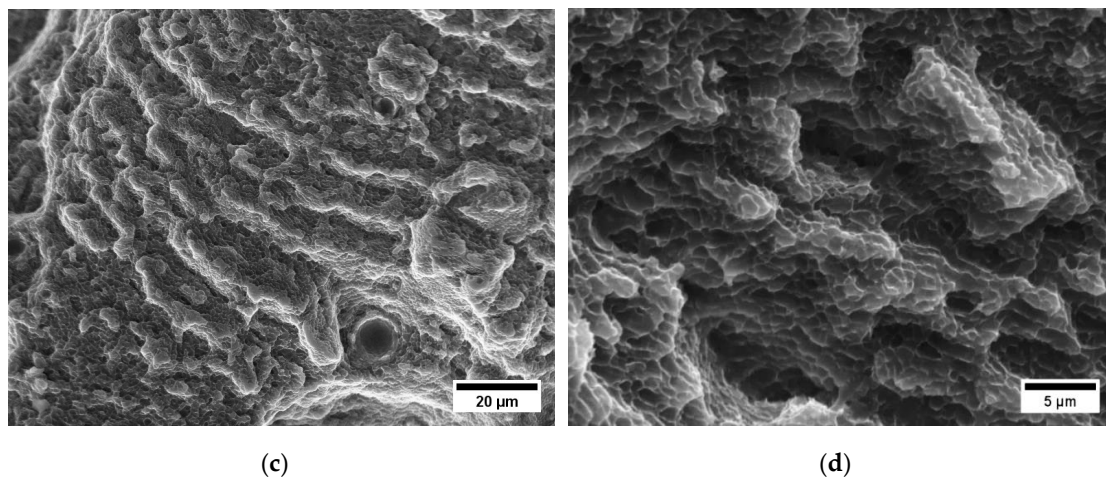
Figure 16. Fracture surface of a SB specimen failed at maximum stress level of 155 MPa. (a) Interface between region II and III of crack propagation; (b) high magnification view of small pores interacting with crack growth front in region II; (c) deeper ridges and (d) micro-dimples detected in region III.

The microscopic features concerned with crack growth in regions II and III of the fatigue process were similar for all the conditions investigated. Crack growth during phase II produced a planar, almost featureless surface showing several shallow ridges. The effects of small pores and inclusions or spatters on the crack growth front were recognized, locally deviating it and changing its growth rate (Figure 16b). In zone III (bottom of Figure 16a,c) deeper ridges and occasional micro-dimples corresponding to the size of the cellular microstructure are observed. A fully dimpled fracture is eventually observed in last stages of crack evolution, suggesting a ductile mechanism of fracture in the overload fracture zone (Figure 16d).
