Corrosion products resulting from carbonation acting upon chloride-induced corrosion in 22 years old blast furnace slag concrete

Abstract

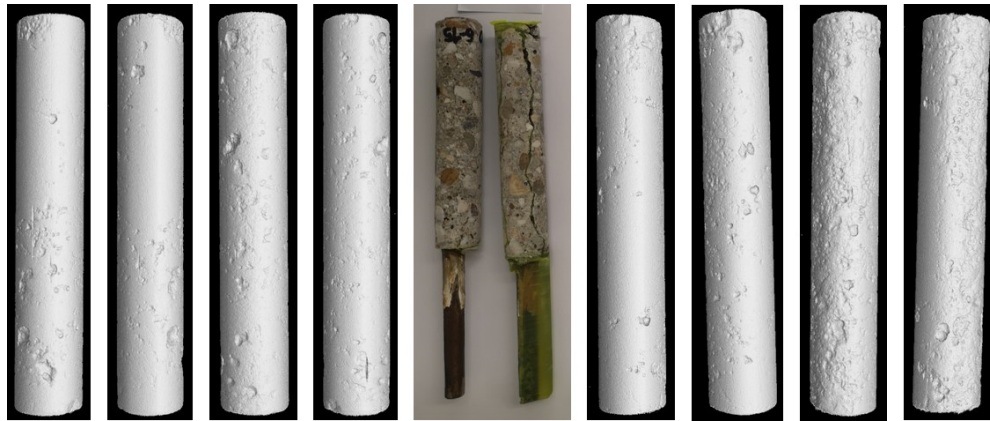
Fig. 2 Renders of the steel surface (four images showing four different faces) for the core in sound concrete (left) and the one with an associated crack (right).

The renders of the CT scans are shown in Fig. 2, together with the investigated cores, illustrating the distribution of pits over the steel surface. In the renders, only the scanned portion of the rebar is visible, in four different pictures in order to show the whole steel surface. It can be noticed that after the exposure for 22 years, corrosion has propagated in the form of pits distributed on the whole surface of the bar in the uncracked core. In the cracked core, however, a portion of the steel seems to be more subject to pitting corrosion, with a higher density of several minor pits distributed over the whole length.

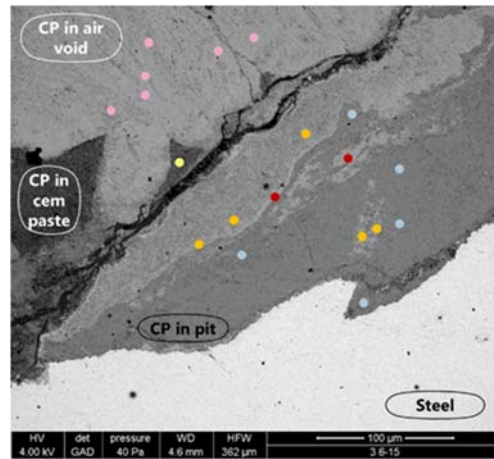
Fig. 5 Raman data superimposed on reflective light (left) and SEM image (right, detail), rebar in sound concrete. Green maghemite / ferryhydrite / feroxyhyte, light green maghemite / ferryhydrite / feroxyhyte and cement paste, pink and orange maghemite, blue goethite, red magnetite. For discussion, see text.

2. In the uncracked core, shallow, broad pits filled with corrosion products and with bright marblings towards the outside (Fig. 5). The corrosion product layer in this case does not continue along the steel outside the pit. In the cement paste, corrosion products probably completely filling an air void at the steel concrete interface and further deposited in the cement paste.

4. Corrosion products precipitated in the cement paste, beyond the brighter mill scale layer, both in the uncracked (Fig. 5) and in the cracked core (Fig. 4, and also visible in Fig. 7 as brown deposits among the aggregates in concrete).

5. Corrosion products precipitated as euhedral crystals in air voids at the steel-concrete interface, both in the uncracked and cracked cores. In the uncracked core, the air void appeared completely filled with corrosion products, and the euhedral structure is very dense (Fig. 5, right). In the cracked core, corrosion products appeared partly as well defined euhedral crystals growing into the void, partly as layered products on the void walls (Fig. 6).

- **Mill scale:** Raman analyses on the brighter layer detected the presence of iron oxides such as magnetite and wüstite, confirming that this layer corresponded to the original mill scale present on the steel surface at the moment of concrete casting [5], [6]. The mill scale textures observed suggested that the pits were located at places where the mill scale was originally damaged, enabling ingress of corrosive agents, and giving rise to crevice corrosion (Figs. 3, 5).
