Effects of laser treatment for surface structuring on AZ31 Mg alloy degradation

AG Demir¹, TB Taketa², R Tolouei³, V Furlan¹, C Paternoster³,
MM Beppu², D Mantovani³, B Previtali¹

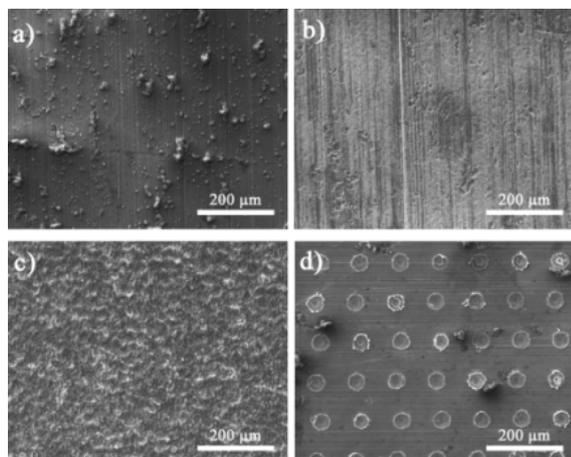
Fig. 1: Tested surface structures a) plain; b) low roughness, c) high roughness, d) dimpled.

AZ31 plates (0.4-mm-thick) were cut in 10×20 mm² specimens. Laser surface structuring was performed and 3 structures were patterned: 1- high roughness – HR ($R_a = 1.069 \mu\text{m}$), 2- low roughness – LR ($R_a = 0.218$), and 3- dimpled – DP ($R_a = 0.862 \mu\text{m}$) (Fig. 1). In order to assess the degradation behaviour, static immersion tests was carried out in PBS solution for 14 days. The average corrosion rate (CR_a) was determined based on the weight loss method. Cross sections of the specimens allowed observing the degradation layer. Atomic absorption spectrometry was employed to measure the release

The hindered corrosion rate for DP type is suspected to be mainly due to changes in surface chemistry. The formation of degradation layer also followed the dimple geometry, depicting the geometrical influence. The laser treatment can be further optimized for graded corrosion behaviour of Mg-based alloys.
